# Aviation Investigation Final Report

| <b>Location:</b> | Little Rock, Arkansas | <b>Accident Number:</b> | CEN23FA113 |
| <b>Date &amp; Time:</b> | February 22, 2023, 11:56 Local | <b>Registration:</b> | N55PC |
| <b>Aircraft:</b> | Beech B200 | <b>Aircraft Damage:</b> | Destroyed |

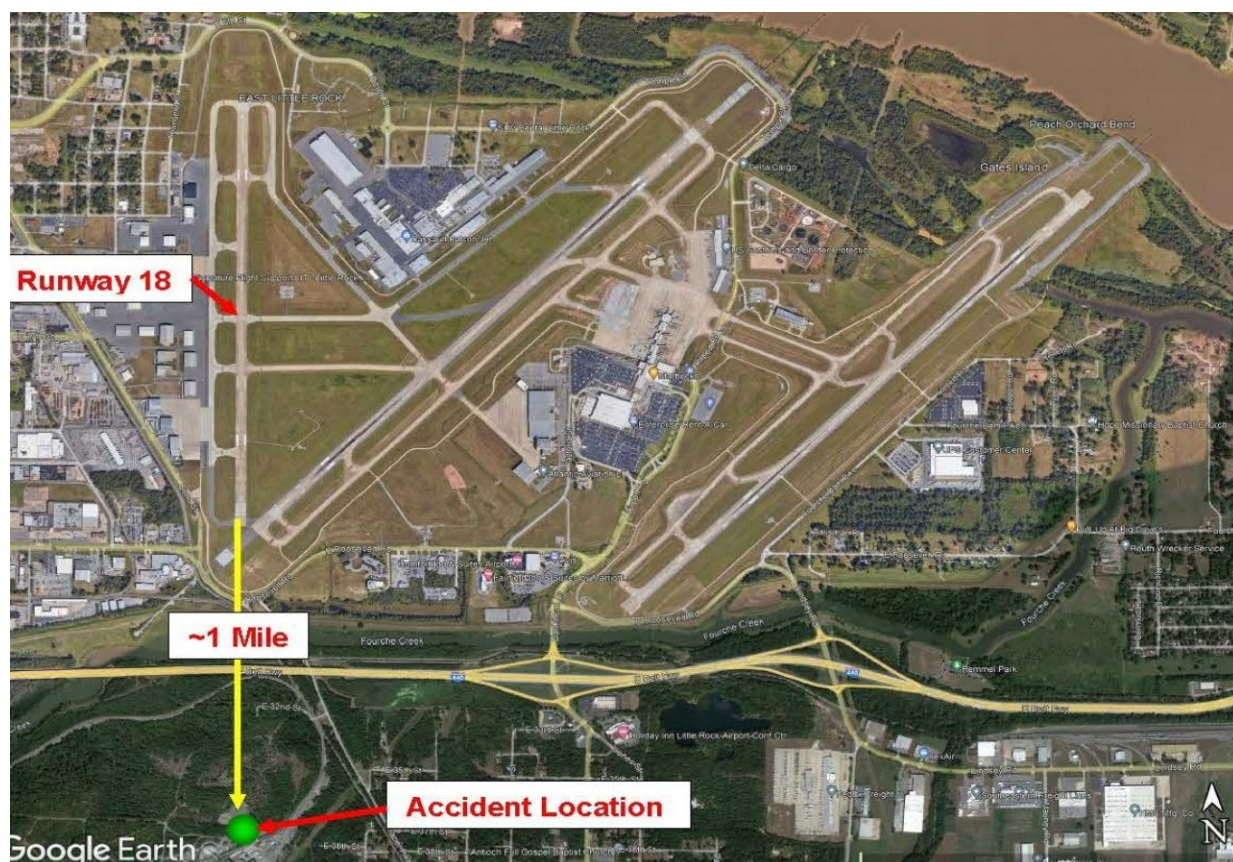
The wreckage of the airplane was found amidst heavily wooded terrain adjacent to a factory about 1 mile south of the departure end of runway 18. (See Figure 1.)

Figure 1. Accident location (green dot) in reference to runway 18 at LIT.

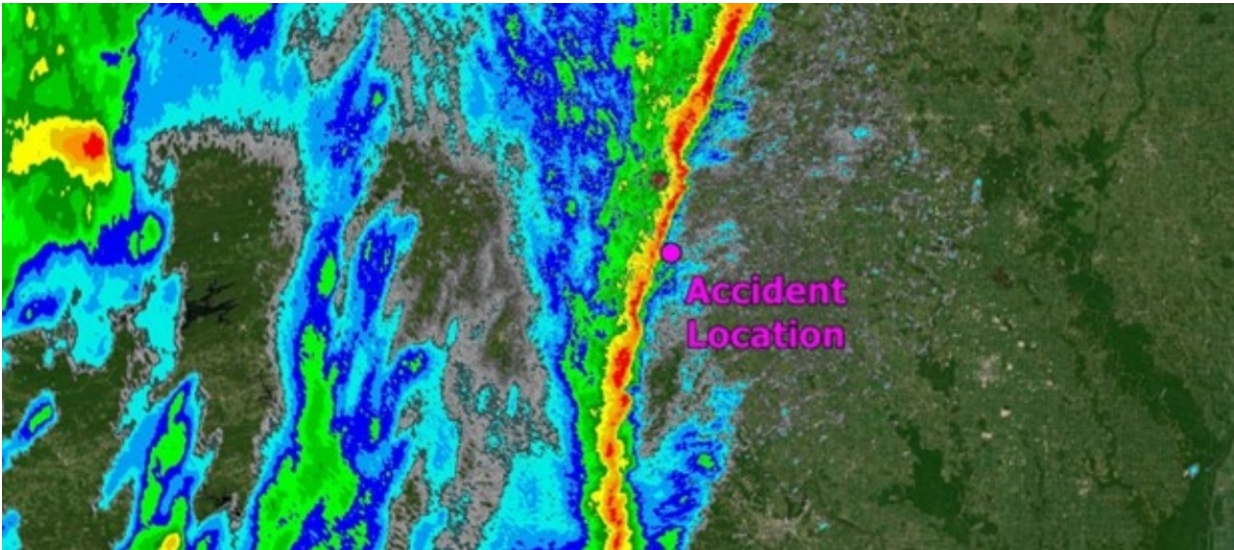
Weather radar imagery identified a line of extreme-intensity precipitation approaching LIT from the west during the period before the accident. (See Figure 2.) Velocity imagery depicted the accident location along a line of radial wind shift about the accident time.

Figure 2. Weather Radar Image. The accident site is depicted by a pink dot.

According to the National Weather Service, based on information gathered by radar, a wind shift occurred about 1 nautical mile to 1.10 nautical miles ahead of the 25dBz precipitation values in the vicinity of the accident site.

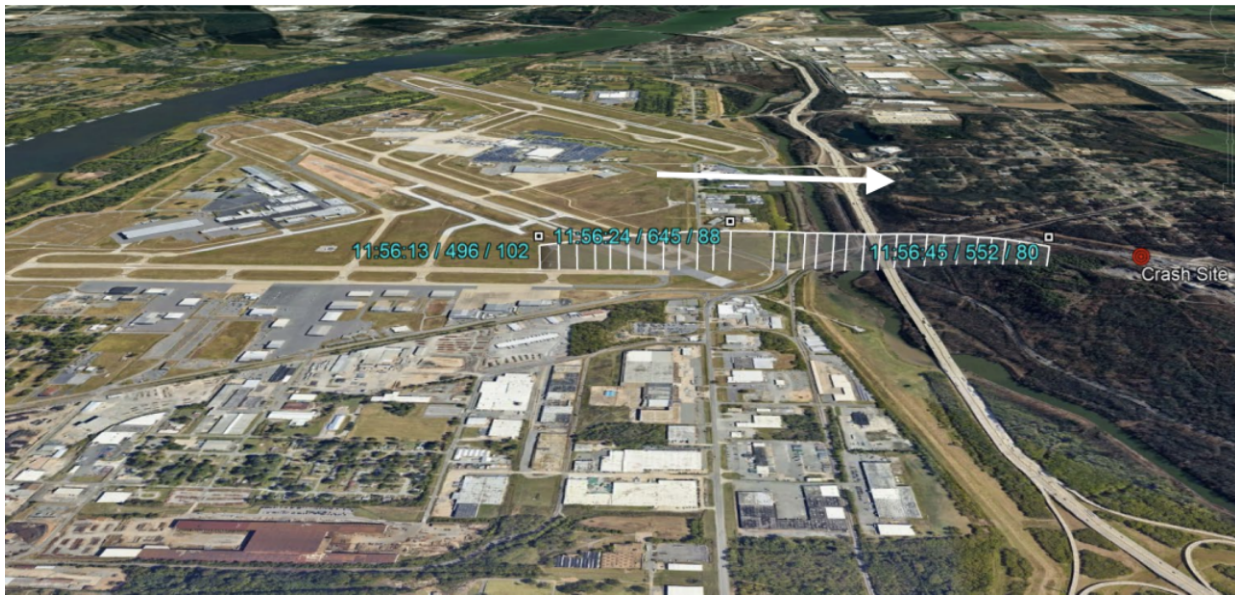
peak altitude. A simplified mathematical model of the airplane was used to calculate thrust and horsepower; both thrust, and horsepower showed sharp decreases at 1156:20, consistent with a decrease in total energy. Each of the airplane's engines was rated at 850 shaft horsepower (hp) for a total of 1700 hp. The actual power delivered to the airframe will be less than the total because the engines and propellers are not 100% efficient. During the accident takeoff, the maximum value calculated was only about 900 hp, and after 1156:20, the value was less than 400 hp. A profile view of the airplane's flight path can be seen in Figure 3 below.

Figure 3. Profile view of the accident takeoff with direction of flight denoted by white arrow.

Assuming that the airplane's flaps were retracted during the accident takeoff, the hp calculated during the last 25 seconds of recorded data from the accident flight was about 20% of the hp calculated for the two previous takeoffs. With the flaps fully extended, the hp calculated during the accident takeoff was only about 56% of that calculated from the two previous takeoffs.
