Air Accident Investigation Unit Ireland

FORMAL REPORT

**Partenavia P68, F-HIRD
Near Carnsore Point, Co. Wexford**

AAIU Report No: 2025-001

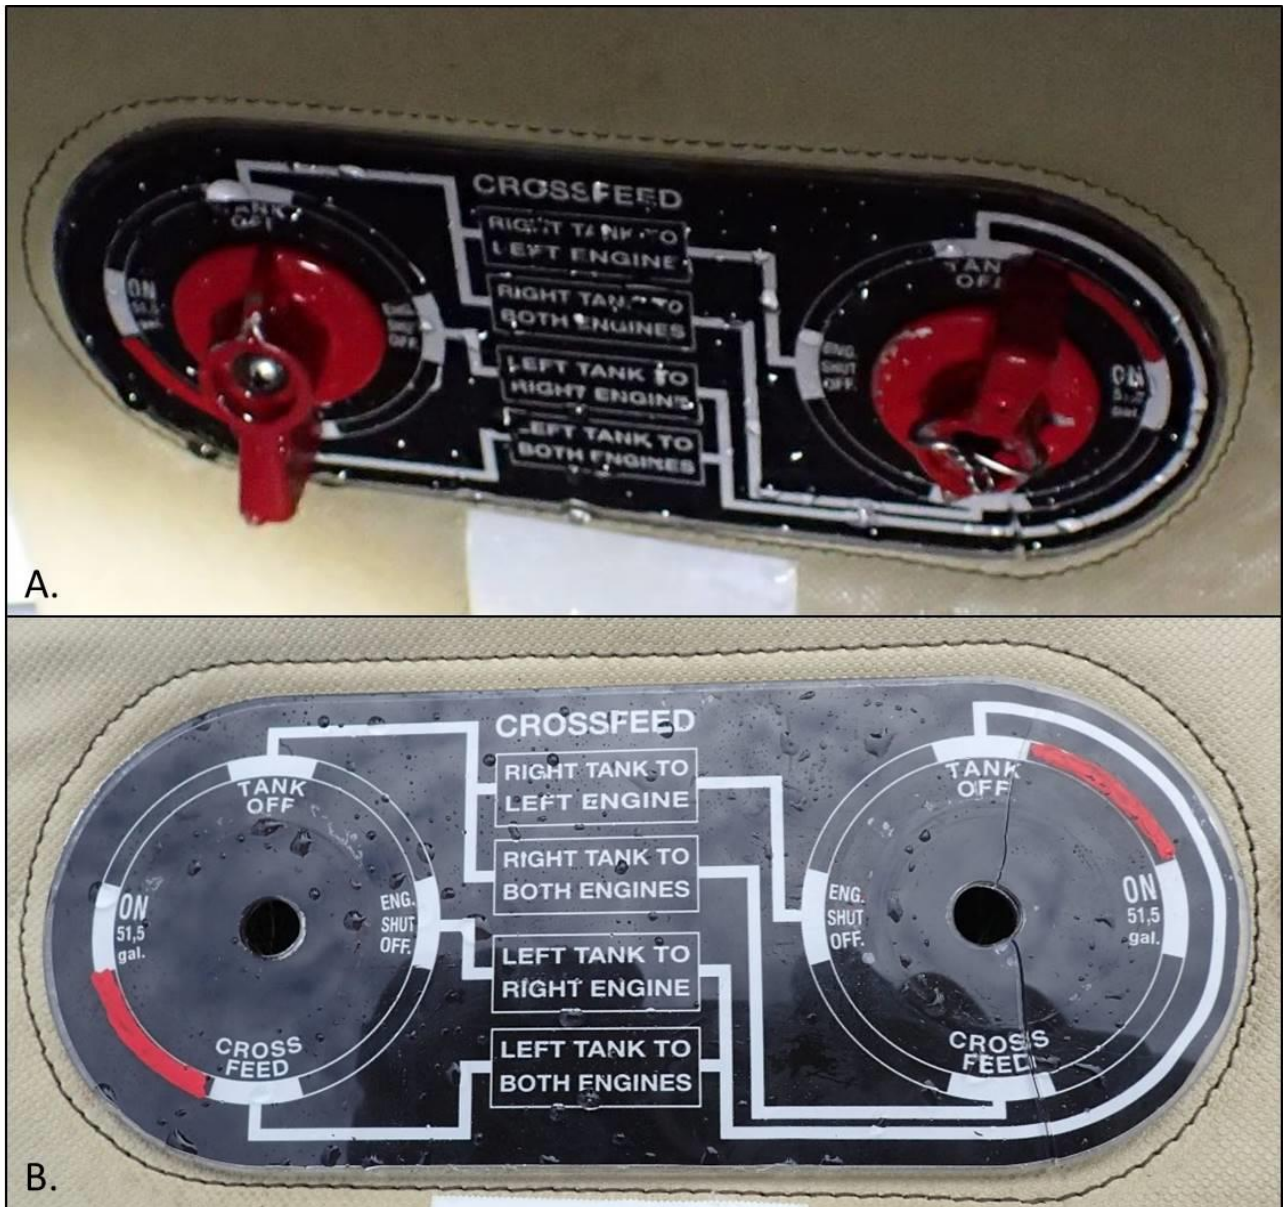
Figure No. 3: Fuel Selectors - A. Showing Fuel Selector Panel with fuel selector knobs installed and B. with Fuel Selector knobs removed.

Red quadrants indicate the positions through which the fuel selector knob cannot pass. However, the Investigation found that the red quadrant for the right engine was incorrectly marked. The red marking was between the 'TANK OFF' and the 'ON' positions but when checked after the accident, the Investigation found that it was not possible to move the fuel selector knob between the 'ENG. SHUT OFF' and 'TANK OFF' positions. The Investigation also observed that the inaccessible positions were different for the left engine. In the case of the left engine, it was not possible to move the fuel selector knob between the 'CROSSFEED' and 'ON' positions. This was consistent with the red quadrant.

The examination showed some free play in the fuel selector knobs. It was also observed that the inaccessible portion of the right fuel selector (shown in red at the right side of **Figure No. 3** in **Section 1.6.2.1**) was incorrectly indicated. The aircraft fuel selector showed the inaccessible (red) quadrant in the 1-3 o'clock position. The Investigation found that the inaccessible portion of the right fuel selector approximately corresponded to the fuel selector being positioned in the 10-12 o'clock arc.

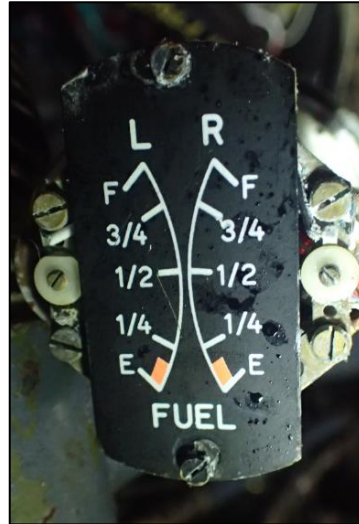
Photo No. 1: Fuel Gauge (post-accident)

A fuel gauge for each wing tank was installed in the aircraft instrument panel (**Photo No. 1**).

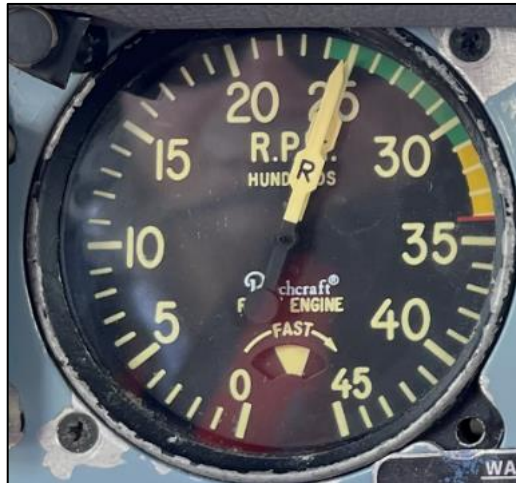
Figure No. 4: RPM Gauge from the Subject Aircraft

During the inspection of the aircraft, the Investigation observed that the RPM gauge¹⁵ (tachometer) for the engines was from another aircraft manufacturer. The RPM gauge indicated green and amber running ranges and a red RPM limit (**Figure No. 4**). However, these ranges and the limit were different, and were higher than those specified in the AFM for the subject aircraft (**Figure No. 5**). Further information is contained in **Section 1.17.4.3**.

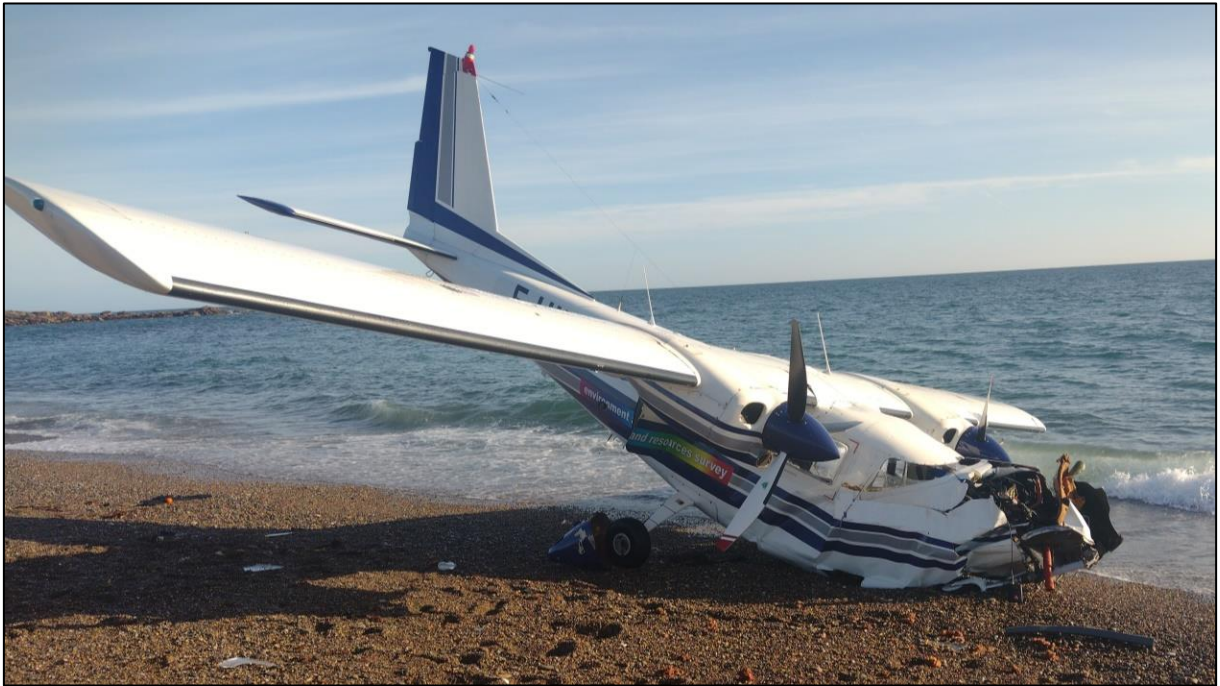
Photo No. 2: Aircraft wreckage immediately after impact

One of the Task Specialists on board the aircraft took a photograph (**Photo No. 2**) immediately after the accident. **Photo No. 3**, which was taken by the Investigation team on arrival at the accident site several hours later, indicates the extent of damage that was caused by the incoming tide.

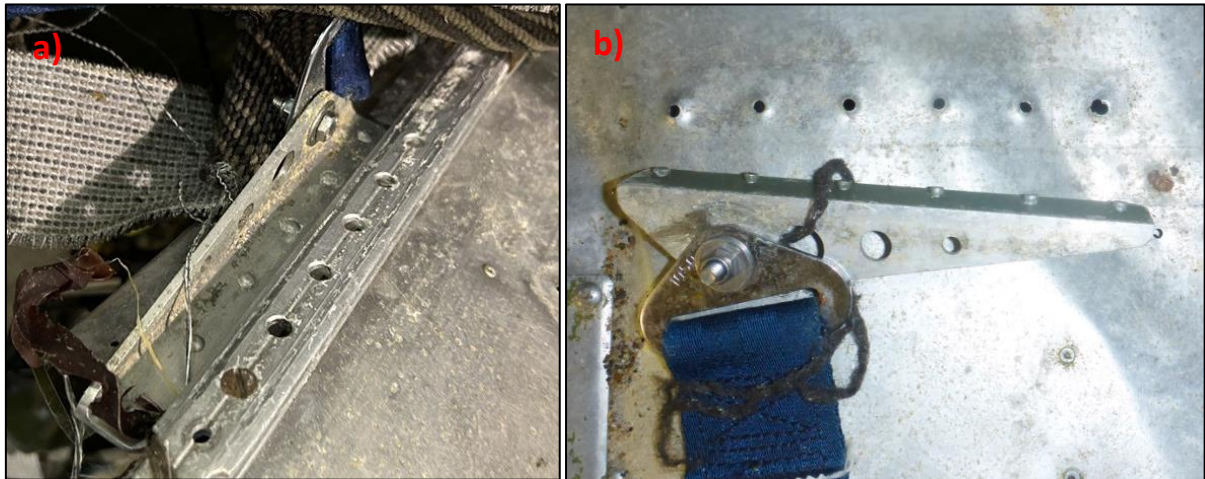
Figure No. 11: Seatbelt attachment brackets ((a) attached, and (b) detached)

As outlined in **Table No. 5**, some of the seatbelt attachment brackets had separated from the floor area during the accident sequence. The aircraft Type Certificate Holder advised that the lap strap style seatbelts should be attached to the aircraft floor and that the location of the attachment points was designed such that the seat belts would be anchored to aircraft structure underneath the floor. However, a review of the original drawings for the aircraft did not show the detail of this attachment. The attachment points of the seatbelts that had separated in the accident were secured to sheet metal floor panels rather than aircraft structure. In some cases, the mounting brackets and associated rivets had been pulled away from the sheet metal panels during the accident sequence. Examples of an attached and detached seatbelt are shown in **Figure No. 11**.

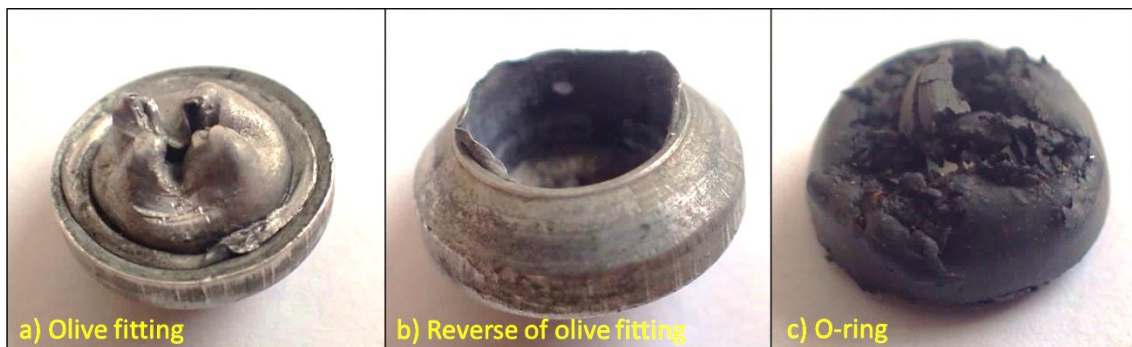
Figure No. 12: Damage to Olive Fitting

During the inspection of the crossfeed system, the Investigation observed that a fitting on the crossfeed pipe (**Figure No. 1** in **Section 1.6.2**) where it connected to the right-hand fuel transfer valve, was loose, and that the pipe could move in and out along the longitudinal axis of the pipe and fitting. The Investigation disassembled the fitting and found significant damage to the olive fitting (**Figure No. 12a** and **12b**) and o-ring (**Figure No. 12c**). The damage did not appear to be recent.

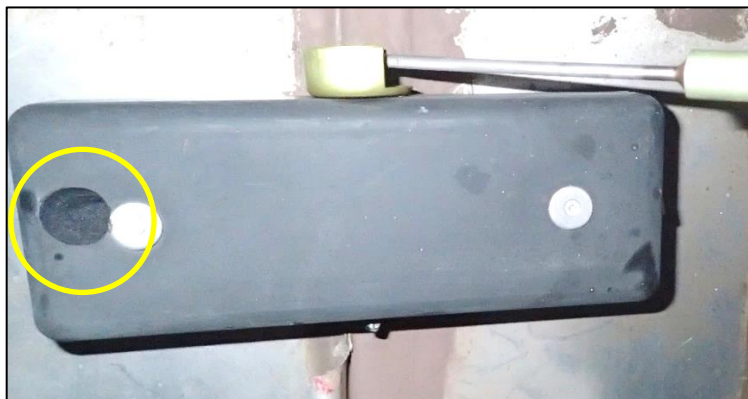
Photo No. 4: Left Fuel Tank Transmitter float (damaged area highlighted)

- The Investigation observed that it was possible for the left float to become caught on the fuel tank access panel nut and if this occurred, it would be possible for the left transmitter to read 'full' although the fuel level was reducing.
