AIRCRAFT ACCIDENT INVESTIGATION REPORT

**Formosa Airlines
SAAB-340, B-12255
March 18, 1998**

June 5, 2001

Civil Aeronautics Administration

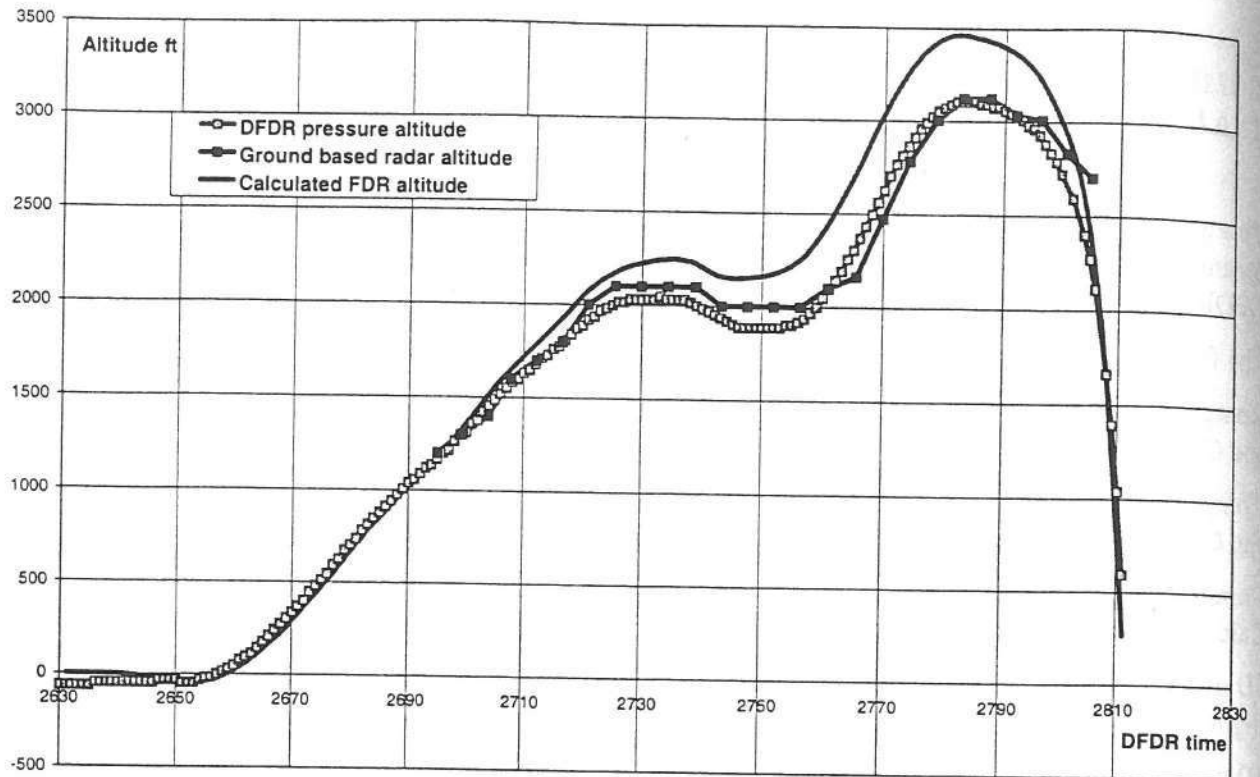
Comparison between DFDR pressure altitude, Ground based Radar altitude and Calculated altitude based on DFDR parameters versus DFDR time.

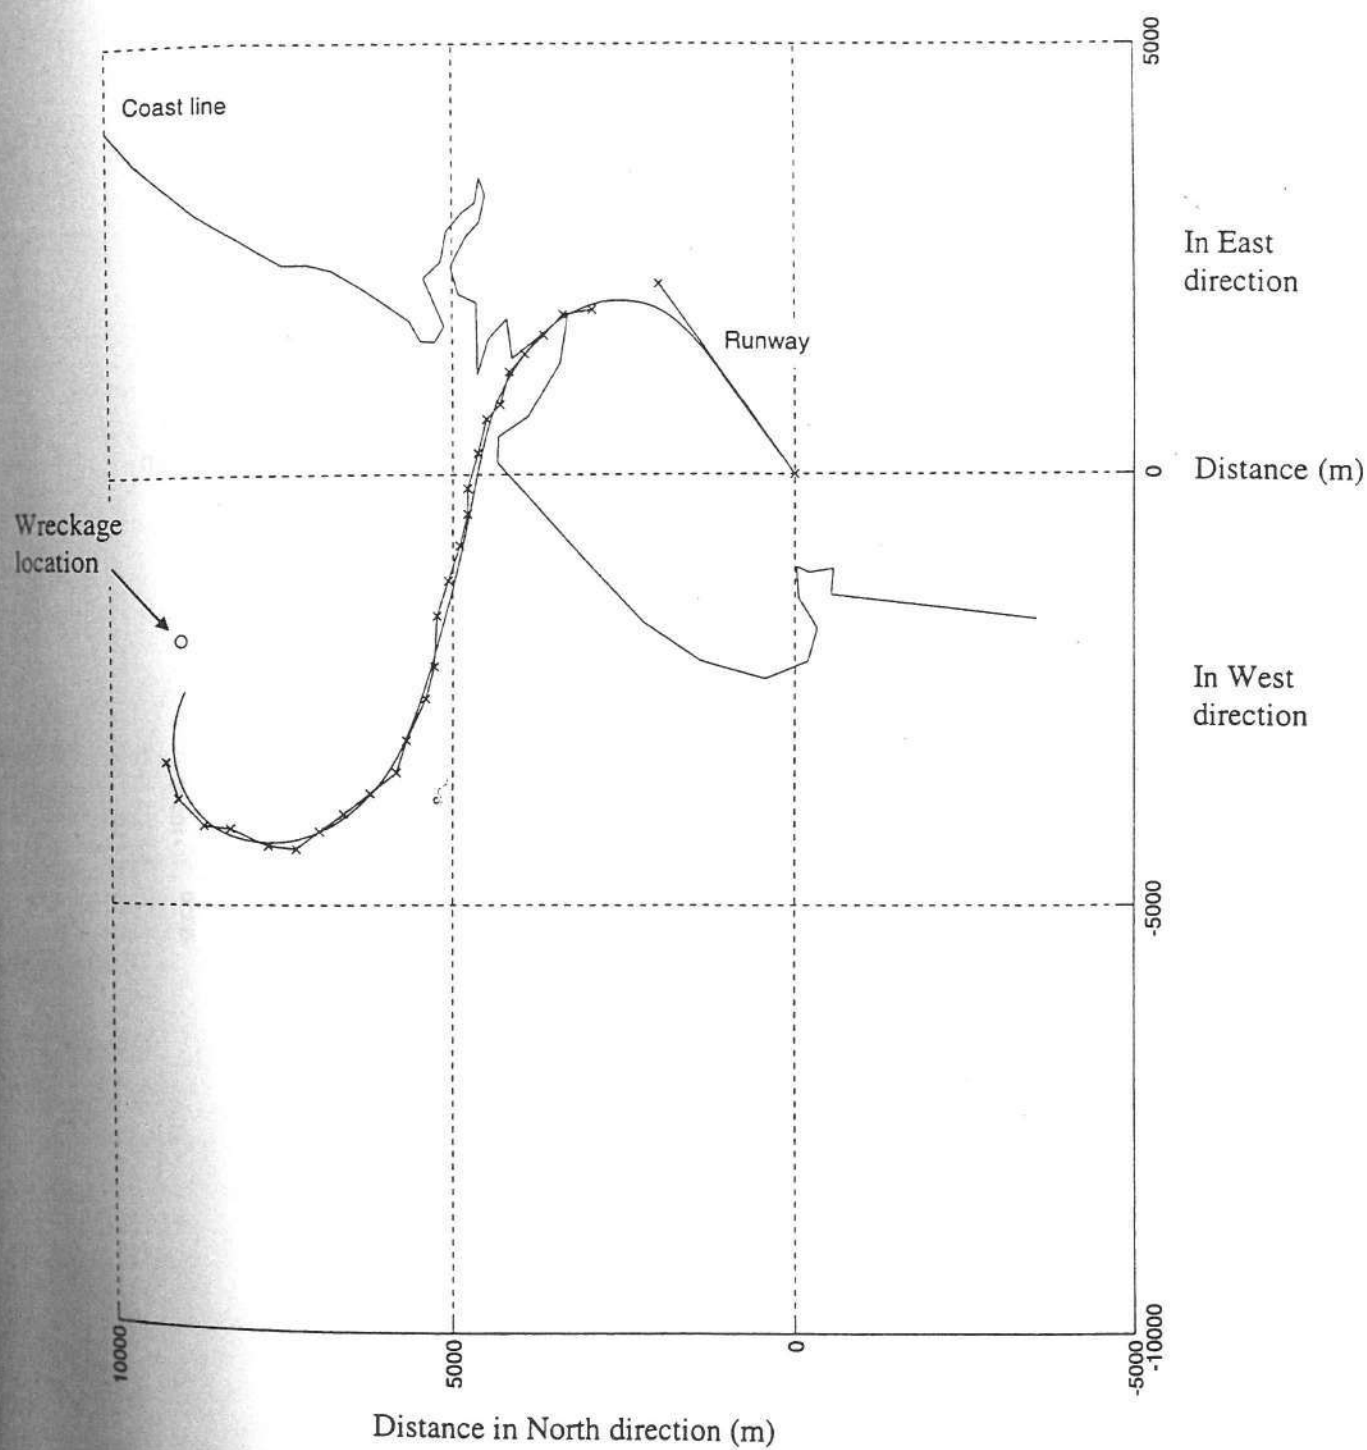
Comparison of ground referenced track between Ground based Radar and Calculated track based on DFDR parameters. Origo at beginning of runway.

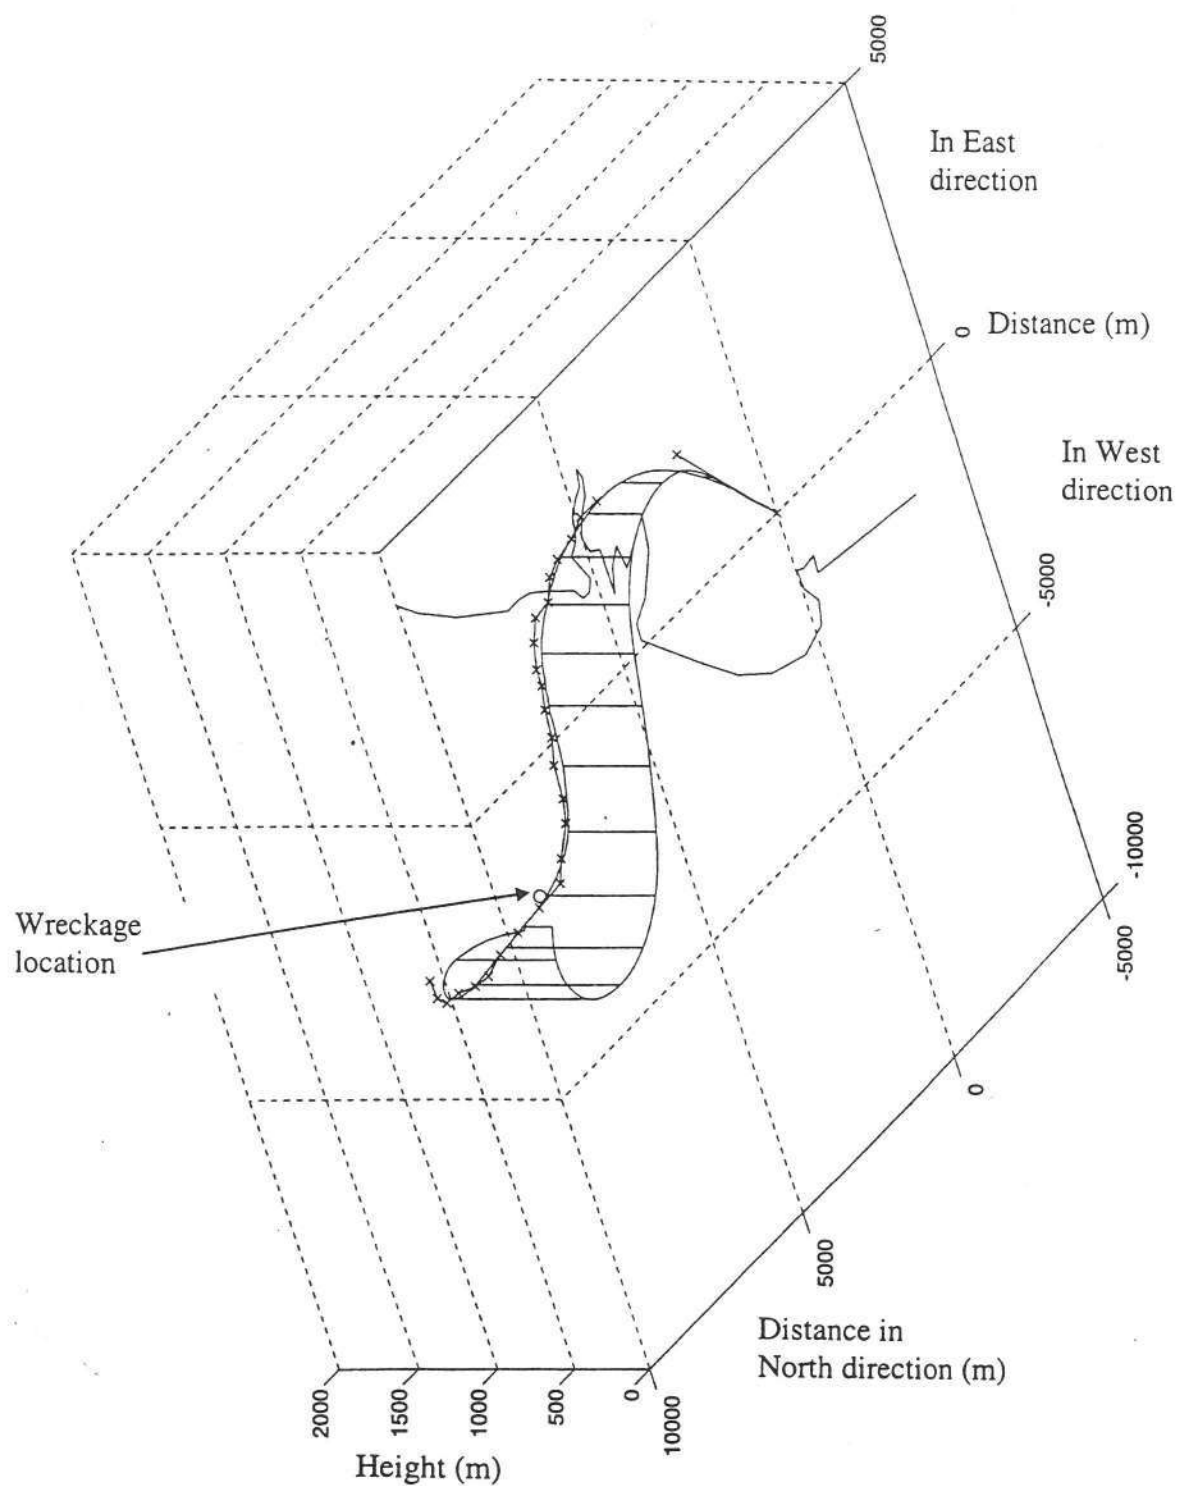
3D plot comparison between Ground Based Radar and DFDR calculated flight trajectories - view from southwest. Origo at beginning of runway .

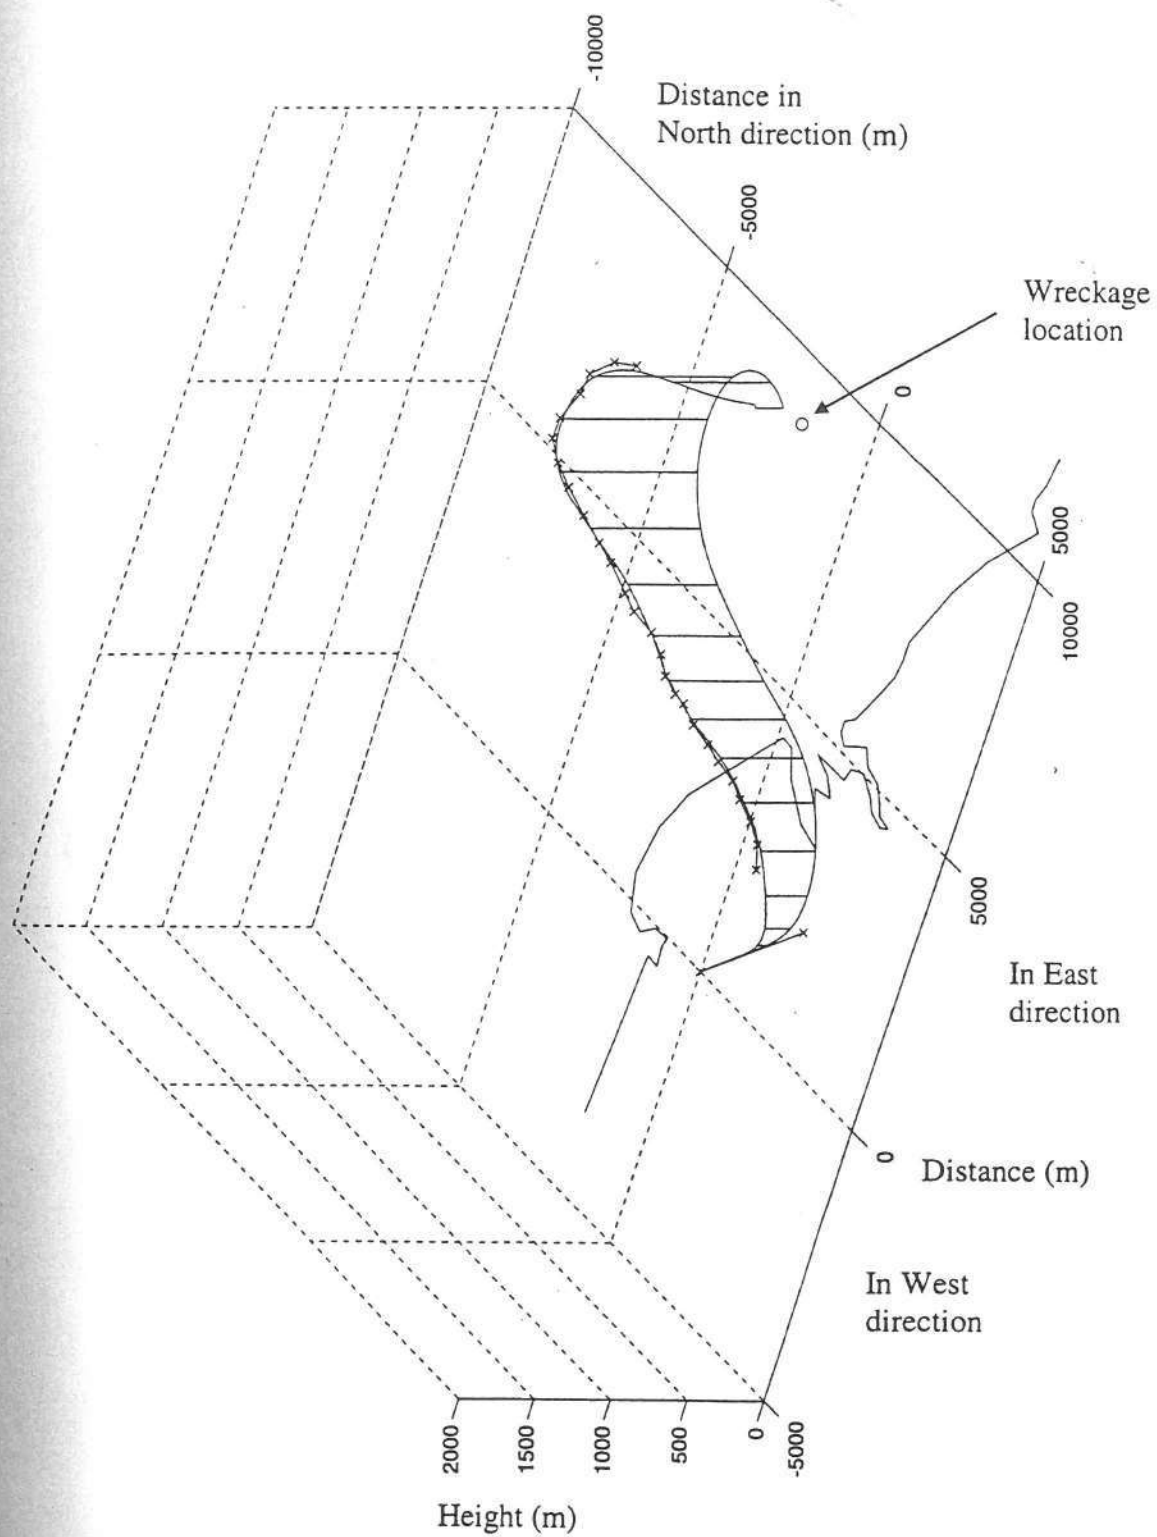
3D plot comparison between Ground Based Radar and DFDR calculated flight trajectories - view from southeast. Origo at beginning of runway.

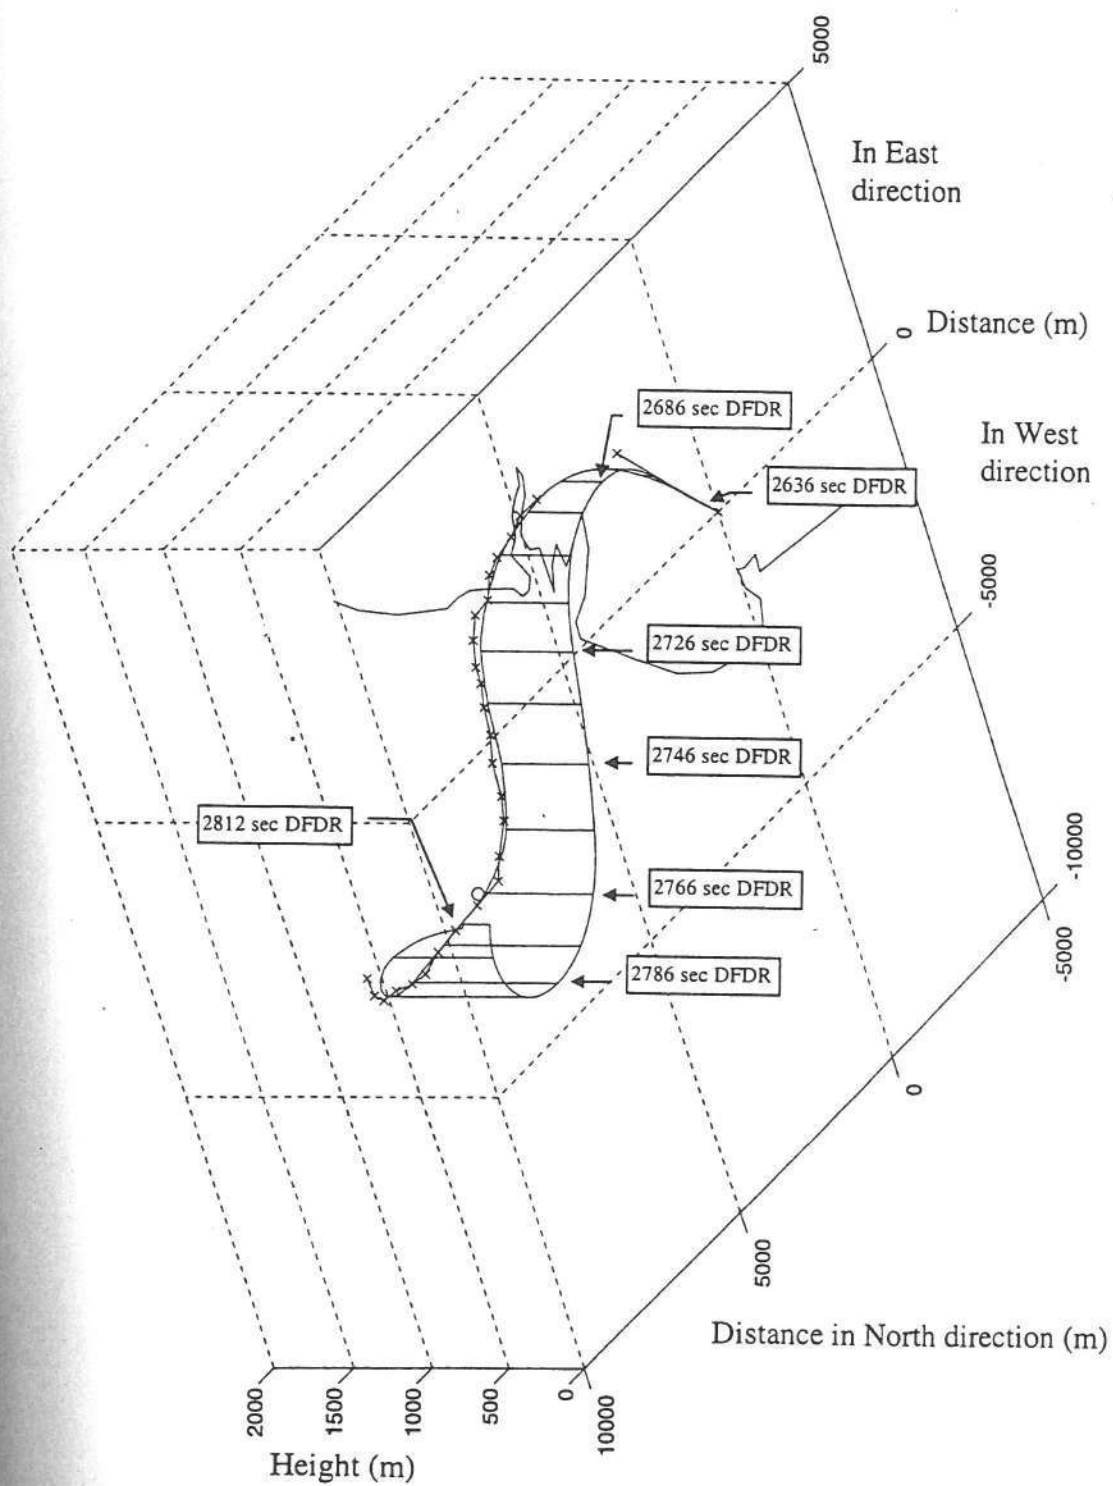
Calculated flight trajectory with DFDR time. Note that there are 10 seconds between each vertical line.

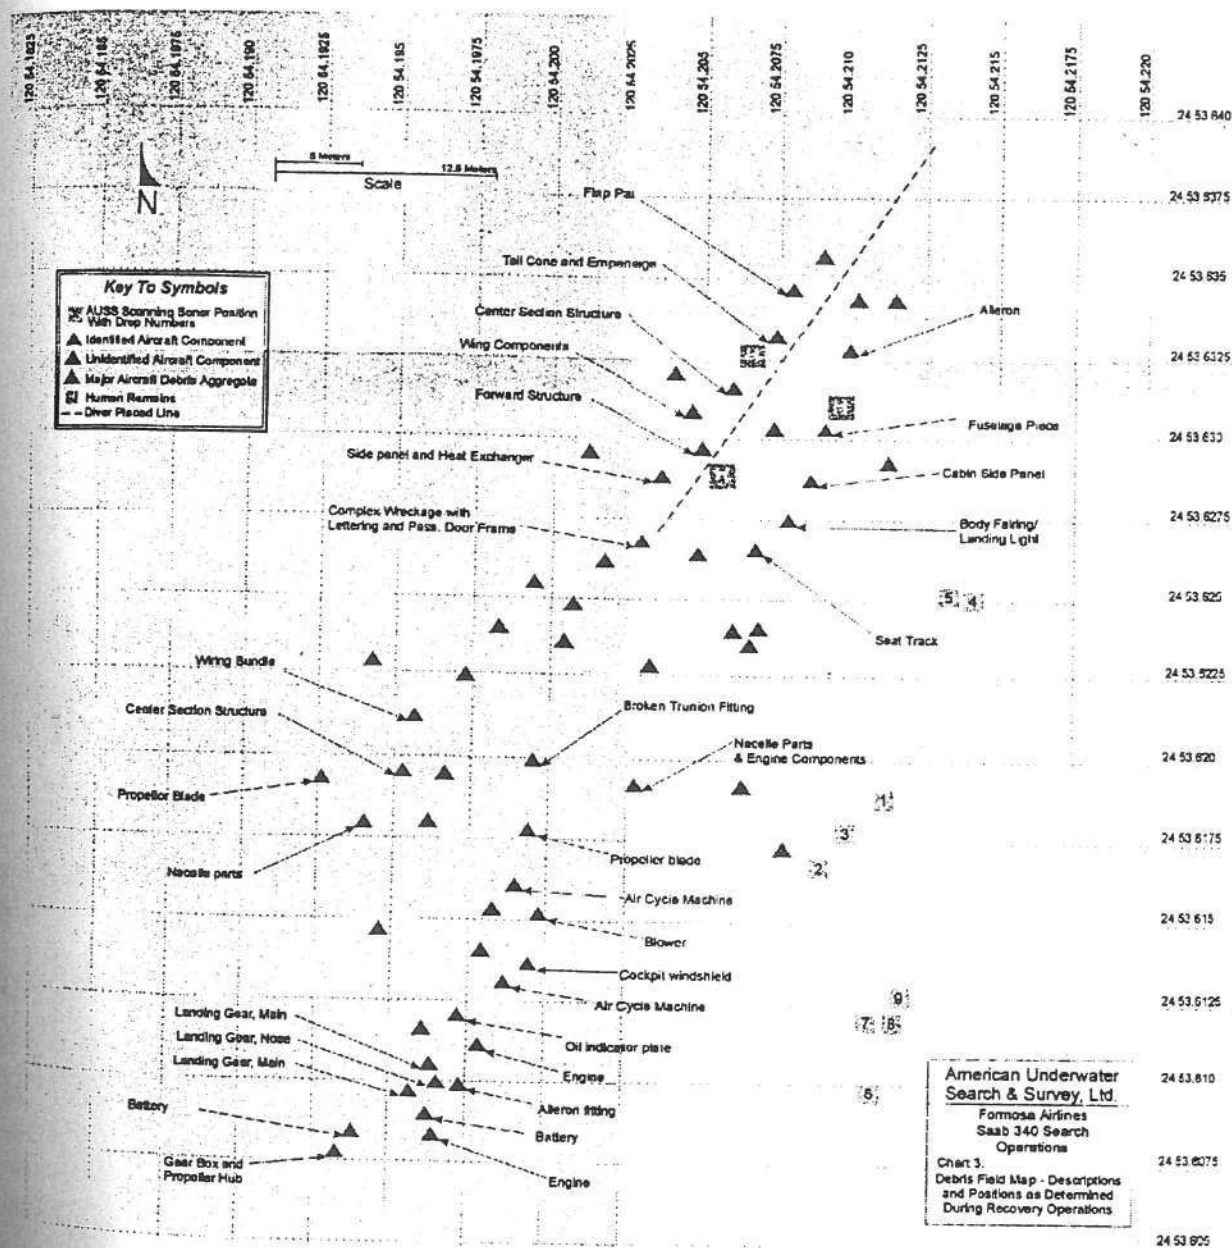
Position Major Parts Recovered from the Bottom of the Sea

Position of major aircraft parts recovered from the bottom of the sea.
