# Aviation Investigation Final Report

| <b>Location:</b> | Provo, Utah | <b>Accident Number:</b> | WPR23FA080 |
| <b>Date &amp; Time:</b> | January 2, 2023, 11:35 Local | <b>Registration:</b> | N555NR |
| <b>Aircraft:</b> | EMBRAER EXECUTIVE AIRCRAFT<br>INC EMB-505 | <b>Aircraft Damage:</b> | Substantial |

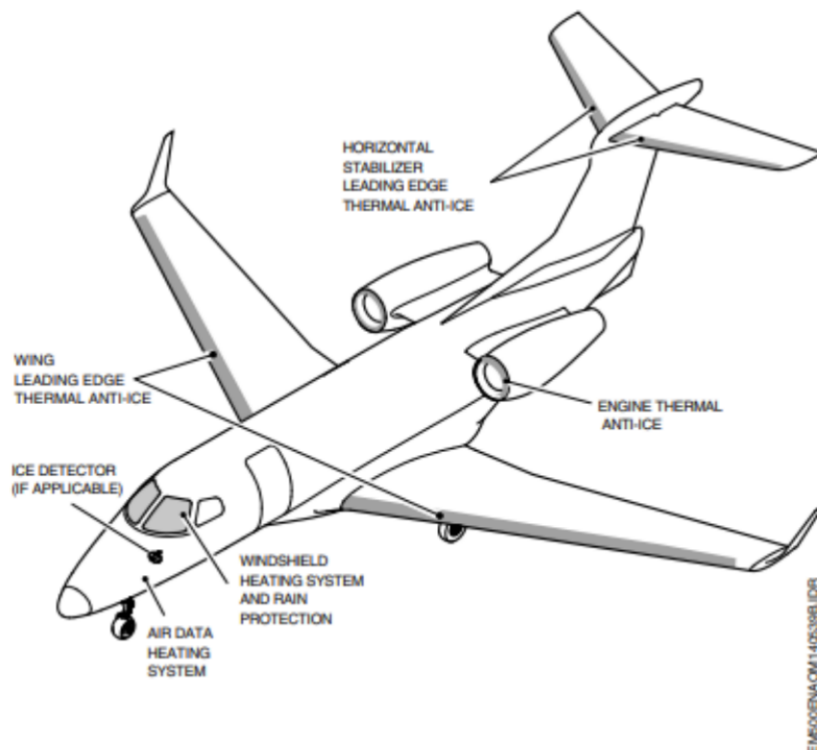
The airplane was equipped with a Wing and Horizontal Stabilizer Anti-Icing System (locations depicted in figure 1), which was designed to prevent ice formation and remove any ice formed on the leading edges of the wing and the horizontal stabilizer. The system was activated by a

Figure 1: Airframe Ice and Rain Protection System Deice Systems (Source: Phenom 300 Pilot's Operating Handbook, Volume 1)

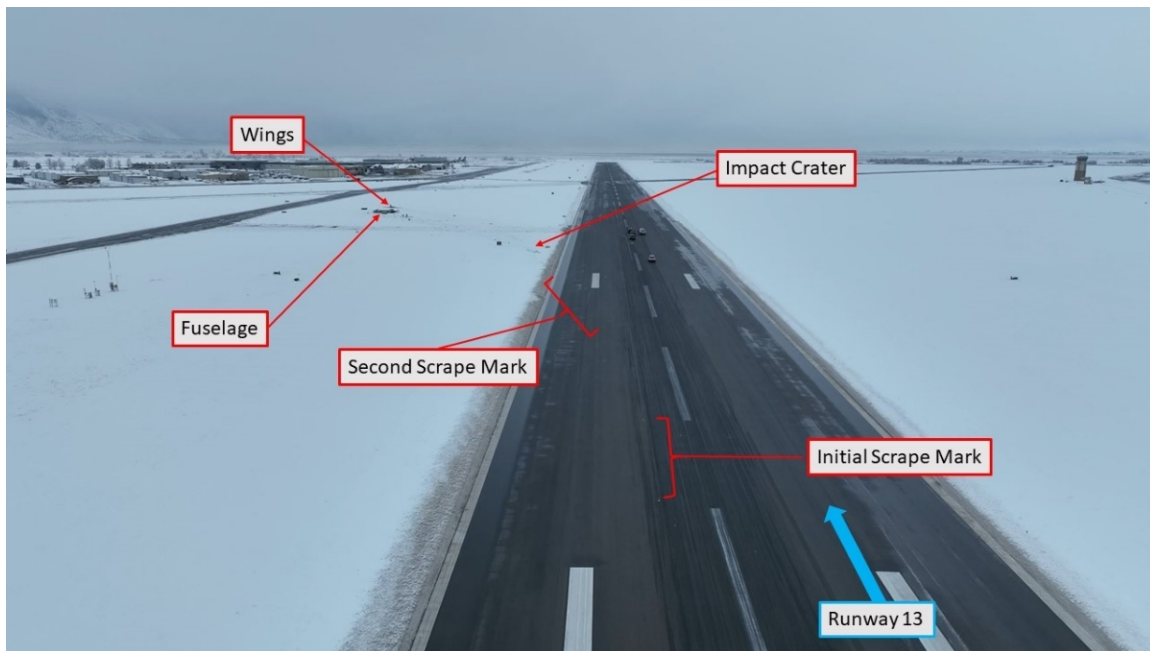
Investigators arrived onsite about 23 hours after the accident, and about 4 to 6 inches of fresh snow had fallen, masking impact marks, ground scars, and debris. Examination of the accident site revealed that the airplane impacted the runway surface about 2,626 ft from the approach end of runway 13 and about 20 ft left of the runway centerline. A scrape mark extended about 91 ft and was parallel to the runway centerline.

A second scrape mark was observed about 2,903 ft from the approach end of runway 13, and arced left to the left edge of the runway surface about 3,126 ft from the approach end of the runway. A swath of displaced snow and dirt extended from the runway's left edge about 100 ft to a large impact crater. The crater contained portions of airframe debris and various airframe components. Wreckage debris extended from the crater about 597 ft to the fuselage. The wings were separated from the airframe and were located about 106 ft beyond the fuselage. Both engines were separated and located adjacent to the fuselage.

Figure 2: Aerial overview of the accident site. Image courtesy of Provo Police Department with NTSB annotations.
