INVESTIGATION REPORT

**Embraer EMB-110-P1  
Bandeirante DQ-AFN**

**24 July 1999**

**Delailasakau  
Republic of the Fiji Islands**

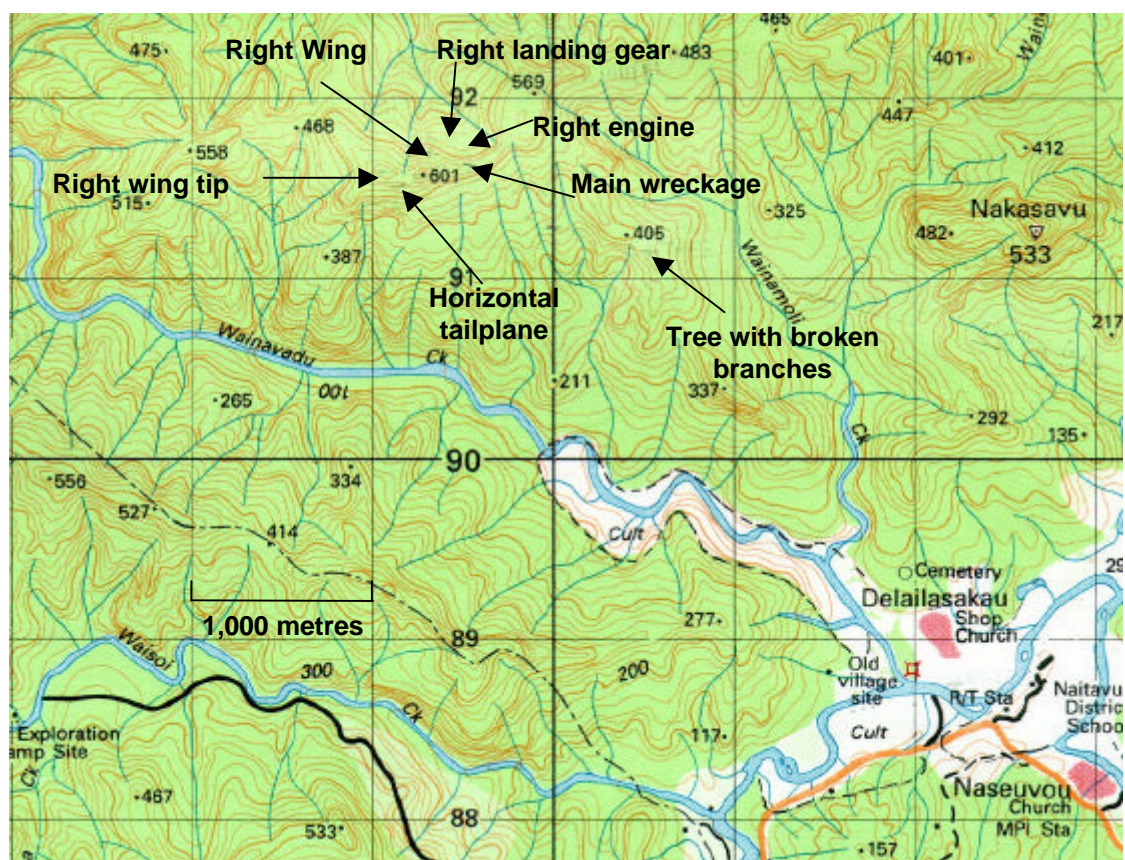
The locations in which the components were found suggested that the aircraft began to break up and separate shortly before impacting the trees and ridge. The aircraft's final flight path was in a north-easterly direction and descending at an angle of 40°.

The aircraft had sustained significant damage to the leading edge of the right wing, 2.2 metres inboard of the wingtip. About a metre of the leading edge was torn away and the main spar of the right wing had fractured 2.2 metres inboard of the wingtip and was deformed rearwards about 100 millimetres, at the fracture point. The deformation is consistent with a collision with a solid object. The main and rear spars had also fractured at three locations between the engine nacelle and immediately outboard of the wing attachment fittings. The fractures exhibited rearward and upward bending consistent with stresses that exceeded the structural strength of the wing.

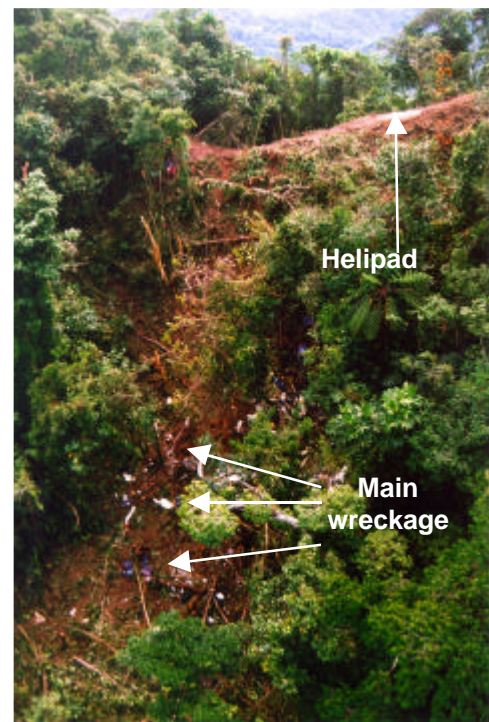
The left engine and propeller were found with the main wreckage. Both were substantially damaged during the final impact. The right engine and propeller had separated from the aircraft prior to the final impact. The right engine was substantially damaged by impact forces. Damage sustained by the right propeller was consistent with the propeller blades having collided with one or more objects while operating under power.

Examination of the engines and propellers indicated that both engines had been operating under power during a collision with one or more objects.

Although the witnesses reported an unusual engine sound while observing the aircraft, no evidence of a pre-existing defect with the aircraft or its systems, that may have influenced the circumstances of the accident, was found.
