Overseas National Airways, Douglas DC-10-30, N1031F, accident at Istanbul
Yasilkoy Airport on 2 January 1976, report dated 7 September 1976, released
by the General Directorate of Civil Aviation, Ministry of Communications,
Ankara, Turkey

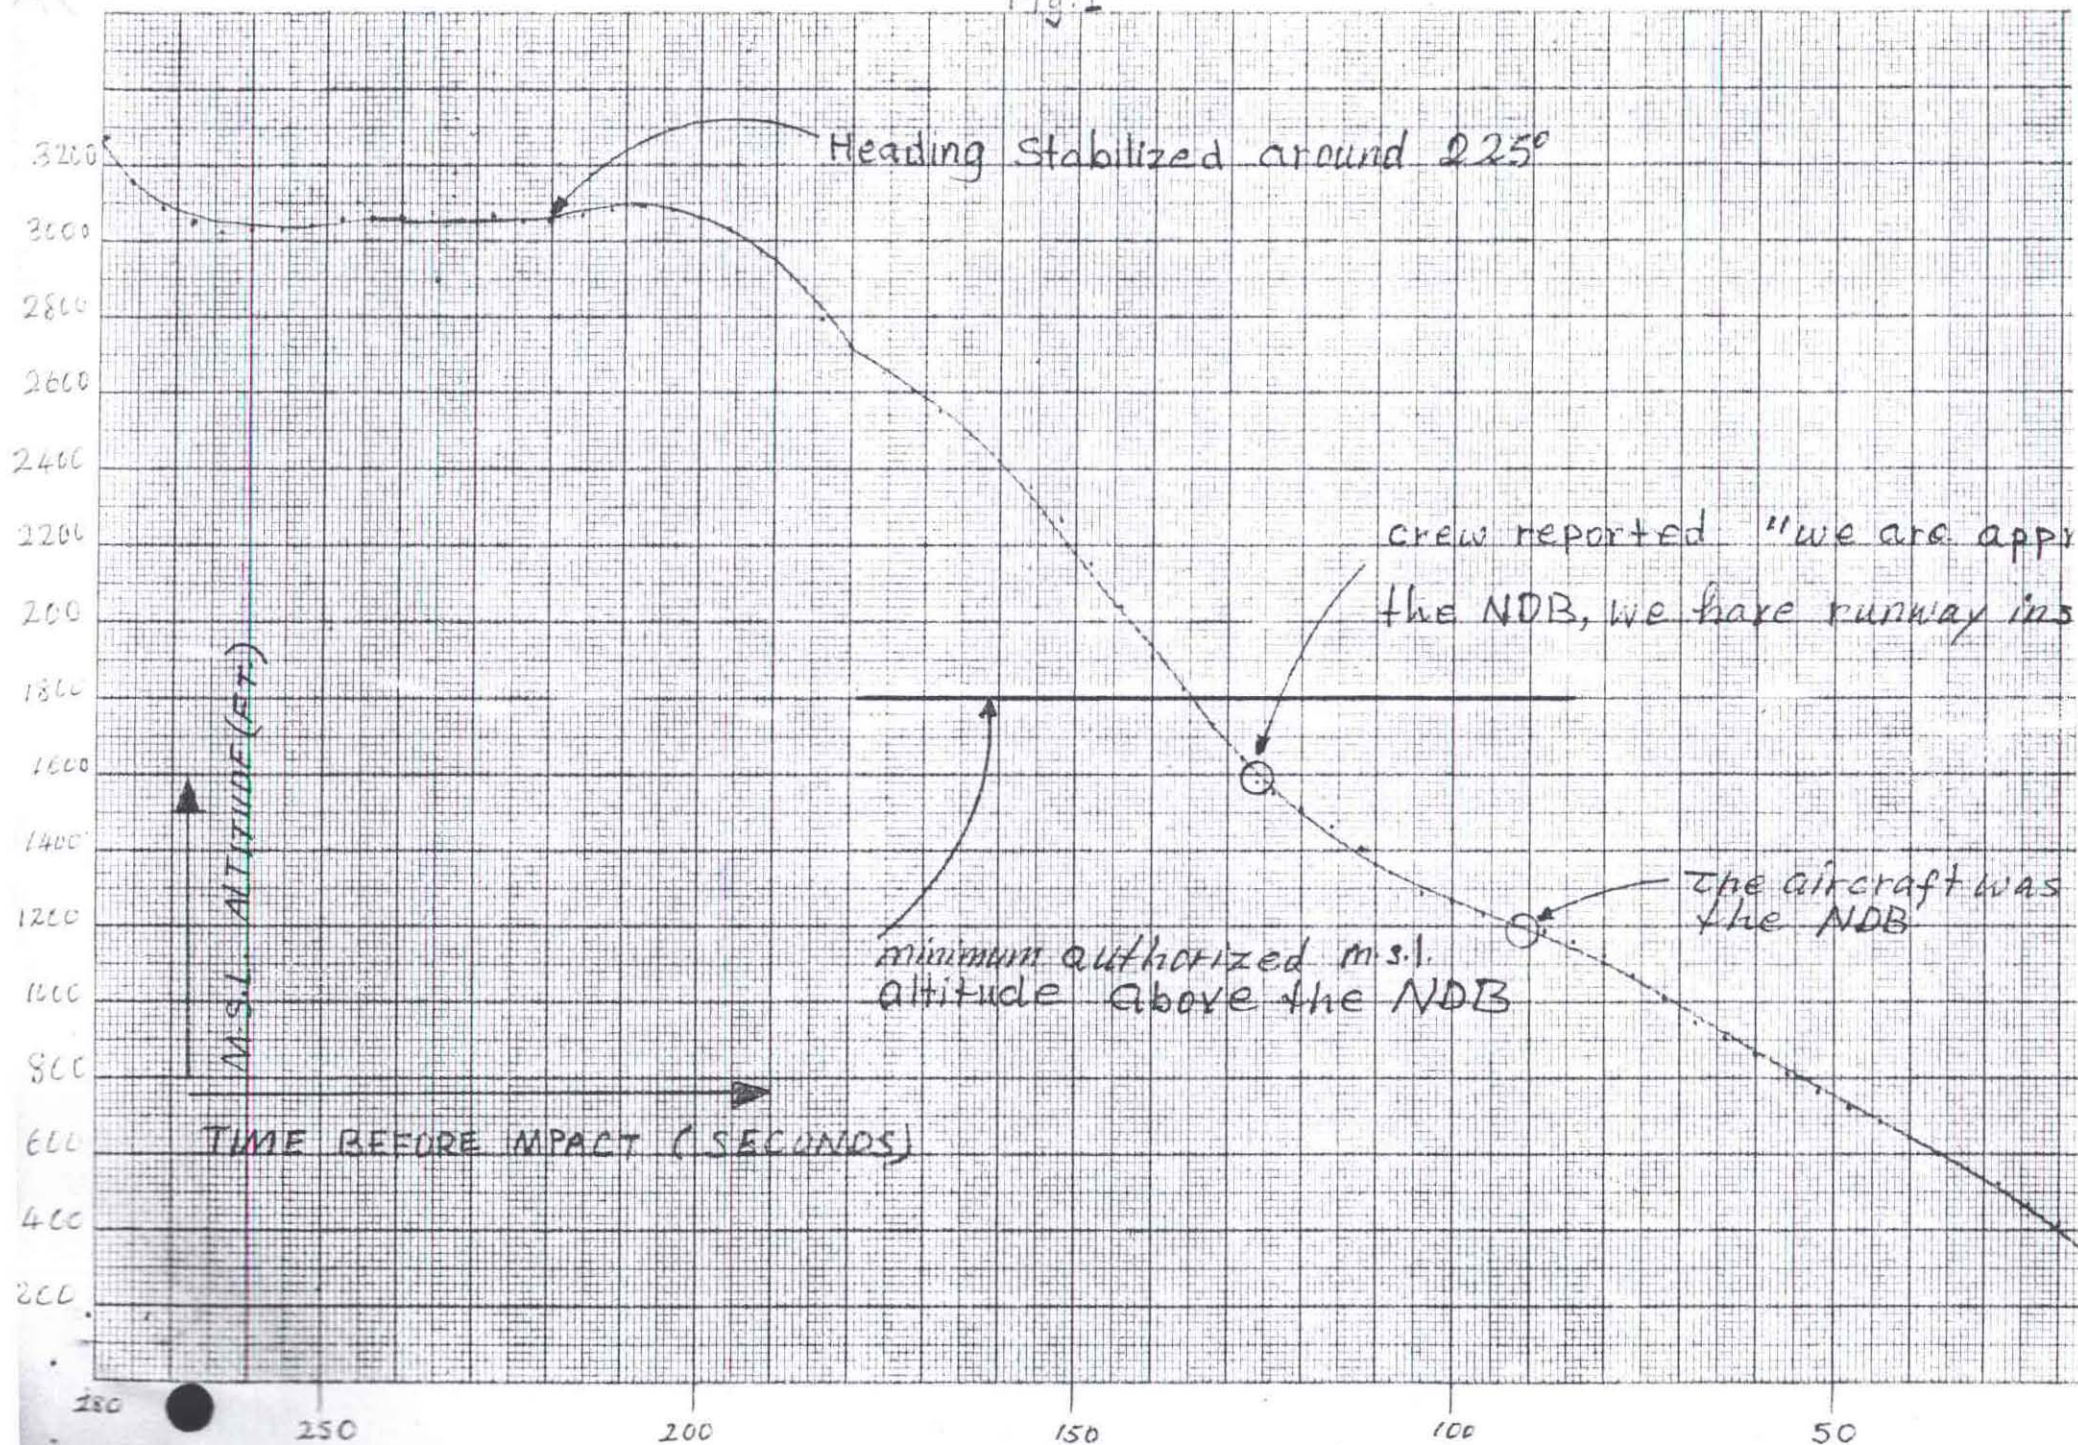
Fig. 1

The Tower controller requested the flight to report leaving NDB. The crew replied to this that they were approaching the NDB and they had the runway in sight. This reporting from the crew took place 126 seconds before the impact at an altitude of 1621 ft. msl. (See Figure 1)

The approach profile of the aircraft for the last 280 seconds of the flight before the impact is plotted in Figure 1 and for the last 66 seconds in Figure 2.

(3) Approximately 36 seconds before the NDB the crew reported, "We are approaching the NDB, we have runway in sight." At this time the msl altitude of the aircraft was calculated to be 1621 ft., heading 215°.

(4) Approximately 90 seconds before the impact it was calculated that the aircraft was over the NDB. This time the msl altitude and heading of the aircraft were calculated to be 1210 ft. and 218° respectively.

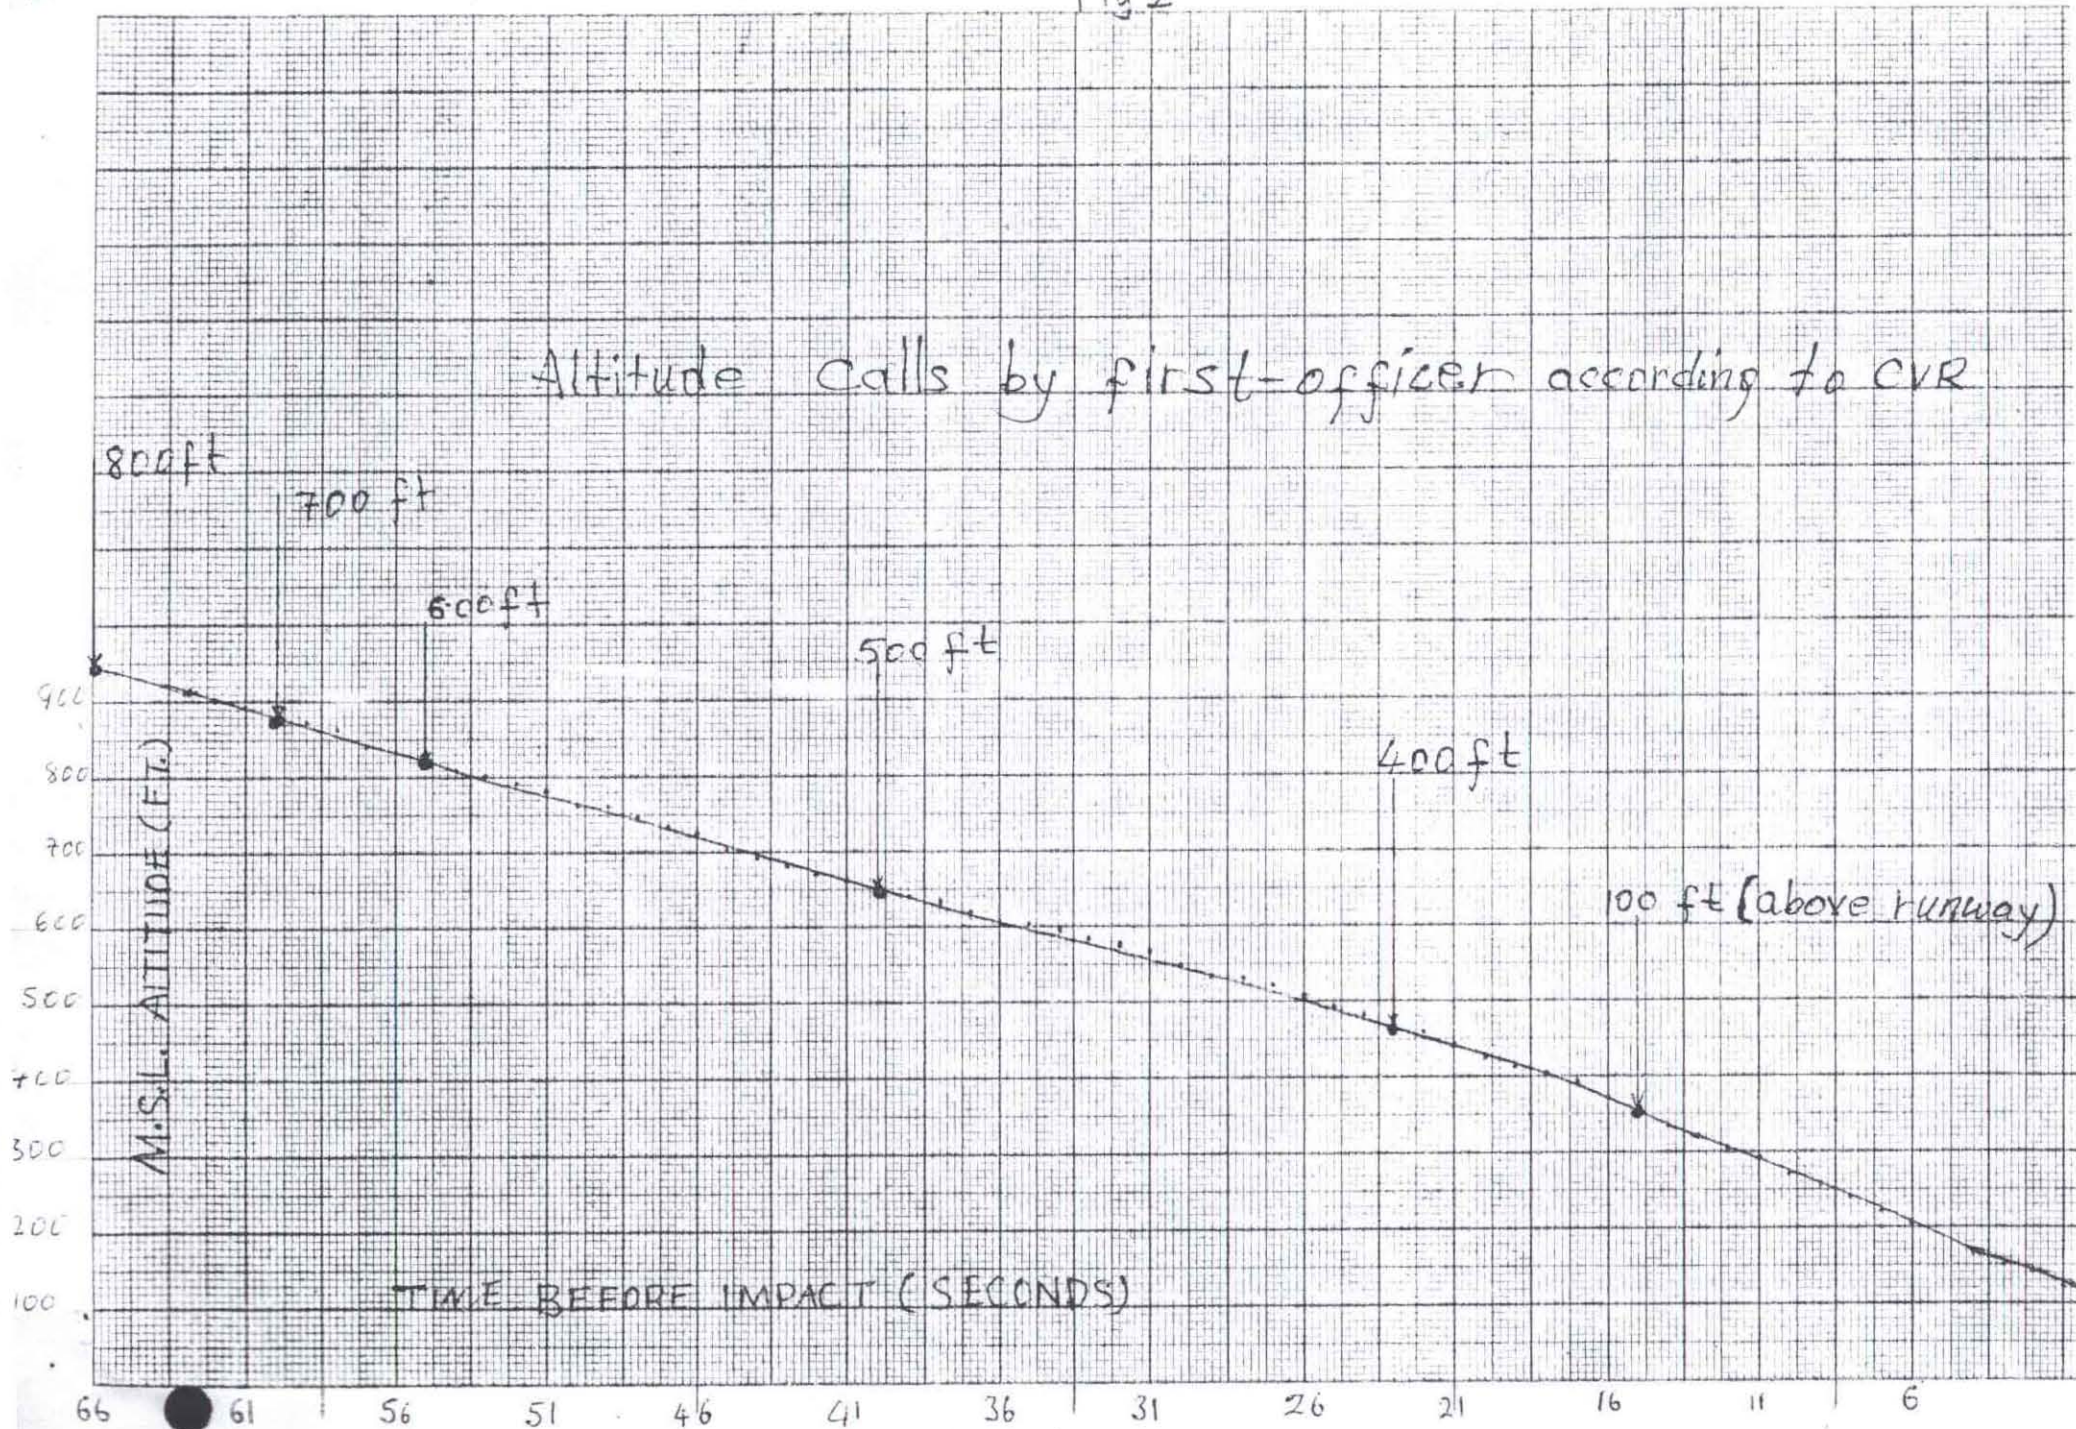
Fig. 2

The CAS (Calibrated Air Speed) print-outs and the approximate msl altitude of the aircraft were used to establish the last 67 seconds approach profile of the aircraft with respect to the horizontal distance of the aircraft from the point of impact. This profile was also compared with the 3° VASIS slope. (Figure 3) The last 67 seconds of the flight before the point of impact was established by taking the average CAS and vertical speed at intervals of 5 seconds up to 60 seconds and an interval of 7 seconds thereafter. Some of the results of these calculations were as follows:

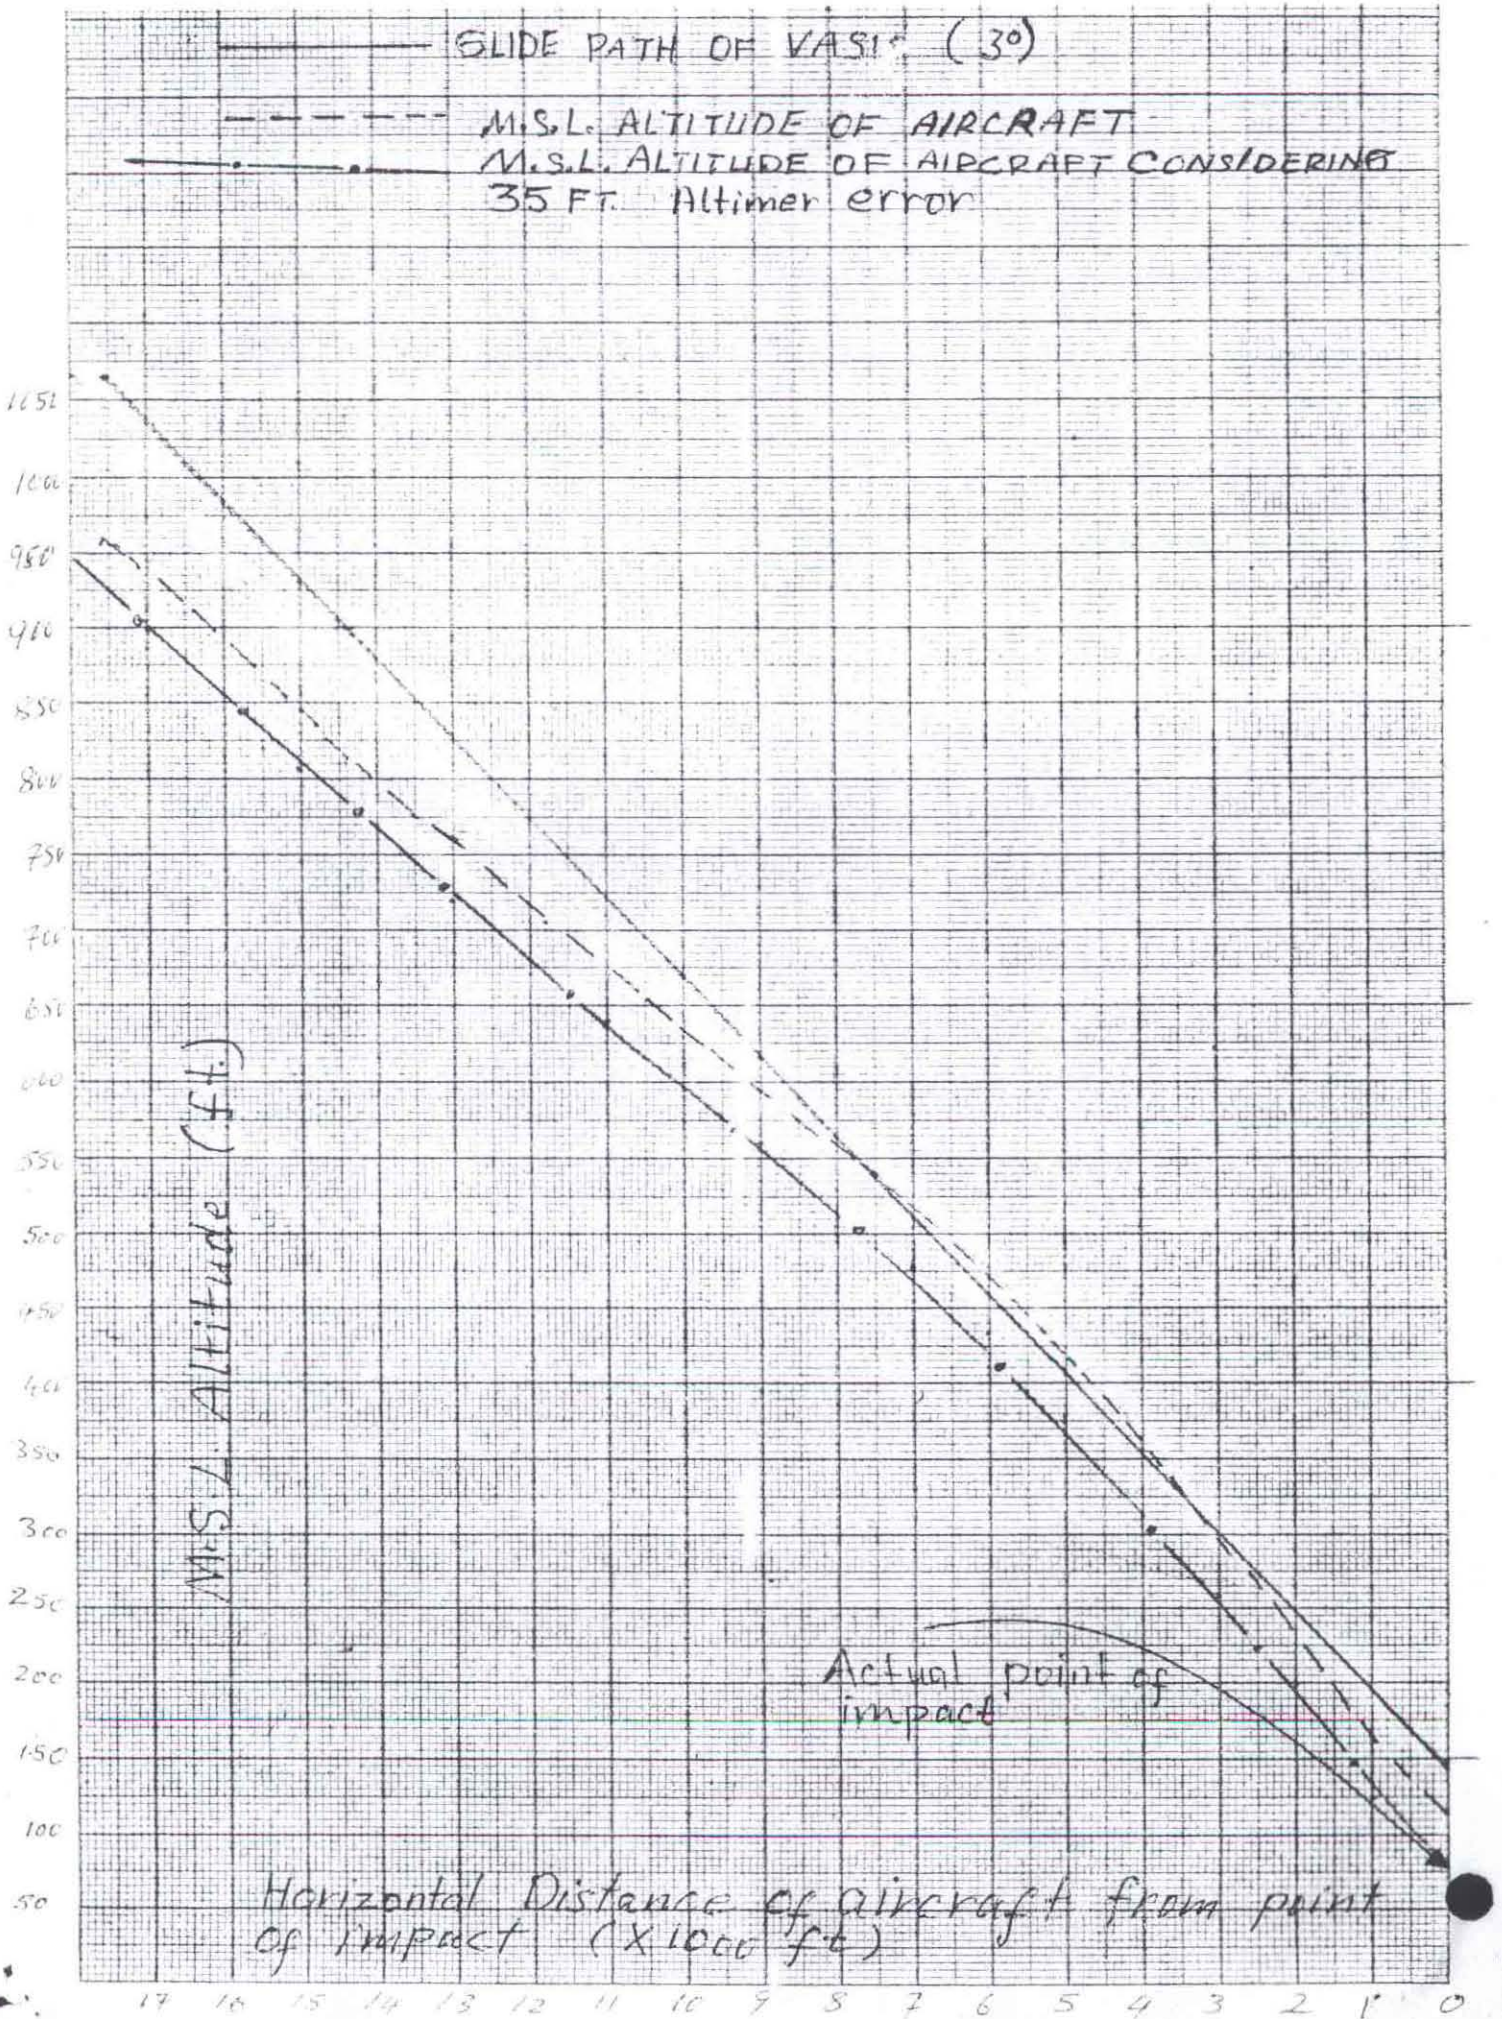
This approach profile was compared with the glide slope of the VASIS, which started at the touch down zone of the runway 24 at a distance of 255 meters from the threshold. (Figure 3) A further calculation showed that approximately 90 seconds before the impact the aircraft was over the NDB when its msl altitude and heading were 1210 ft. and 218° respectively. The msl altitude of the VASIS Approach slope over NDB was 1330 ft.

According to this calculations the aircraft was considerably below the glide slope before the NDB until 25 seconds before the impact. 25 seconds before the impact the aircraft crossed the approach slope and flew above the approach slope for a time of 10 seconds. During this flight the maximum height of aircraft above the approach slope was 12 ft. 15 seconds before the impact the aircraft started to deviate downward from the approach slope progressively until the point of impact. During the impact the value of the barometric altimeter was retrieved to be a msl altitude of about 115 ft. The msl altitude of the point of impact was about 80 ft. This showed that the barometric altimeter error was about 35 ft., which was not in favour of the pilot. Considering this error it is possible to say that the aircraft has never been on the approach slope during the last 90 seconds of the flight. (Figure 3)

The flight engineer in his statement pointed out that at some time prior to 100 ft. call out, which according to the CVR transcription took place 15 seconds before the initial impact, he remembered glancing out to see top VASI bar red. This evidence indicated that at this moment the aircraft was close to the approach slope of the VASIS, but the closeness maintained only for about 10 seconds. This statement was in agreement with calculations which compared the glide path of the aircraft with the 3° approach slope of the VASIS. (Figure 3)
