# Aviation Investigation Final Report

<b>Location:</b>	Vienna Center, Ohio	<b>Accident Number:</b>	ERA24FA308
<b>Date &amp; Time:</b>	July 19, 2024, 19:04 Local	<b>Registration:</b>	N23553
<b>Aircraft:</b>	Beech B-60	<b>Aircraft Damage:</b>	Destroyed
<b>Defining Event:</b>	Loss of control in flight	<b>Injuries:</b>	3 Fatal
<b>Flight Conducted Under:</b>	Part 91: General aviation - Personal

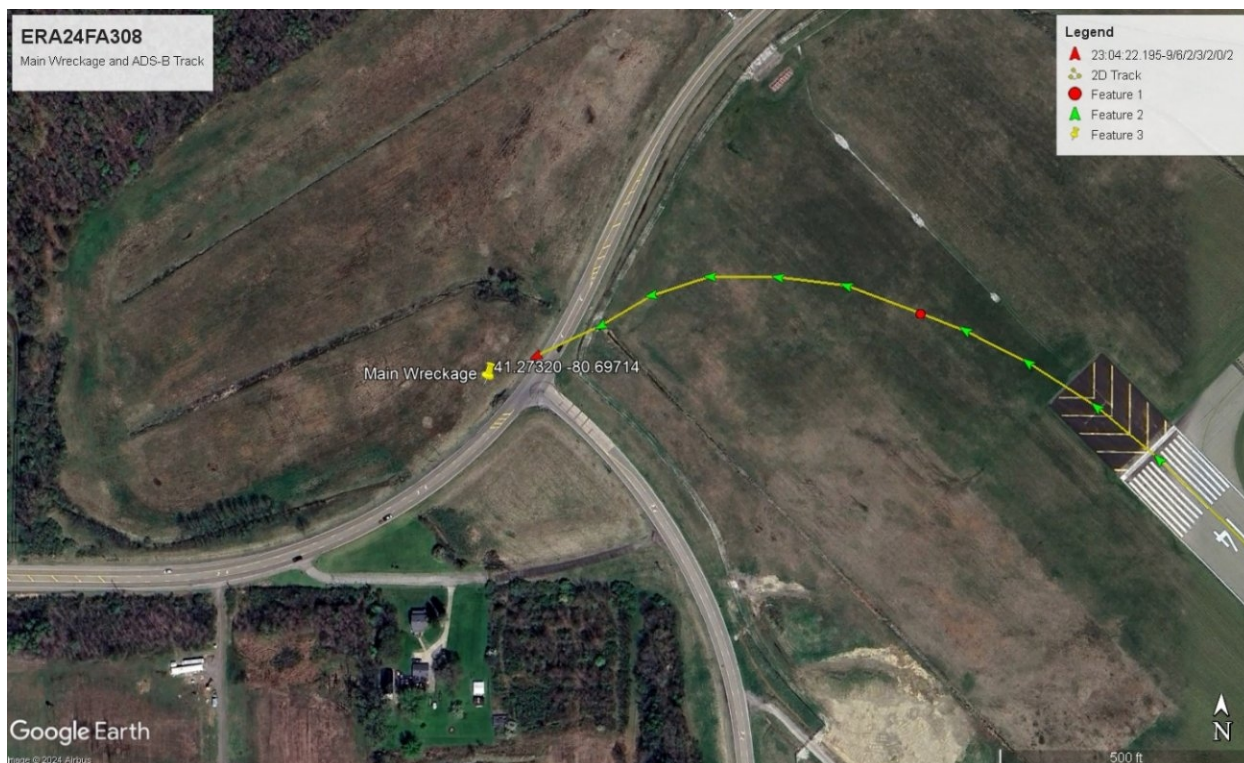
The airplane proceeded to YNG from the south and arrived overhead the approach end of runway 32 at 3,200 ft mean sea level, or about 2,000 ft above ground level (agl), at 114 kts ground speed. While descending, the airplane twice circled to the left near the approach end of runway 32, eventually lining up on final approach over the approach end of the runway, about 500 feet agl at 123 kts ground speed. The airplane then proceeded down the centerline of runway 32 while continuing to descend. About 3,500 ft from the departure end of the runway, the ADS-B data indicated that the airplane was close to the airport elevation at a ground speed of 131 kts. At the end of the runway, the airplane’s ground speed slowed to 95 kts. Airport surveillance video showed the airplane pitch up and to the left at the departure end of the runway; it continued into a left, descending turn until it impacted terrain about ¼ mile west of the departure end of the runway (see figure).

Figure. Final flight track and main wreckage site.
