COMANDO DA AERONÁUTICA
CENTRO DE INVESTIGAÇÃO E PREVENÇÃO DE
ACIDENTES AERONÁUTICOS

FINAL REPORT
A-015/CENIPA/2022

OCCURRENCE:	ACCIDENT
AIRCRAFT:	PP-INQ
MODEL:	TBM700N
DATE:	31JAN2022

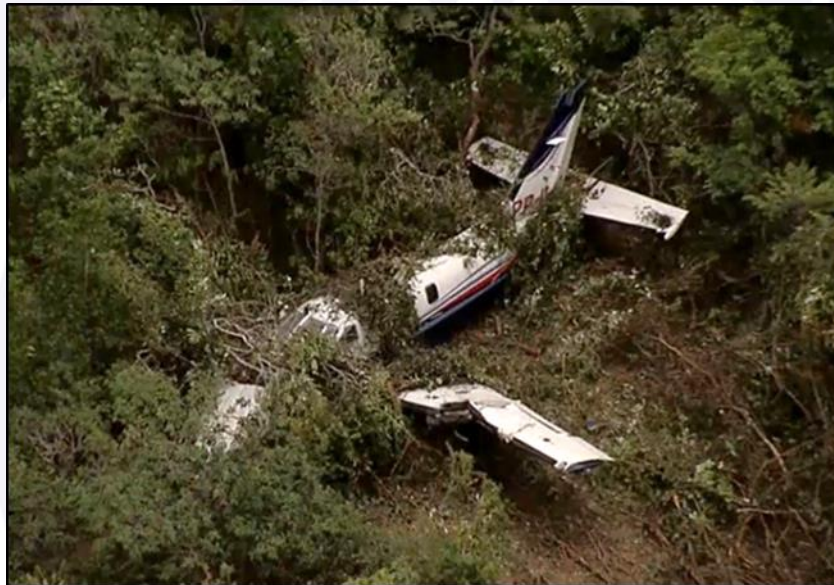
Figure 1 – General view of the aircraft.

The aircraft sustained substantial damage. Damage occurred to the wings, landing gear, engine, and fairings.

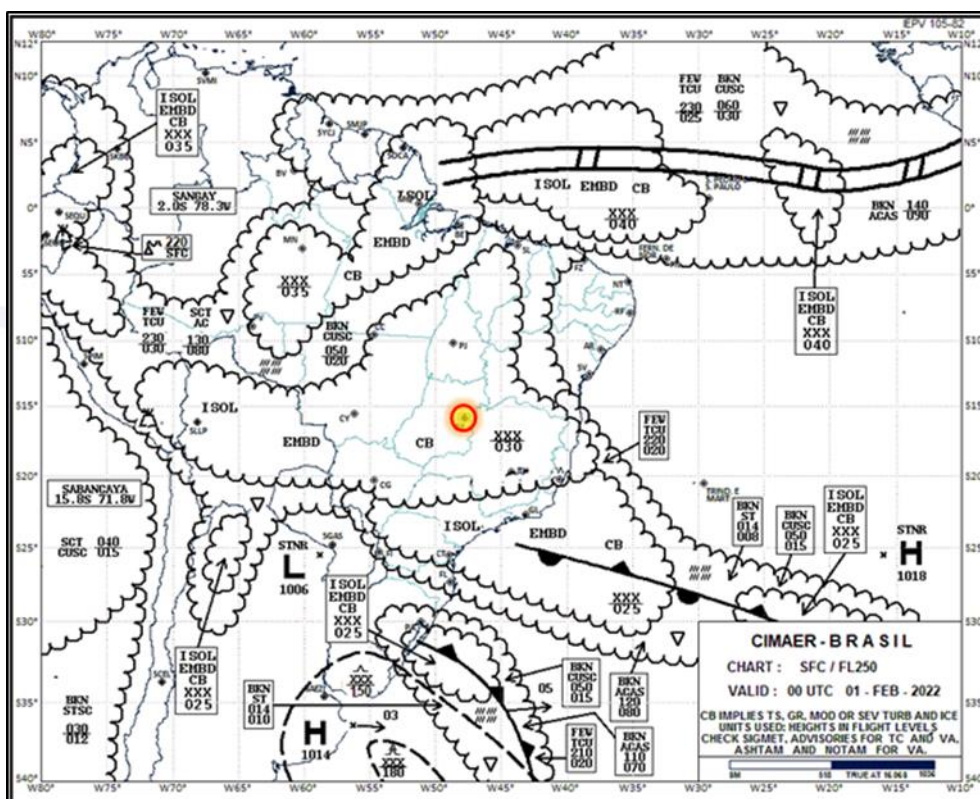
The 1200 UTC Significant Weather Chart (SIGWX) showed the presence of few Towering Cumulus (TCU) clouds, which exhibit significant vertical development but do not yet have electrical activity, with base at 2,000 ft. and tops at FL220, along with embedded and isolated Cumulonimbus (CB) clouds, which have strong vertical development with electrical activity associated with severe weather, with base at 3,000 ft., as shown in Figure 3.

Figure 3 – SIGWX chart from the surface to FL250, for January 31, 2022, covering the time of the occurrence.

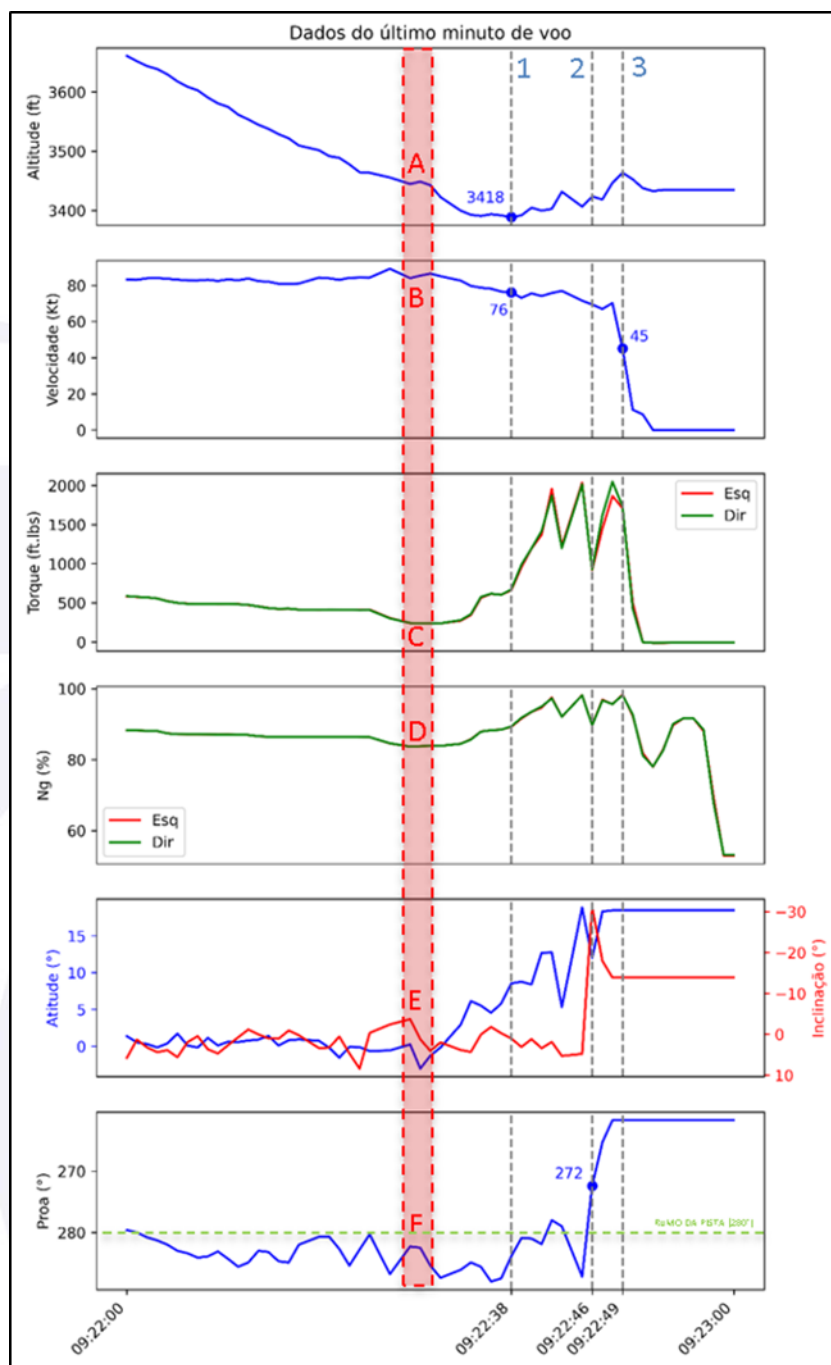
Figure 5 – Recorded data for the final minute of recording.

Line 1, shown as a dashed gray line, marks the lowest altitude reached in flight and the beginning of the go-around. Line 2 marks the maximum bank angle of the aircraft, 30° of left roll (negative sign), and Line 3 marks the moment of collision with denser vegetation, followed by the end of the recording.

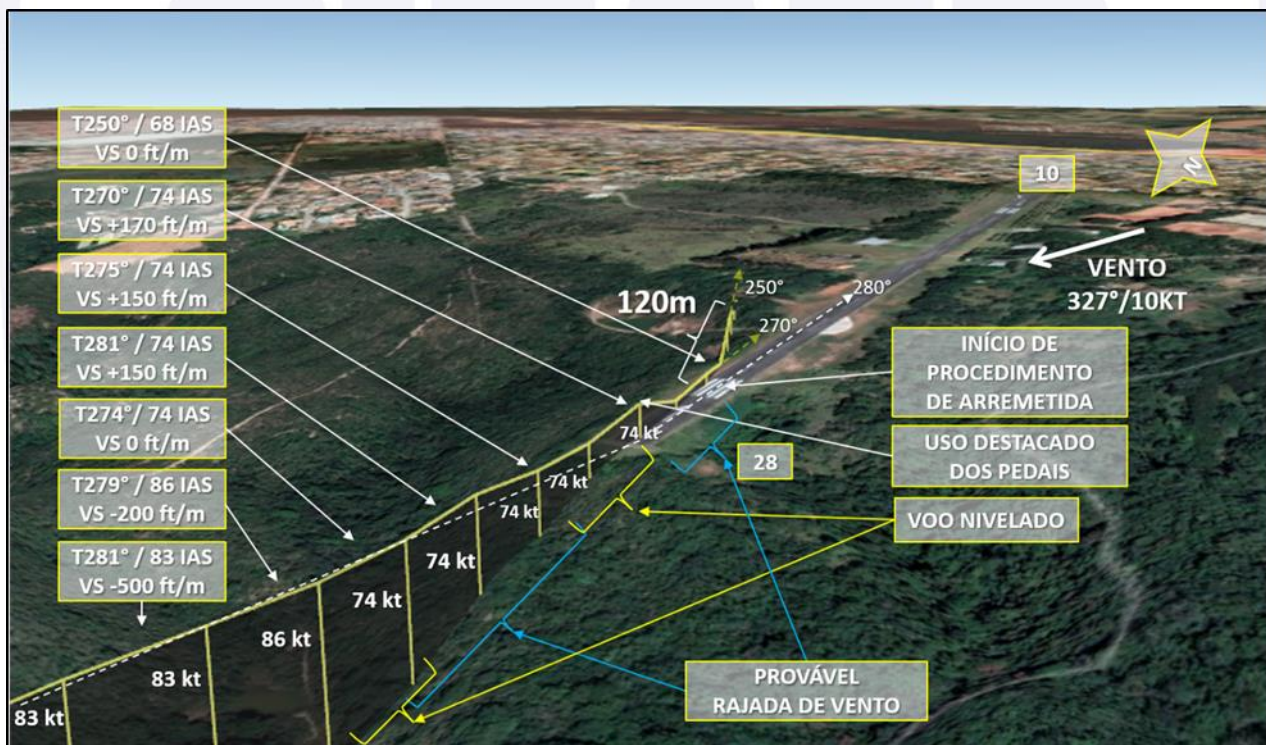
The pilot attempted to conduct the approach at 85 kt. of Indicated Airspeed (IAS) and a vertical speed of 500 ft. /min, but the data showed the following actual profile (Figure 6).

Figure 6 – Flight profile during final approach. Track, IAS, and VS data obtained from the onboard avionics readout.

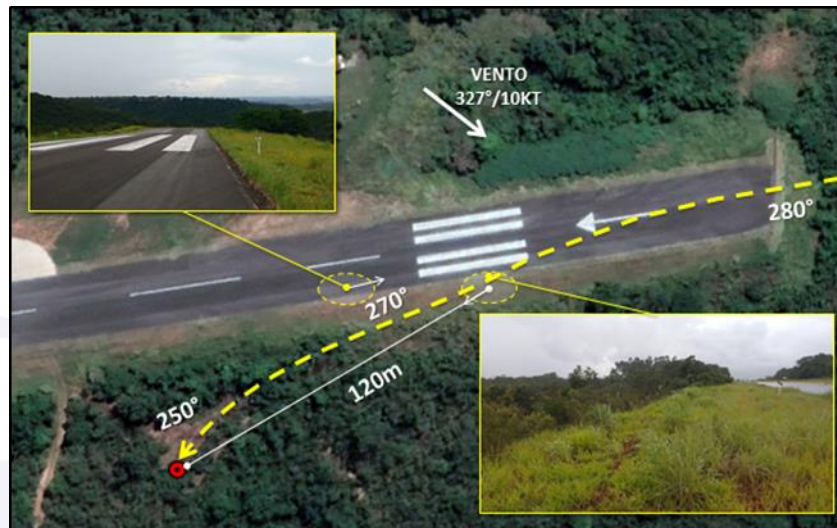
Based on data retrieved from the avionics memory cards, the aircraft was estimated to be flying at 70 kt. when it struck the vegetation, decelerating to a full stop (Figure 7).

Figure 7 – Aircraft trajectory extracted from memory cards (map representation).

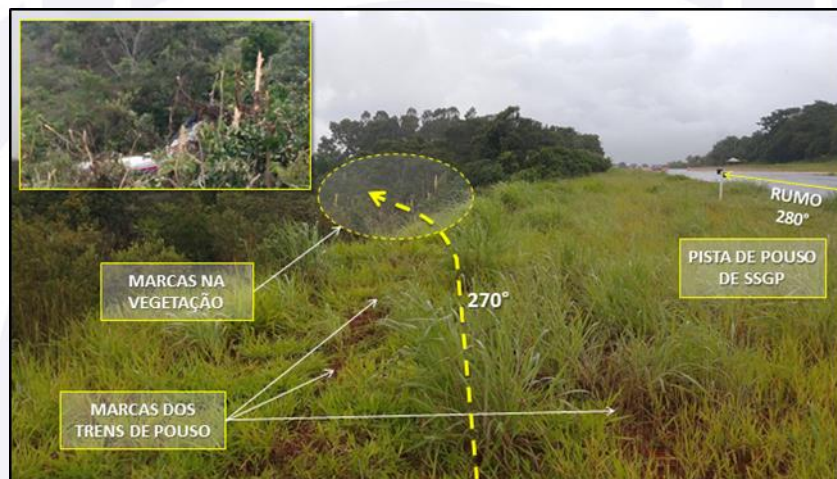
The wreckage distribution was of the concentrated type (Figure 8).

Figure 8 – View from the runway to the aircraft's final stop location.
Photo taken approximately 30 minutes after the event.

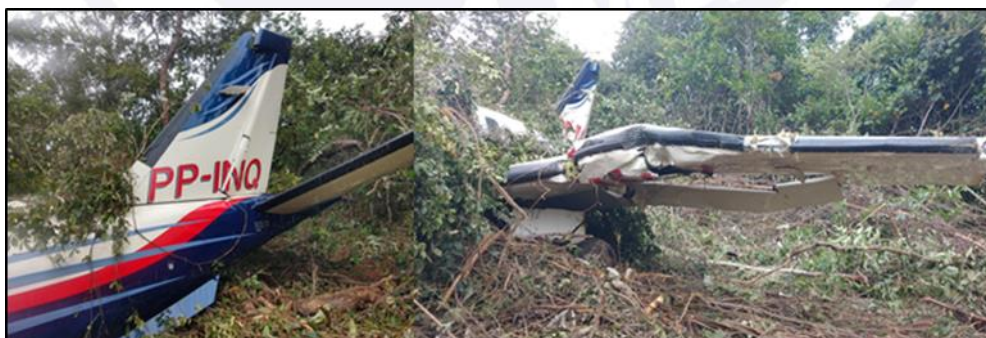
The elevator trim tabs were symmetrical and set in the nose-up direction, and the rudder trim was in the neutral position (Figure 9).

Figure 9 – View of parts of the aircraft after it came to a complete stop.

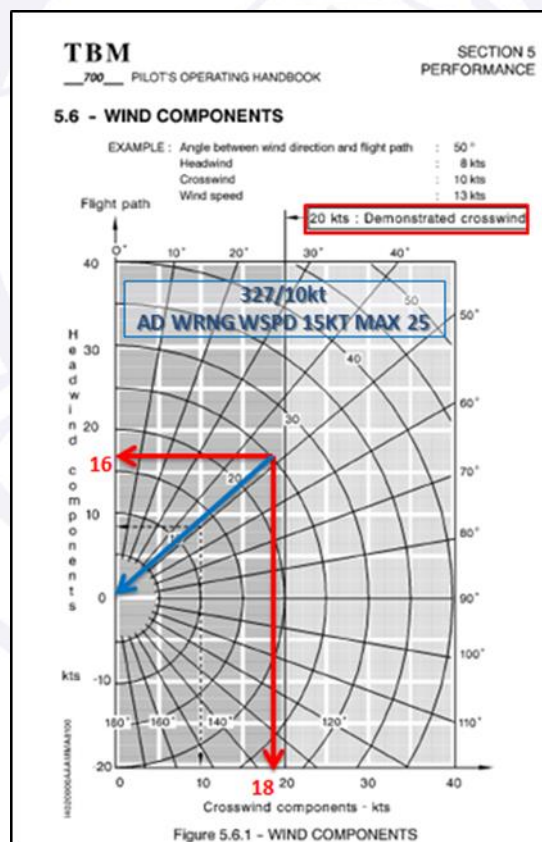
According to the TBM700 *Pilot's Operating Handbook – Section 5 – PERFORMANCE*, the maximum demonstrated crosswind component for the model was 20 kt. The graphic representation of the wind component on final approach to SSGP runway, based on the data retrieved (wind from 327° at 10 kt), extrapolated to the forecasted maximum gust of 25 kt, is shown in Figure 10.

Figure 10 – Representation of the maximum wind component with direction 047° to the right and intensity of 25 kt.
