# Aviation Investigation Final Report

| <b>Location:</b> | Westwater, Utah | <b>Accident Number:</b> | WPR24FA083 |
| <b>Aircraft:</b> | HAWKER BEECHCRAFT CORP<br>HAWKER 900XP | <b>Aircraft Damage:</b> | Destroyed |

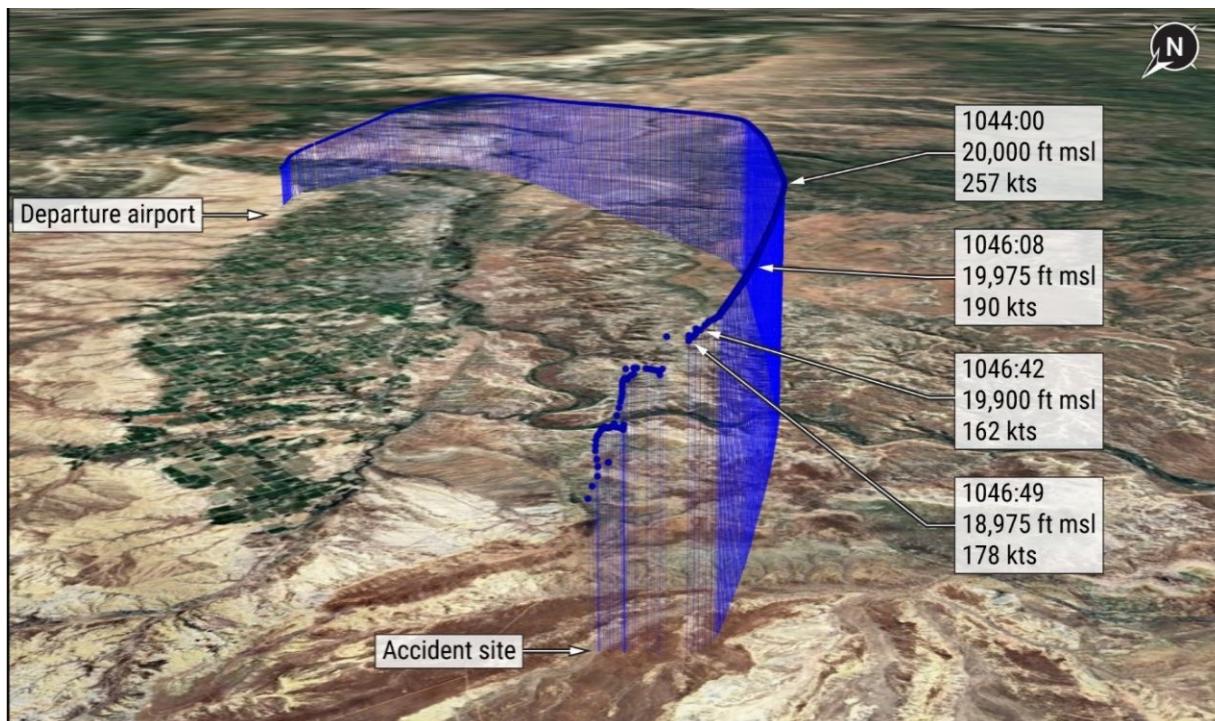
At 1046:47 the flight track data show the airplane began a rapid descent in a pattern resembling the shape of a corkscrew. The airplane’s flight track made multiple circular rotations before ending at 1047:44.

Figure 1: Accident airplane flight track and corkscrew descent

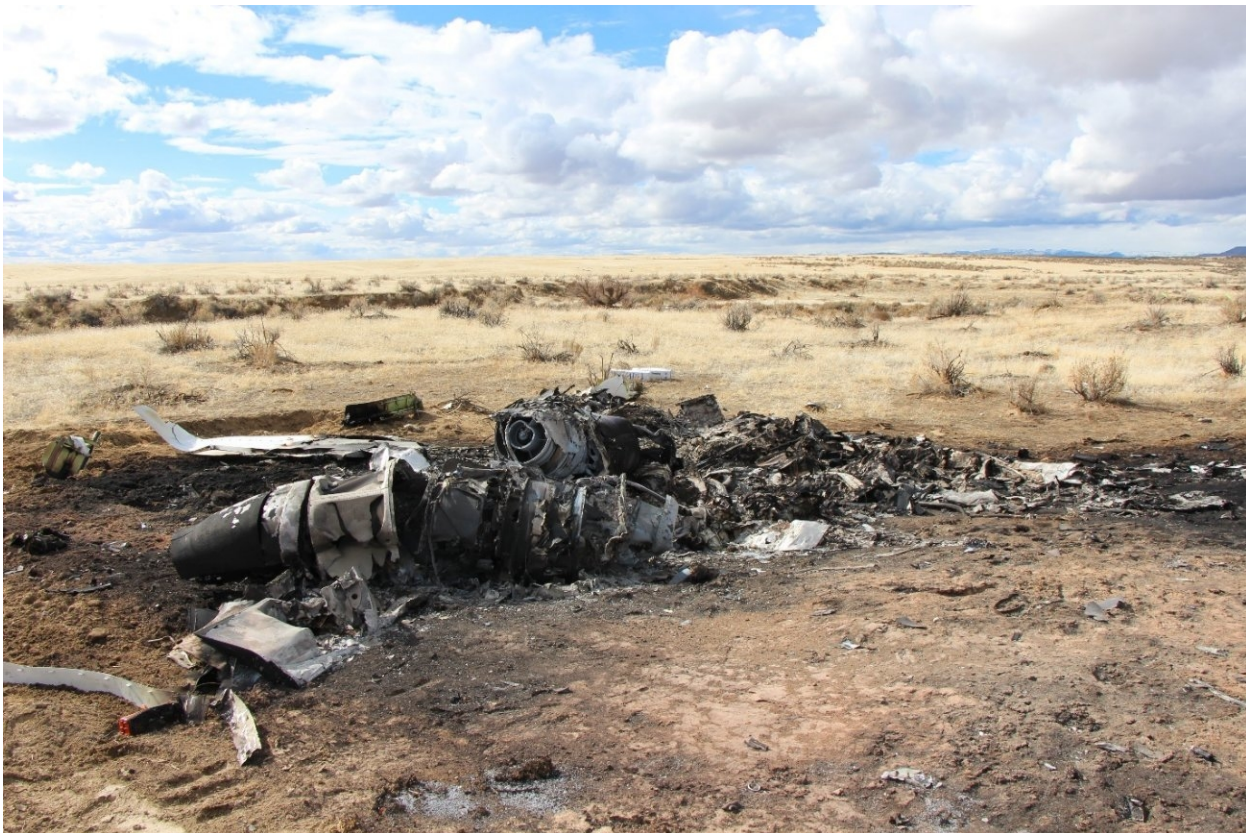
The airplane came to rest in flat open terrain about 25 nm northwest of GJT at an elevation of about 4,800 ft mean sea level and oriented on a west heading. The airplane's major structures were all accounted for at the accident site. A debris path was traced from the main wreckage to the end of a burn area that was about 200 ft long and 175 ft wide at the widest point, oriented on a magnetic heading of 345°. A silhouette of the left wing, fuselage, and both engines was located about 10 ft south of the main wreckage.

Figure 2: Accident site main wreckage

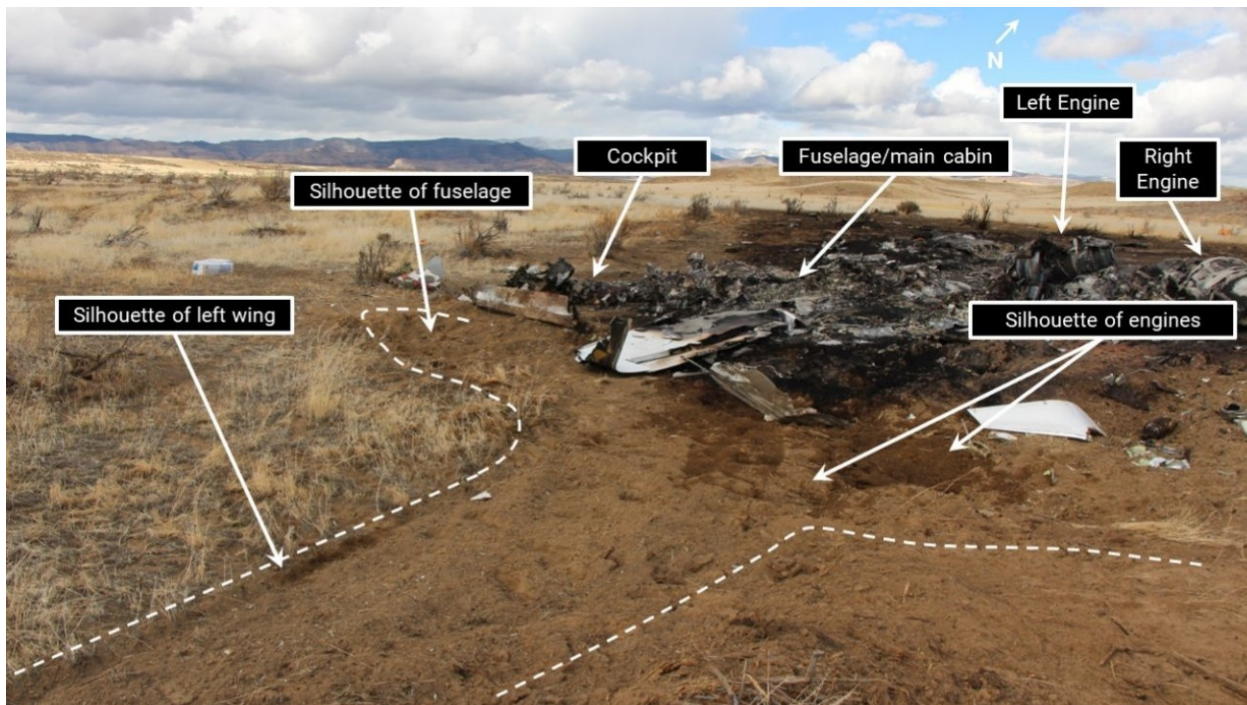
Figure 3: Silhouette of left wing and fuselage with consumed main wreckage in background

The airplane wings and leading edges were mostly destroyed by postcrash fire. Those areas that remained intact were either significantly damaged or covered in soot.
