REPORT # H80003  
AIRCRAFT ACCIDENT  
AIRWEST AIRLINES LTD  
DE HAVILLAND DHC6-200 (FLOATS)  
REGISTRATION CF-AIV  
VANCOUVER HARBOUR, BRITISH COLUMBIA  
00:42 GMT, SEPTEMBER 3, 1978

#### SYNOPSIS

A visual approach was being made to Vancouver Harbour. When at 175 ft above the surface and approximately 2500 ft from the intended landing area, the aircraft suddenly rolled left and plunged into the water.

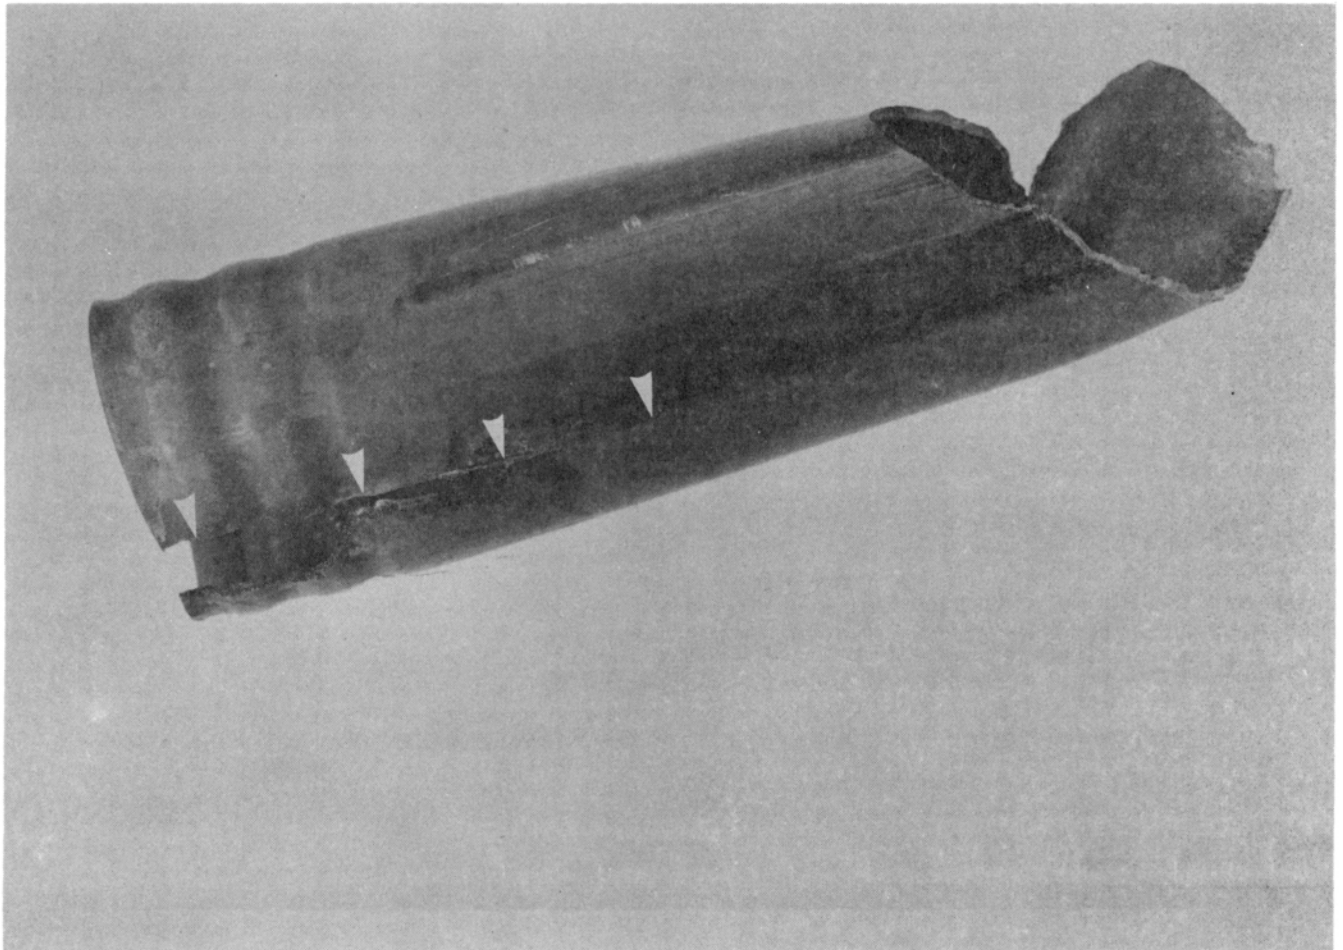
FIG. 2

From these analyses, it was concluded that prior to impact, the flap control rod contained one major and other secondary stress corrosion cracks. The main fracture was 2-3/4 inches in length and extended longitudinally from the open end of the tube. This crack alone was shown to have reached a sufficiently advanced stage of growth to bring about separation of the tube from the end cap fitting at less than applied loads from the full flap setting in the approach configuration. In the case of the accident aircraft, the flaps were set at the full down position during the approach.

DHC 6 FLAP ROD - P/N C6CW 1029-1

CLOSE-UP PHOTOGRAPH OF THE INBOARD TUBE END OF THE  
BELL CRANK TO INBOARD ROD, FLAP ROD ASSEMBLY.  
SHOWN BY ARROWS IS THE 2-3/4 INCH STRESS CORROSION  
CRACK.

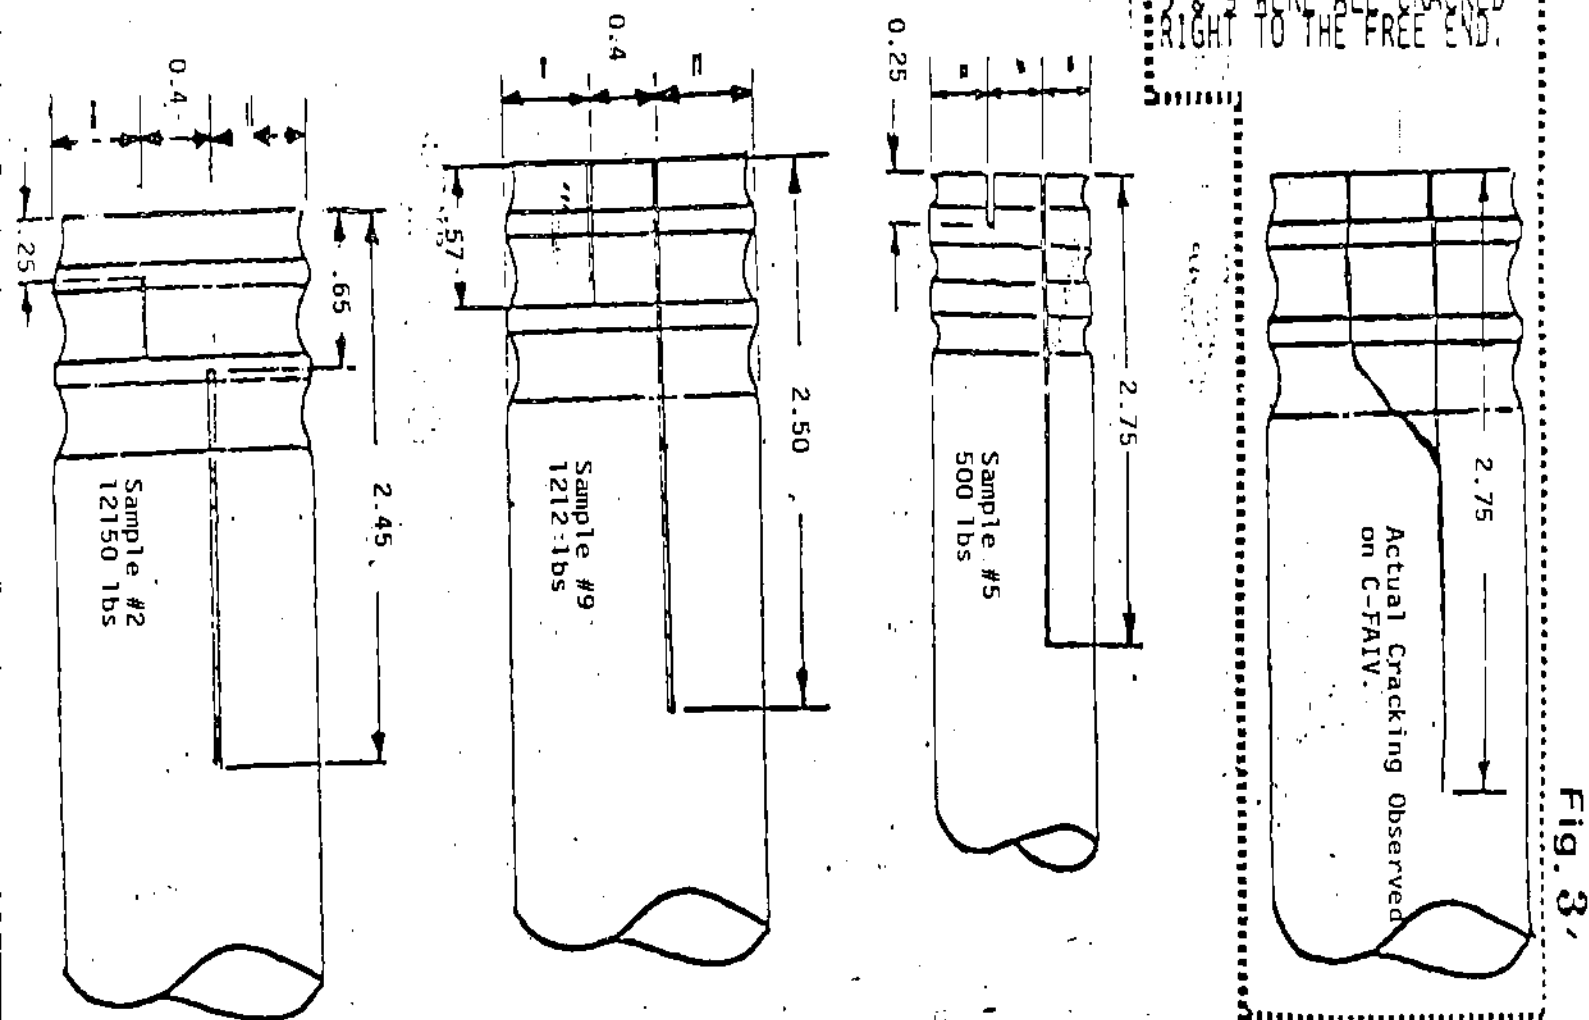
# DHC 6 Flap Rod - Magniform Connection - Tensile Tests

Manufacturer's tests showed that when two rods were cracked in a manner similar to the accident case, one (2.5 inches long), failed at 825 lbs and the other, (2.75 inches long), at 500 lbs. It is considered that the difference in separation loads is because of the variation in original clamping action (i.e. variation in material strength, fit, residual stresses). The manufacturer stated that the working loads on the rod during a normal approach with flaps-down condition vary from 330 to 650 lbs, whereas the design breaking load is 8000 lb. and the nominal breaking load is 11000 lb. The tests therefore clearly showed that cracks greater than two inches (as found on the CF-AIV rod), and which have progressed to the free end, could lower the load-carrying capacity of the rod into the range of the actual loads with flaps down.

The manufacturer carried out a series of tensile tests of the load required to break a magniform connection with cracks artificially cut to specific lengths. Three of these, samples 2, 9 and 5 are shown below with tensile-strength values of 12150 lbs., 1221 lbs. and 500 lbs. Those that were cracked to the free end, failed at low values; such was the case with the CF-AIV rod.

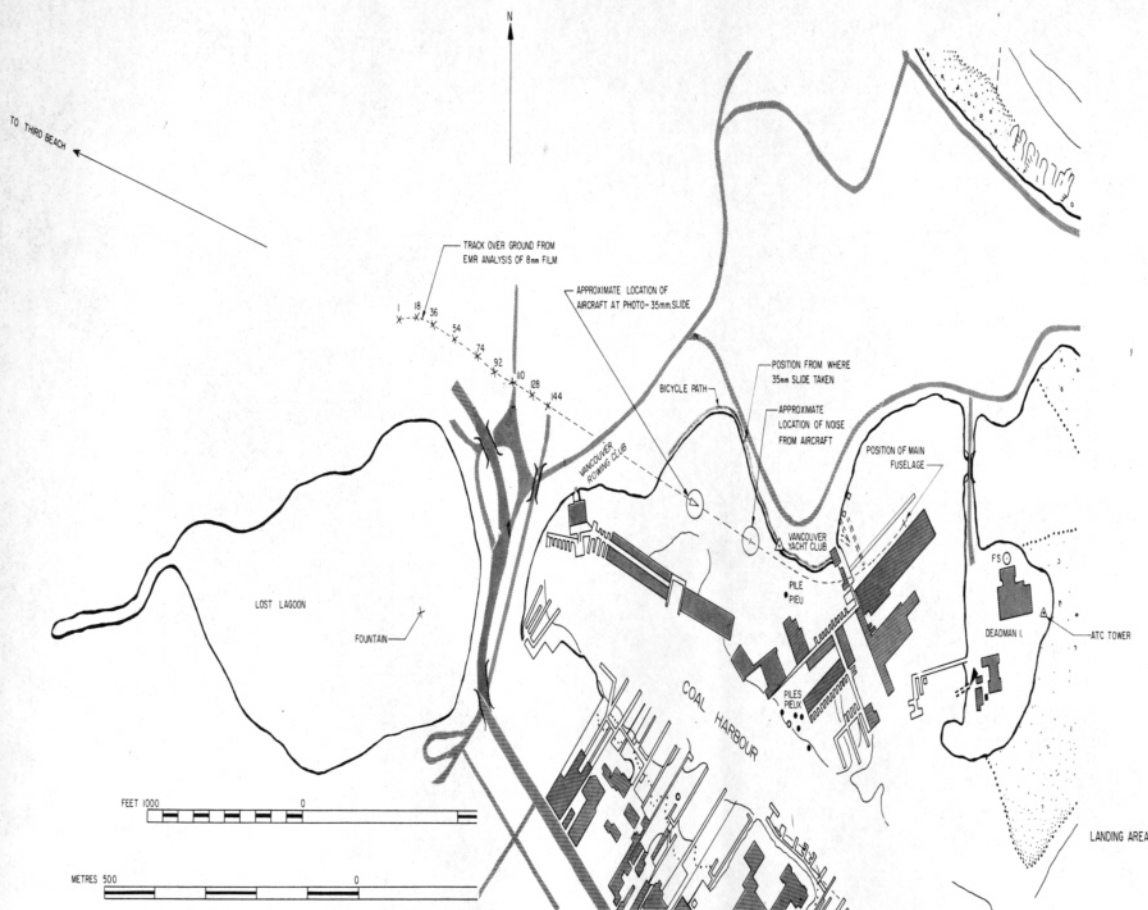
**AREA X**  
AT THIRD BEACH--LAST RADIO TRANSMISSION FROM AIRCRAFT C-FAIV ACKNOWLEDGEMENT OF LANDING CLEARANCE 54 SECONDS PRIOR TO IMPACT AND ELT SIGNAL ESTIMATED 1000FT ASL IS CONSISTENT WITH A NORMAL APPROACH.

**AREA B**  
FROM AN 8mm MOVIE FILM RECOVERED FROM THE WRECKAGE, IT WAS EVIDENT THAT THE CAMERA WAS IN OPERATION THROUGHOUT A PORTION OF THE APPROACH. THIS FILM EMBRACES A SEGMENT OF 7.99 SECONDS--FRAME 1 THROUGH 144. AVERAGE RATE OF DESCENT = 758FT/MIN. AVERAGE GROUND SPEED = 76 KNOTS. FLAPS WERE AT THE 20° SELECTOR POSITION AT FRAME 1 AND AT 28° SELECTOR POSITION AT FRAME 144. THIS IS EQUIVALENT TO 1" OF FLAP EXTENSION PER SECOND.

**AREA E**  
POINT OF IMPACT, LOCATION OF MAIN FUSELAGE AFTER THE CRASH THE AIRCRAFT ENTERED THE WATER IN A LEFT WING LOW AND NOSE DOWN ATTITUDE. THE AIRCRAFT HEADING WAS APPROXIMATELY 23° TRUE. THIS WAS DETERMINED FROM WITNESS OBSERVATIONS, ANALYSIS OF FLIGHT INSTRUMENTS AND THE AIRCRAFT STRUCTURAL DAMAGE PATTERN. USING AN AVERAGE GROUND SPEED OF 76 KNOTS THE TIME FROM THE PLOTTED POSITION OF THE 35mm SLIDE IS 8.2 SECONDS. THE TIME FROM THE PLOTTED POSITION OF THE NOSE TO IMPACT IS 8.2 SECONDS.
