**AVIATION SAFETY  
INVESTIGATION**

Report # P70004  
Rapport

Aircraft Accident Report  
de Havilland DHC-6 C-GNTB  
Terrace, British Columbia

14 January 1977  
15

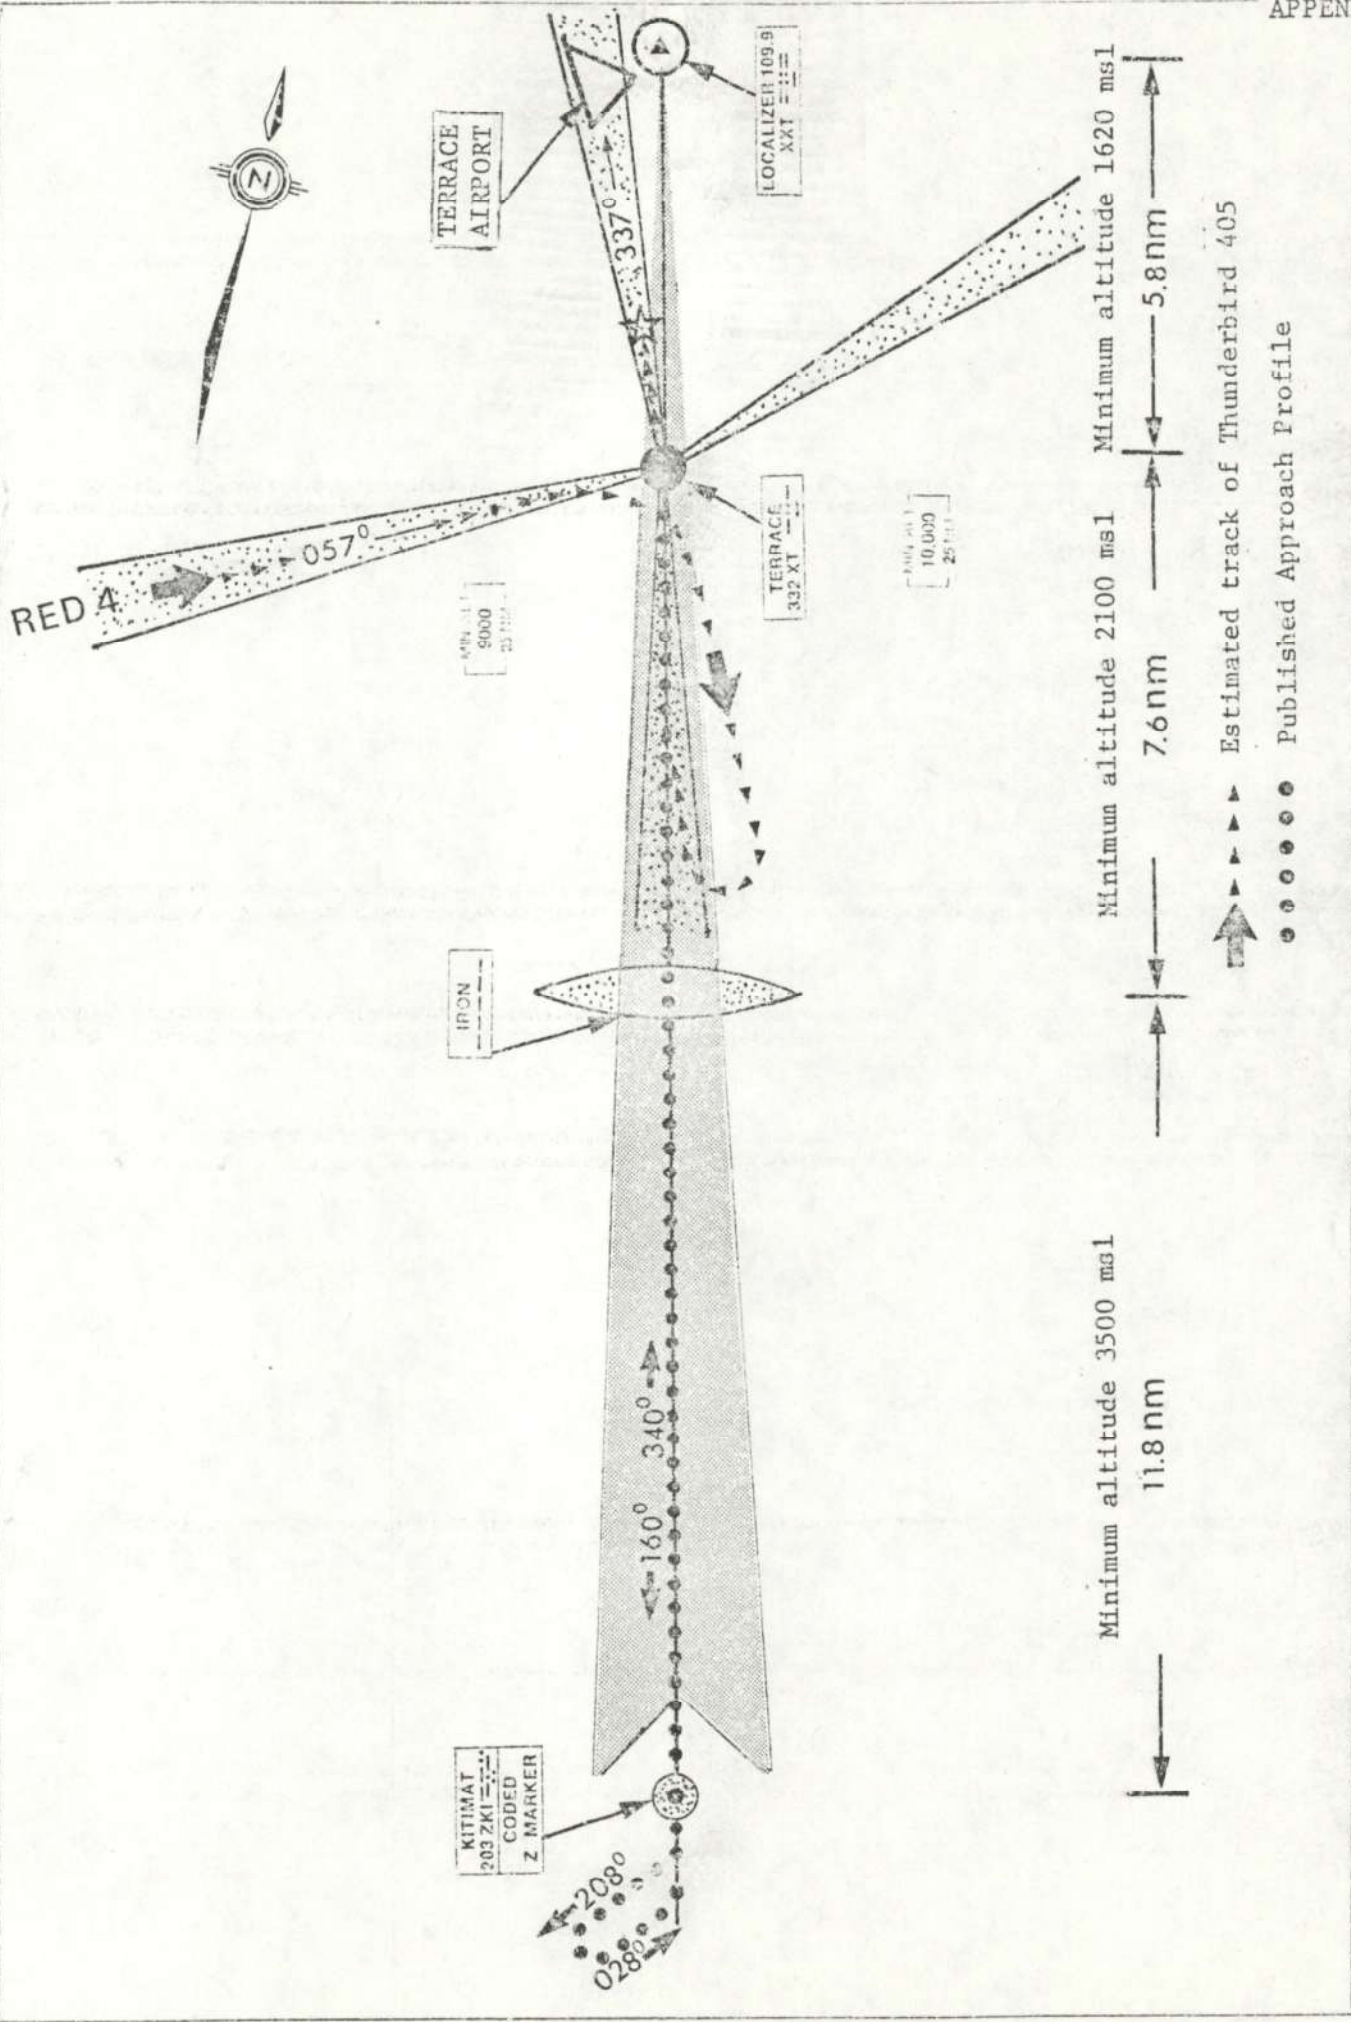
# ESTIMATED FLIGHT PROFILE

9 minutes from overhead to the impact point which was 2 minutes from the runway threshold. To descend from 9000 MSL, the minimum enroute altitude, to the airport ramp in 11 minutes as estimated, would require a rate of descent in excess of 1100 feet per minute from outbound the range to inbound. The actual time element from overhead to impact would have necessitated a 900 FPM rate of descent, almost double the normal rate. (See appendix 1)

The aircraft struck trees in a shallow descent, wings level 440' below MDA at a point 2 miles beyond the range. To attain this level would have required an excessive final rate of descent (approximately 750 FPM), had the aircraft crossed the range at 2100' MSL.

The aircraft struck the side of Little Herman Mountain at the 1180' MSL level, 20' below the crest, on a heading of 340°m. The point of initial impact was 440' below the published minimum descent altitude for the type of approach attempted.

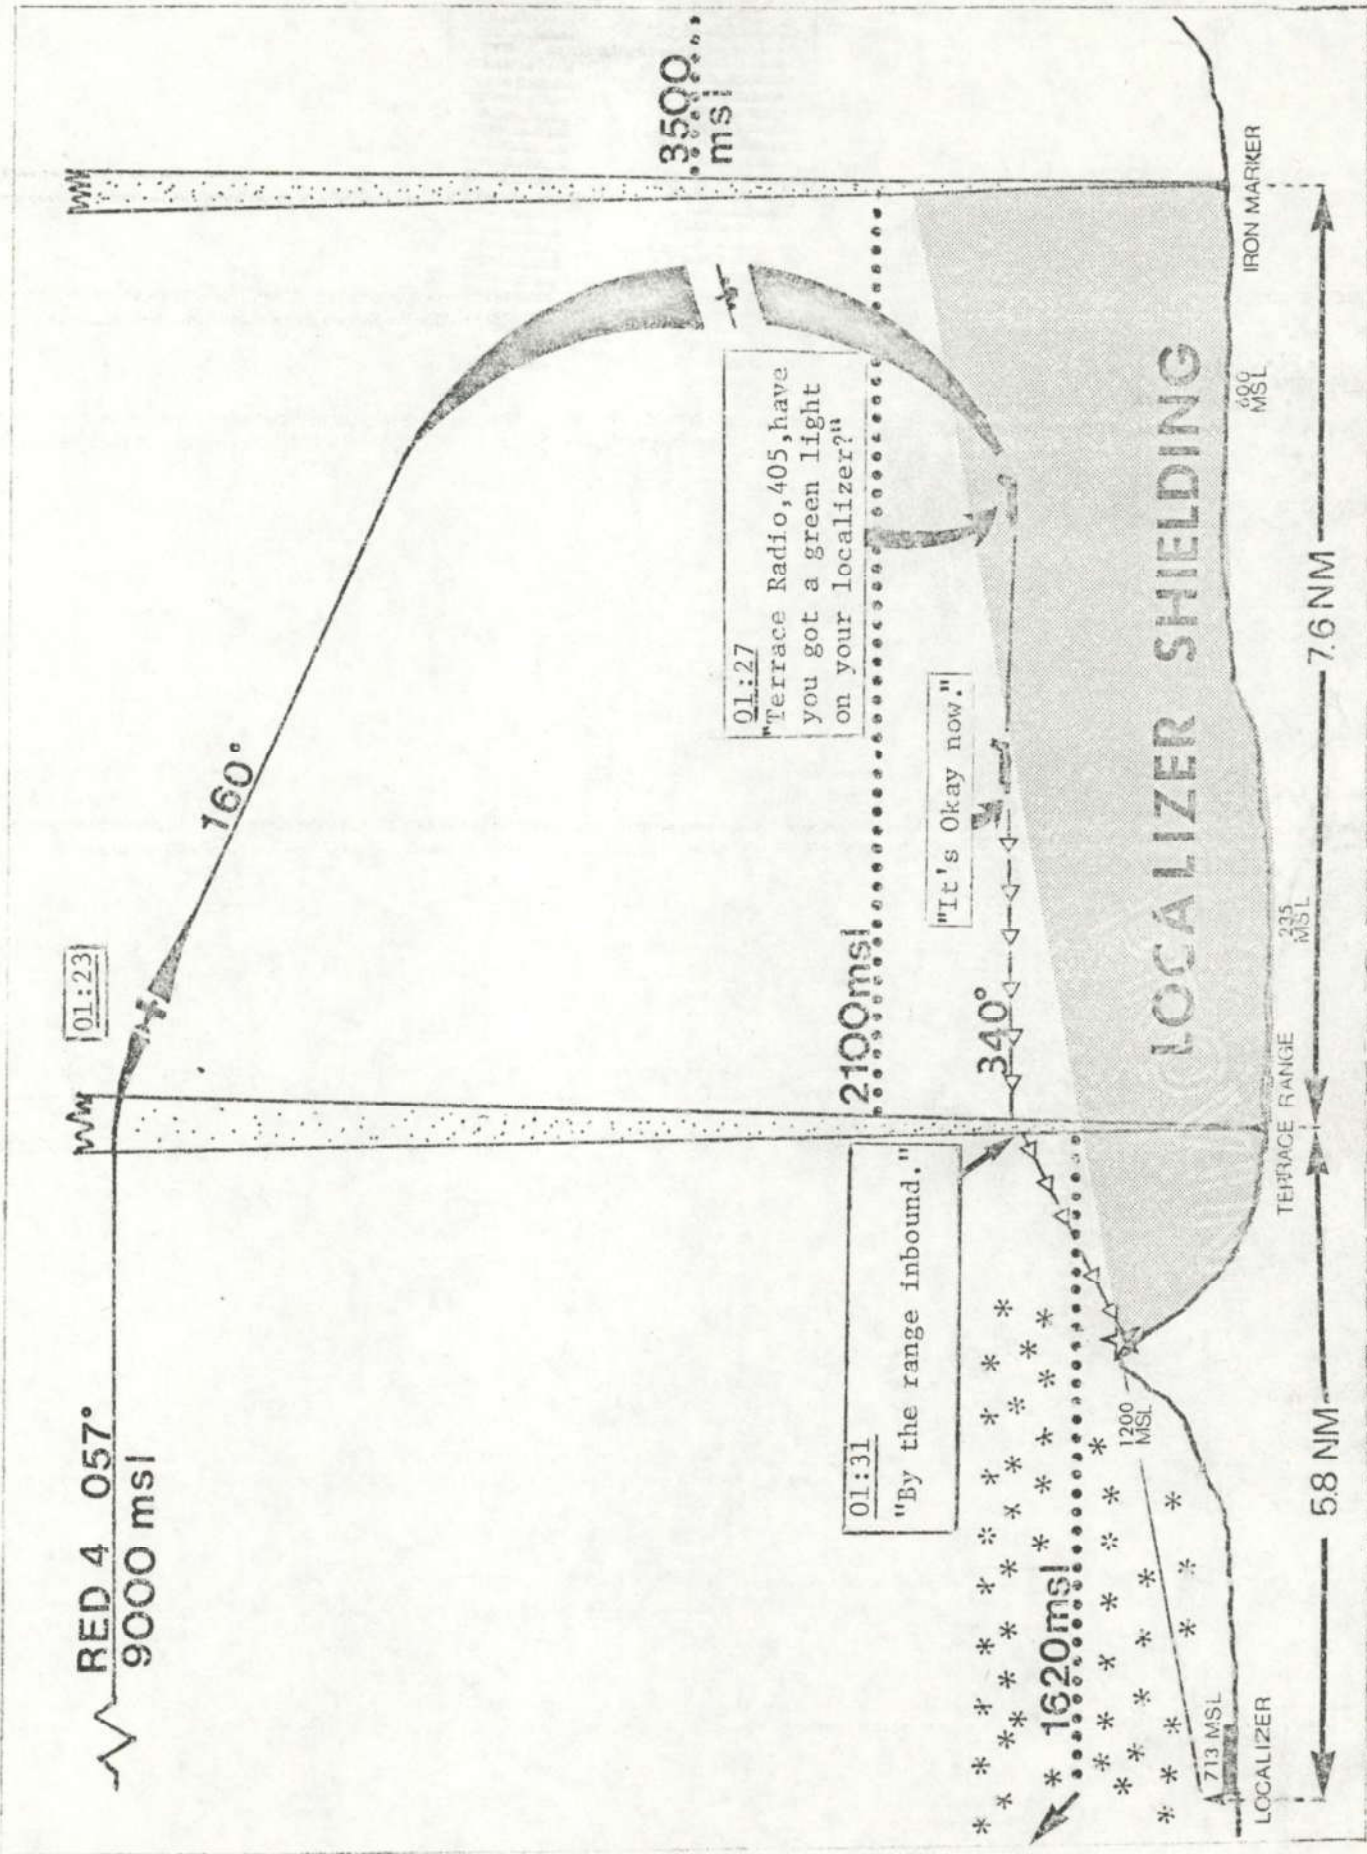
ESTIMATED FLIGHT PROFILE

It appears that after crossing the range inbound the Captain elected to descend below minimums in order to successfully complete the approach. He was ~~fully~~ aware of the massive obstruction in the immediate vicinity. <sup>AS STATED IN THE PATHO REPORT</sup> The onset of the Captain's pathologically determined anxiety and stress period commenced when flight below final approach minimums was continued, or initiated, when by the range inbound and terminated upon impact, 75 seconds later.

(GRAPHIC DEPICTION)  
FINAL FLIGHT PATH

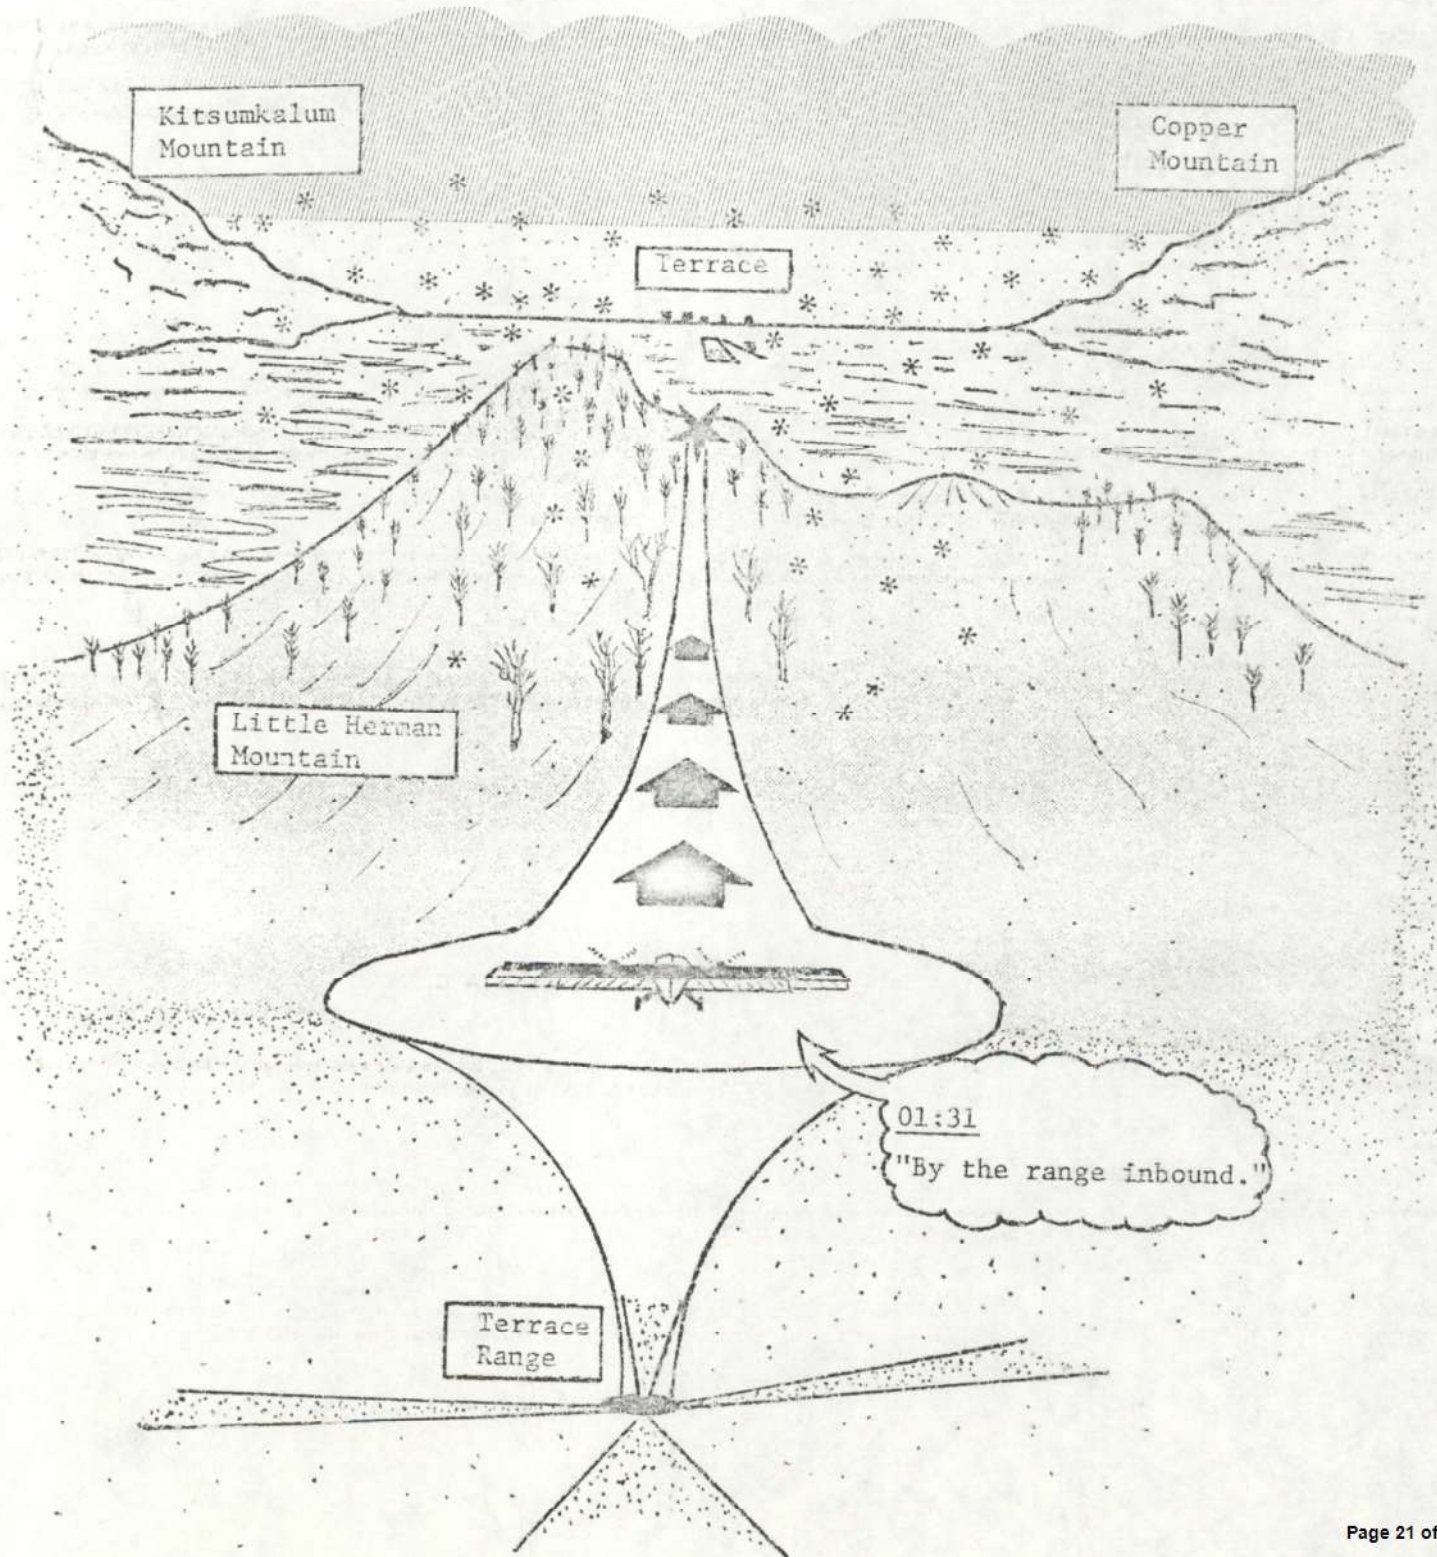
**LOC/NDB/RNG-1** TERRACE BRITISH COLUMBIA

Three minutes before crossing the range inbound, the First Officer queried the Aeradio on the status of the localizer, to which the Aeradio responded that it was functioning normally. (See appendix 2) This transmission was significant for it implied that the

aircraft's localizer had broken lock and was displaying an "off flag". The aircraft's position at this time would have been 5 NM south of the range. Pre and post accident flight checks of the localizer confirmed adequate reception of signals to maintain position lock at 2100' MSL as far south as the Iron Marker 7.6 NM south of the range. It is reasonable therefore, to assume that when the query pertaining to the localizer was made, the aircraft was below the minimum reception altitude of localizer signals. These signals were, in all probability, being shielded to some degree by the Herman Mountains which were between the aircraft and the localizer transmitter site.

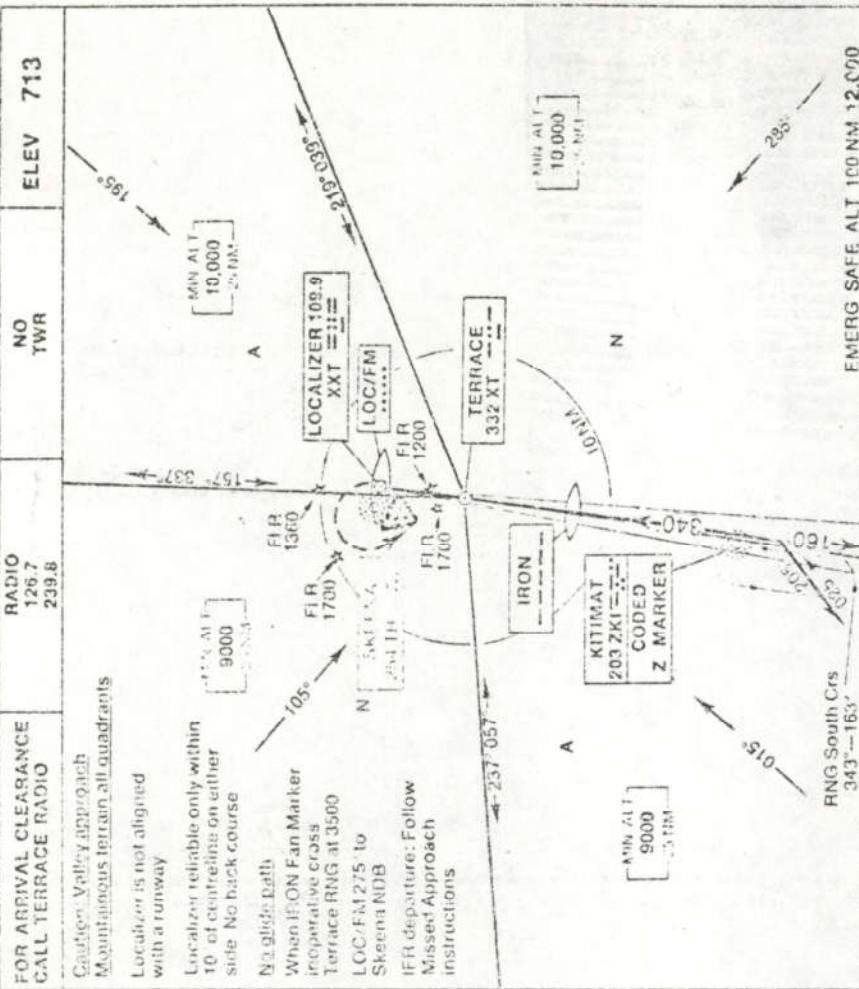
**RNG/NDB-1** TERRACE BRITISH COLUMBIA

The obstruction which the aircraft struck is clearly depicted on both published approach charts for Terrace Airport.
