DC 6/13 RETARDANT-TANK
MAINTENANCE

DC-6 AIR TANKER CONVERSION

RETARDANT SYSTEM MAINTENANCE INSTRUCTIONS

RE: James Fredrick MELVILLE(B:23-3-19) "Et al" 32687 Huntington Rd, Abbotsford, B.C.
 Sudden Death of - Plane Crash.
 Near Ashcroft, B.C. 2 AUG 74
 ASHCROFT DETACHMENT CASE - UNORG.

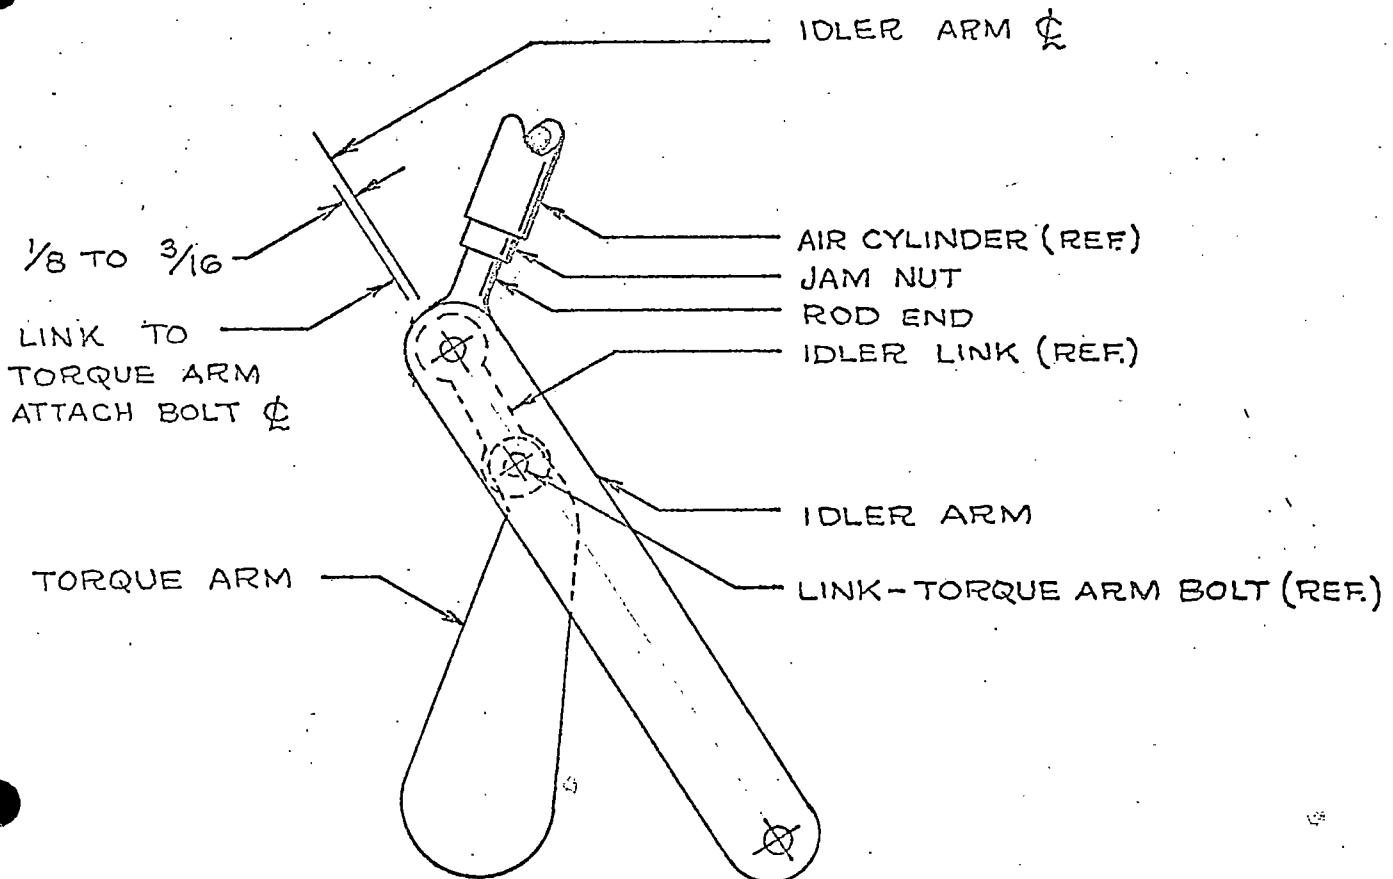
FIG 2-6

- A. Close retardant doors.
- B. Determine that actuator is fully retracted.
- C. Check door linkage for an overcenter dimension of $3/32$ " to $1/8$ " as illustrated in (Fig 2-6).
Adjust actuator rod end to obtain correct setting.
