DIRECTORATE OF CIVIL AVIATION

**AIRCRAFT
ACCIDENT REPORT**

**ALEV
UNGARIAN AIRLINES**

MALEV 731 (REG. HA-MOC)
ACCIDENT IN ØRESUND
ON AUGUST 28, 1971.

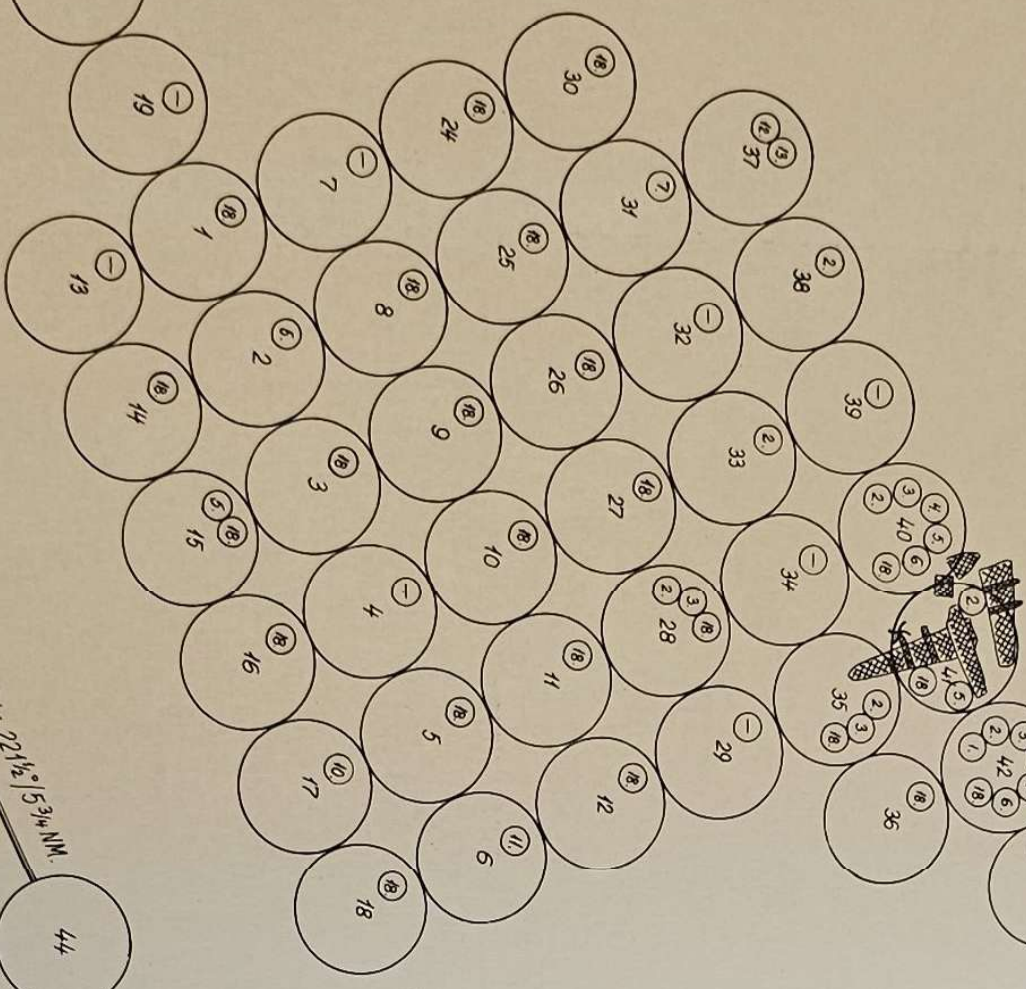
- ① Nose Gear Parts.
 - ② Nose Section Parts.
 - ② Radar (Radome) Parts.
 - ② Cockpit Parts.
 - ③ Forward Cabin Parts.
 - ③ Forward Baggage Compartment Parts.
 - ③ Forward Toilet Parts.
 - ④ Main Landing Gear Parts.
 - ⑤ Wing Center Parts.
 - ⑥ Baggage Compartment Parts.
 - ⑥ Main & Rear Cabin Parts.
 - ⑦ Rear Cabin Parts.
 - ⑧ Tail Section Parts.
- (Hydraulic Jack Parts & Abu Parts)
- ⑨ Right hand Wing Parts.
 - ⑩ Left hand Wing Parts.
 - ⑪ Engine No. 1 Parts.
 - ⑫ Engine No. 2 Parts.
 - ⑬ Engine No. 3 Parts.
 - ⑭ Engine No. 4 Parts.
 - ⑮ Right hand Flap
 - ⑯ Left hand inboard Flap spindle Pa
 - ⑰ Left hand outboard Flap spindle Pa
 - ⑱ Passenger Seat Parts.

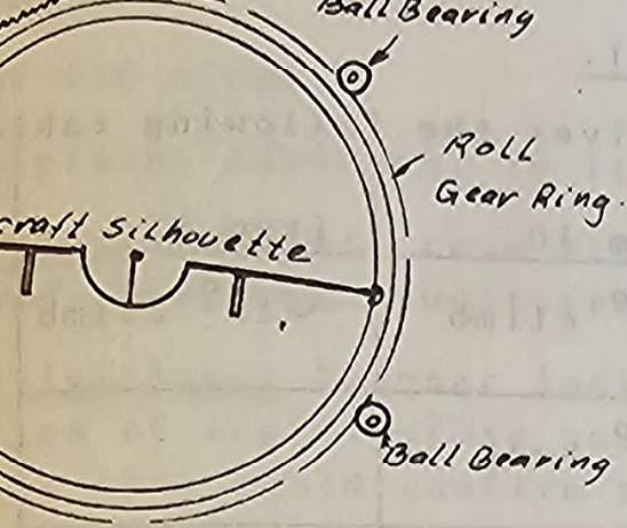
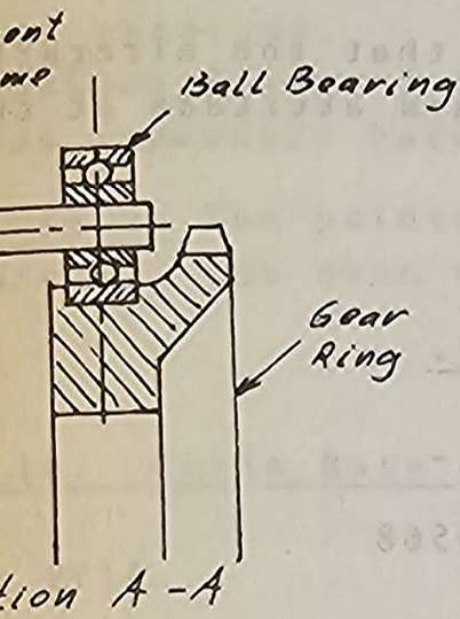
Condition: Slightly damaged on rear section of instrument case. Instrument corroded.

Investigations before disassembly: Pitch indication: 6-8° c
Pitch indication: Approx. 35° right bank.
Disassembly: Instrument

groove along the circumference of the gear ring. No deformation of the ring was observed. Inspection of the groove and its edges showed three minor impressions or marks which could have been caused by the ball bearing. When the gear ring was placed in an approx. 0° bank position, these three impressions corresponded exactly to the position of the three ball bearings.

Conclusion: The indication of servomotor driven indicators is generally reliable provided the servomotor gear train is in mesh also after the impact. In this case the pitch indication of approx. 7° climb must be considered as practically certain, whereas the roll indication of approx. 35° is uncertain. It seems likely that the gear ring went out of mesh at the moment it impacted free, and therefore the bank indication of approx. 0° is more likely than the 35° indication.

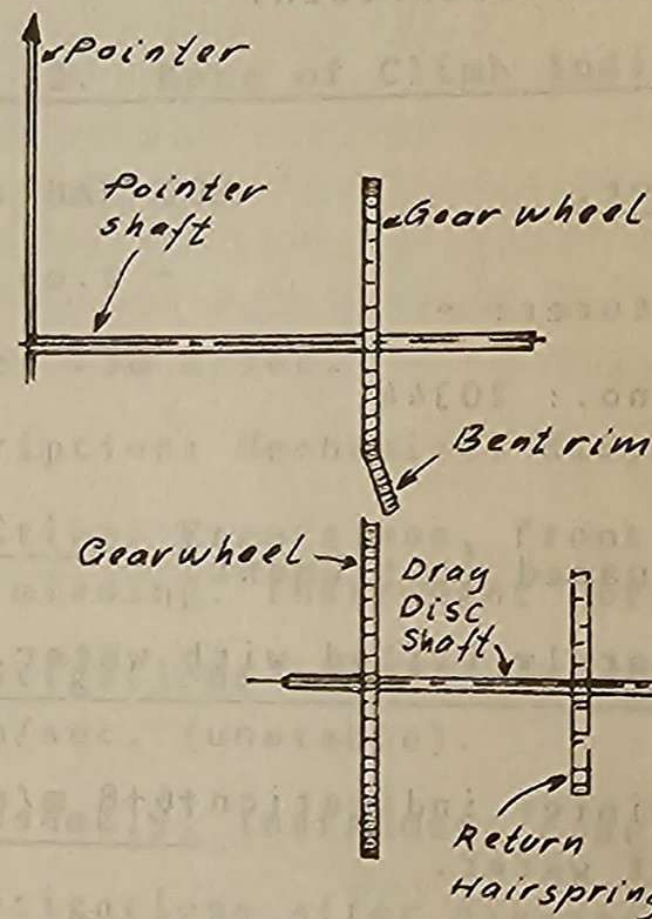
stigations after disassembly: Inspection of scale revealed evidence which could confirm the pointer indications.

Pointer no. 1 mechanism: Pointer drive shaft gear was b

out of mesh with disc gear. Magnetic disc gear could not rotate freely and returned to a Zero position by the return hairspring. With no. 1 pointer indicated 107%, the maximum deflection of the rim of the drive shaft gear was not in mesh with the normal mesh with the magnetic drag disc shaft. The marks shown on the scale were in fact very close to the 107% position.

Pointer no. 2 mechanism: The gears of this mechanism were in mesh and it seemed to be practically intact. When the return hairspring on the drag disc shaft was cut, it moved approximately 15 degrees corresponding to an indication of approx. 5%. The hairspring seemed completely intact. No marks were found on the gear.

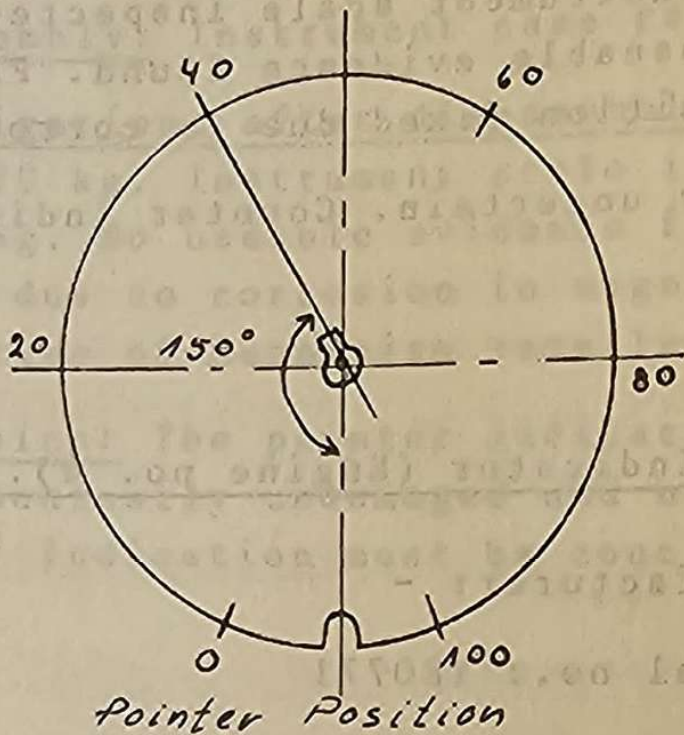
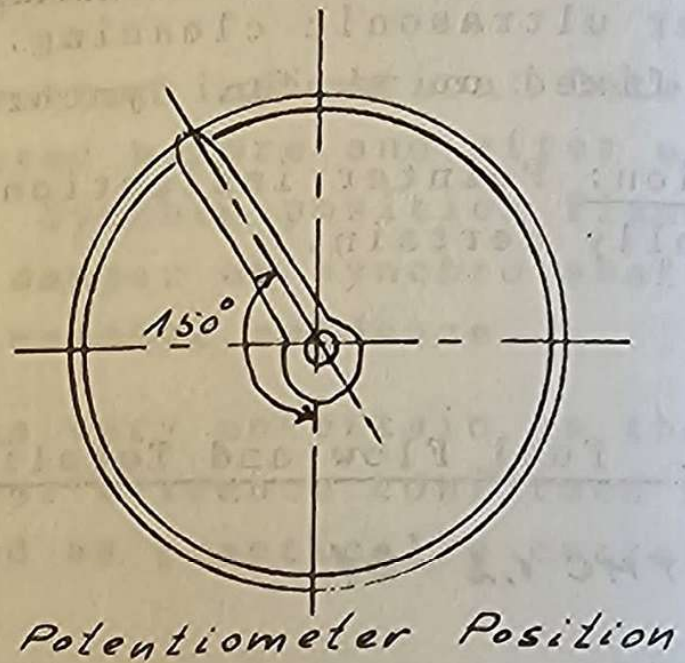
Condition: Instrument case including frontglass missing. Pointer bent near hub. Instrument corroded.

Investigations: Pointer directed against approx. 40 (outer scale). Inspection of scale revealed no useable evidence. Inspection of mechanism showed that the gear train from servomotor to potentiometer was intact.

The potentiometer was intact and its position could be determined corresponding to the pointer deflection.

Conclusion: The indication determined (40% or approx. 3200 kg) is considered as practically certain.

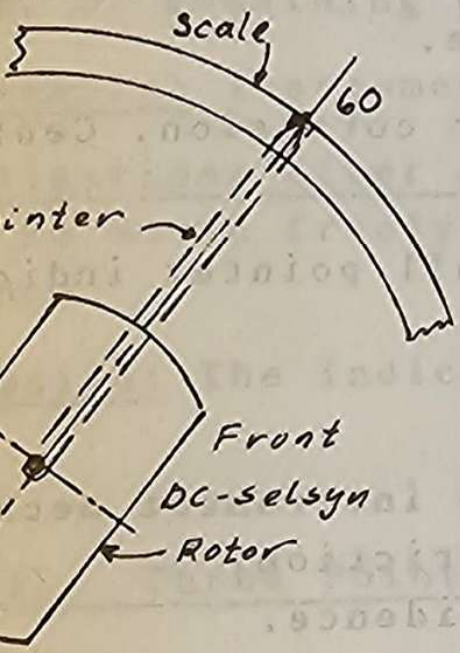
Investigations after disassembly: Inspection of the front Selsyn showed that pointer 2 was aligned along symmetry axis of the rotor as shown on sketch. Inspection of the rear Selsyn showed that this was not the case for pointer 1.

Inspection of the scale revealed no evidence.

Conclusion: The indications observed not confirmed by other evidence and considered as uncertain.

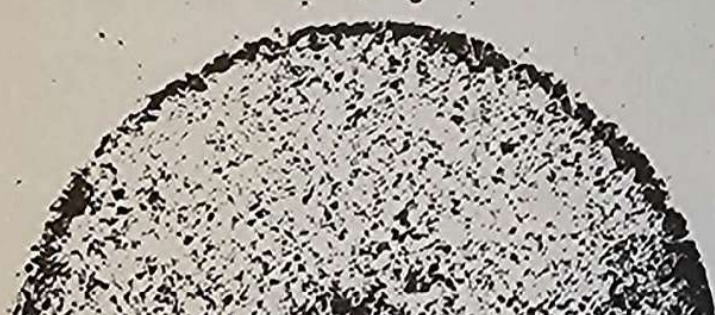
Enlargement

Sample mrk: Governor Filter 2.

Viscosity at 100°F 47.7 c St
Viscosity at 210°F 5.25 c St.
Content of metal flakes about 290 mg. per litre (see fig.)
