AIRCRAFT ACCIDENT
CS2F-1 1543 2 FEB 68

1. At 2130 hrs local on 2 February, 1968 CS2F-1 1543 crashed near Downsview airport in Toronto during the approach to the duty runway. The four crew members listed below were killed in the crash.

Report Mat Eng 113/65
Failure Investigation, Wright R1820-82
Engine Cylinder

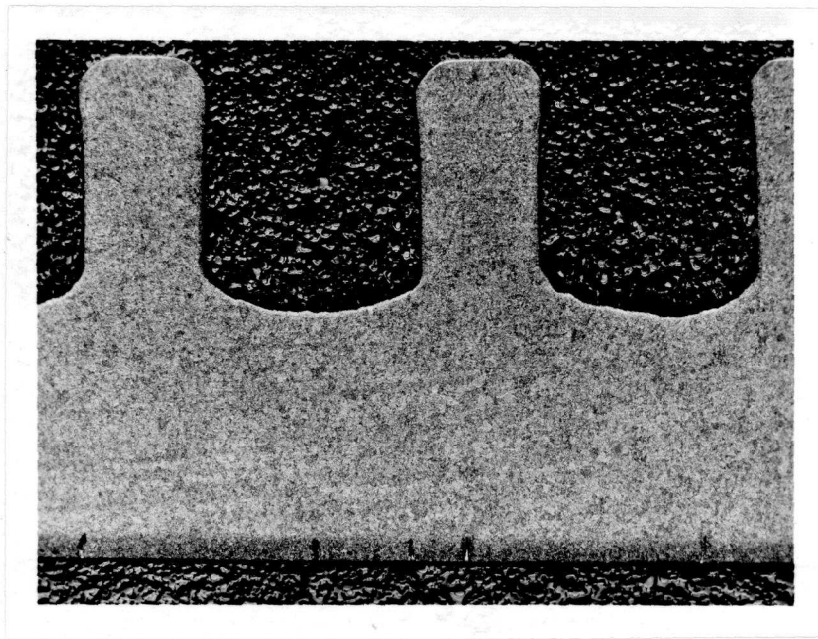
Photo 2

Detail of a crack on the cylinder wall. The crack runs in nitrided layer only. The mouth of the crack is filled with aluminum.
