Board of Inquiry, Bristol  
9697  
Convened at 1 Wing RCAF

1 Aircraft Type Bristol Registration 9697  
 Place 1 Wing RCAF, Marville, France Date 30 Dec 63  
 Parent Unit 109 KU Flt, 2 Wing RCAF, Grostenquin, France

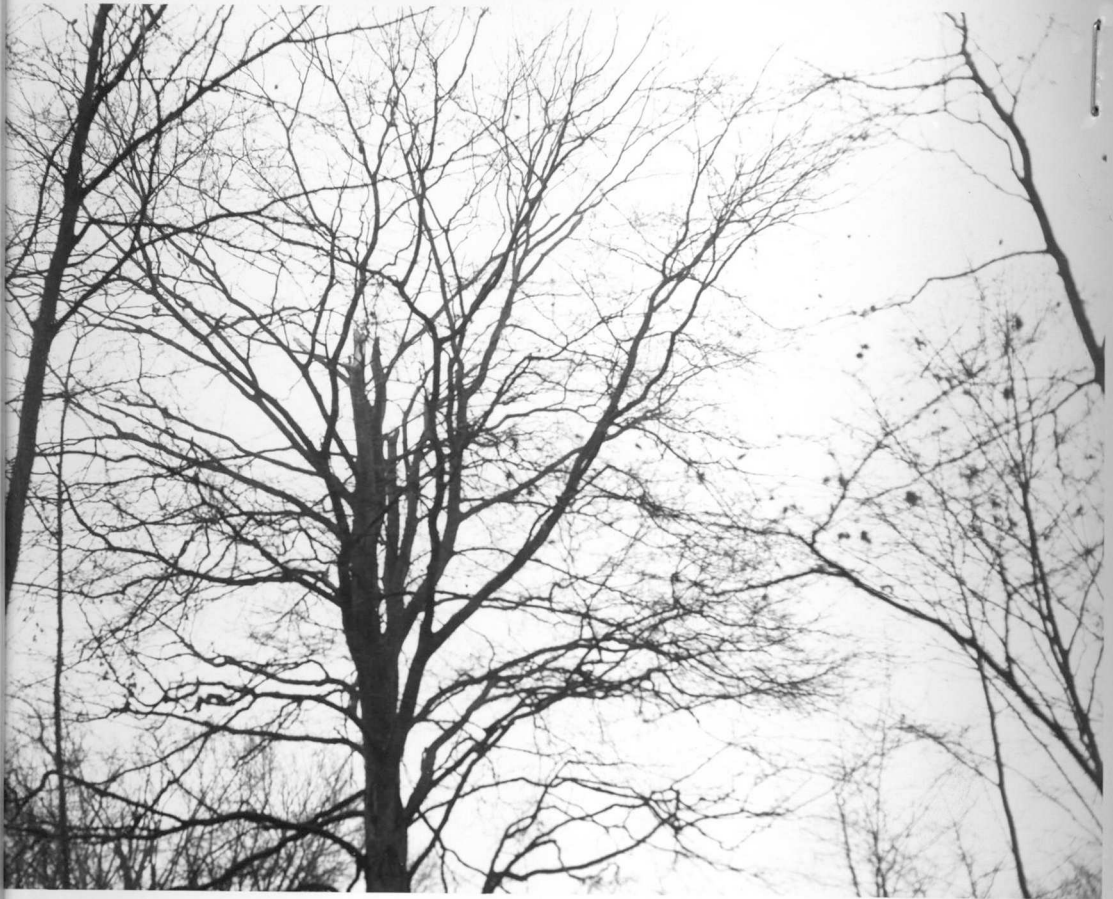
POSITION "2" ON WRECKAGE PLOT (FROM INITIAL IMPACT)

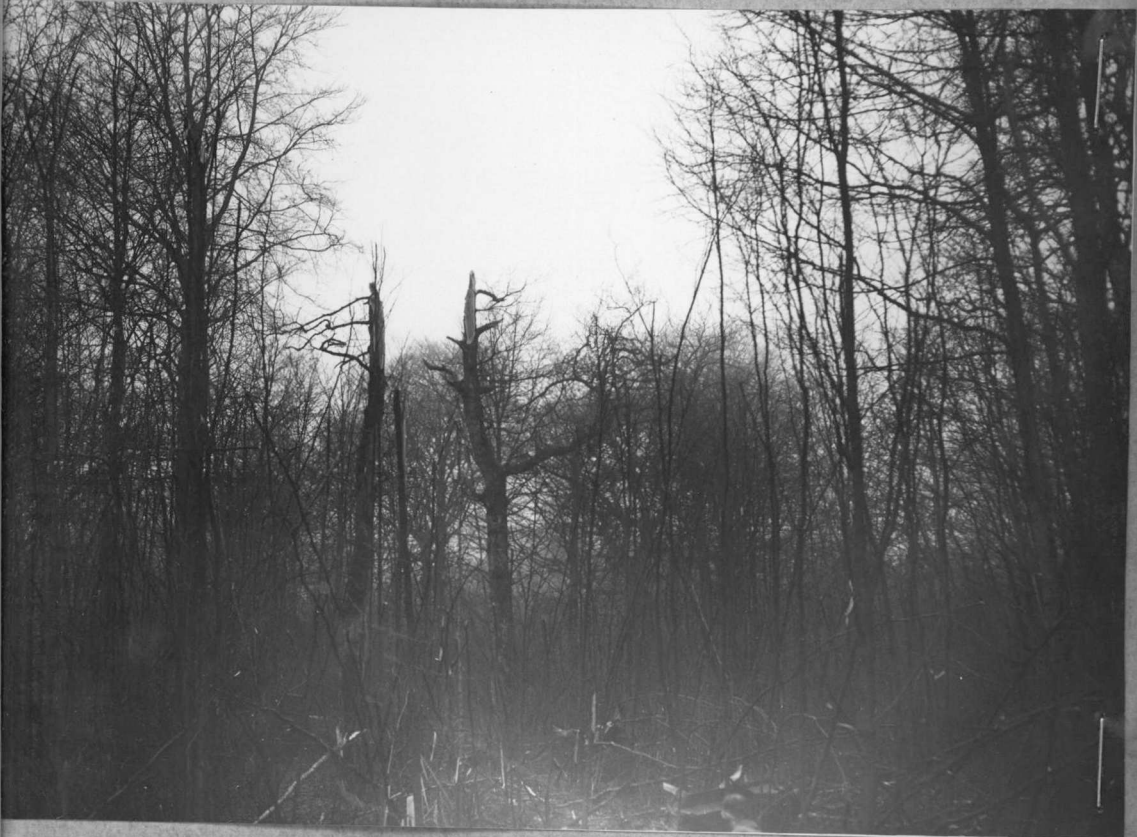
VIEW OF TREES FROM FINAL POSITION OF WRECKAGE

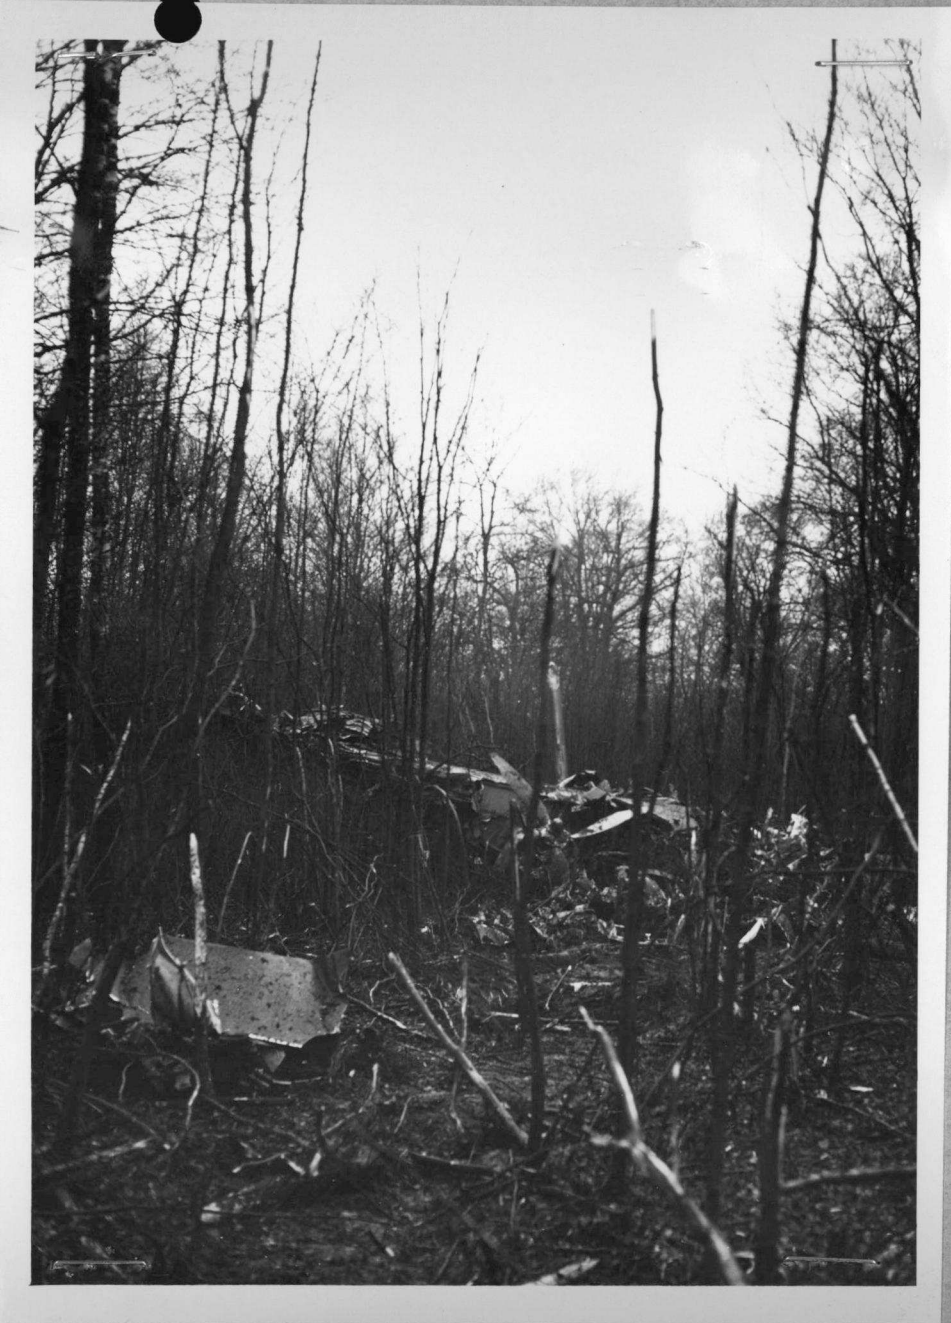
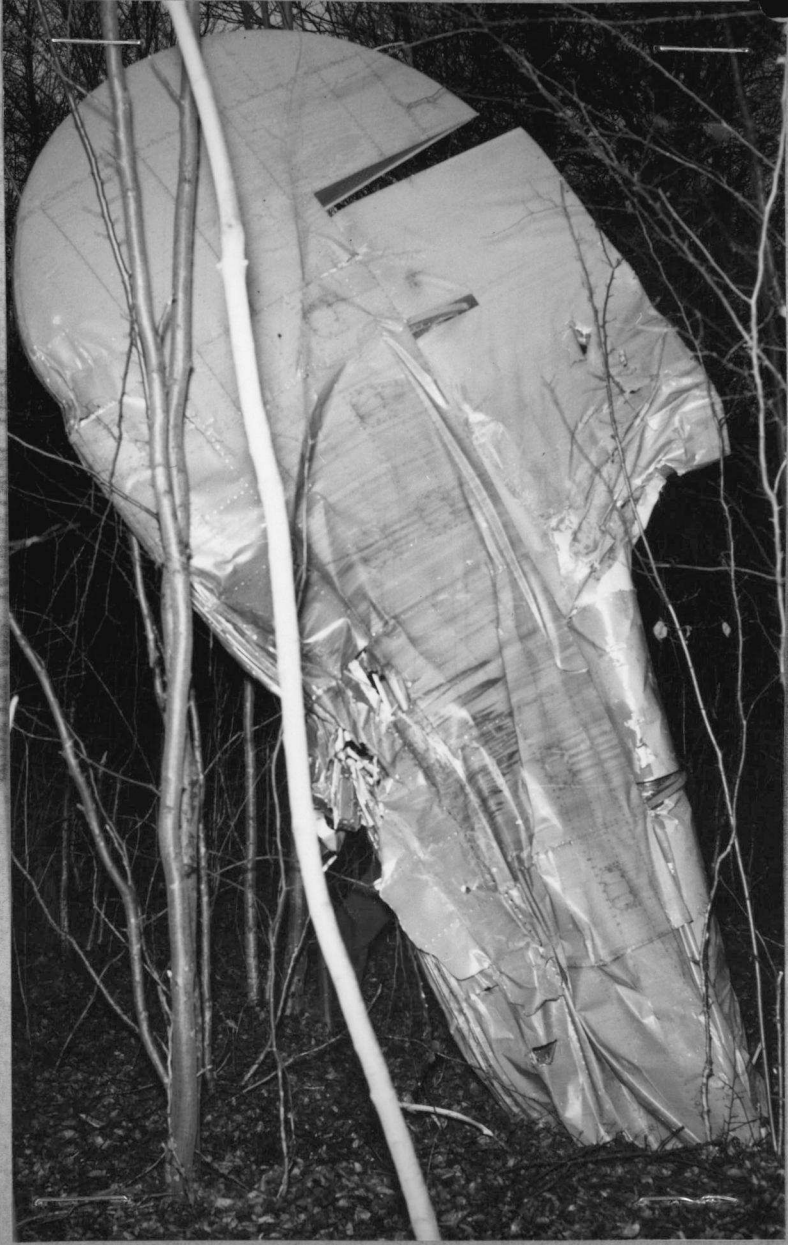
VIEW OF COMPLETE WRECKAGE

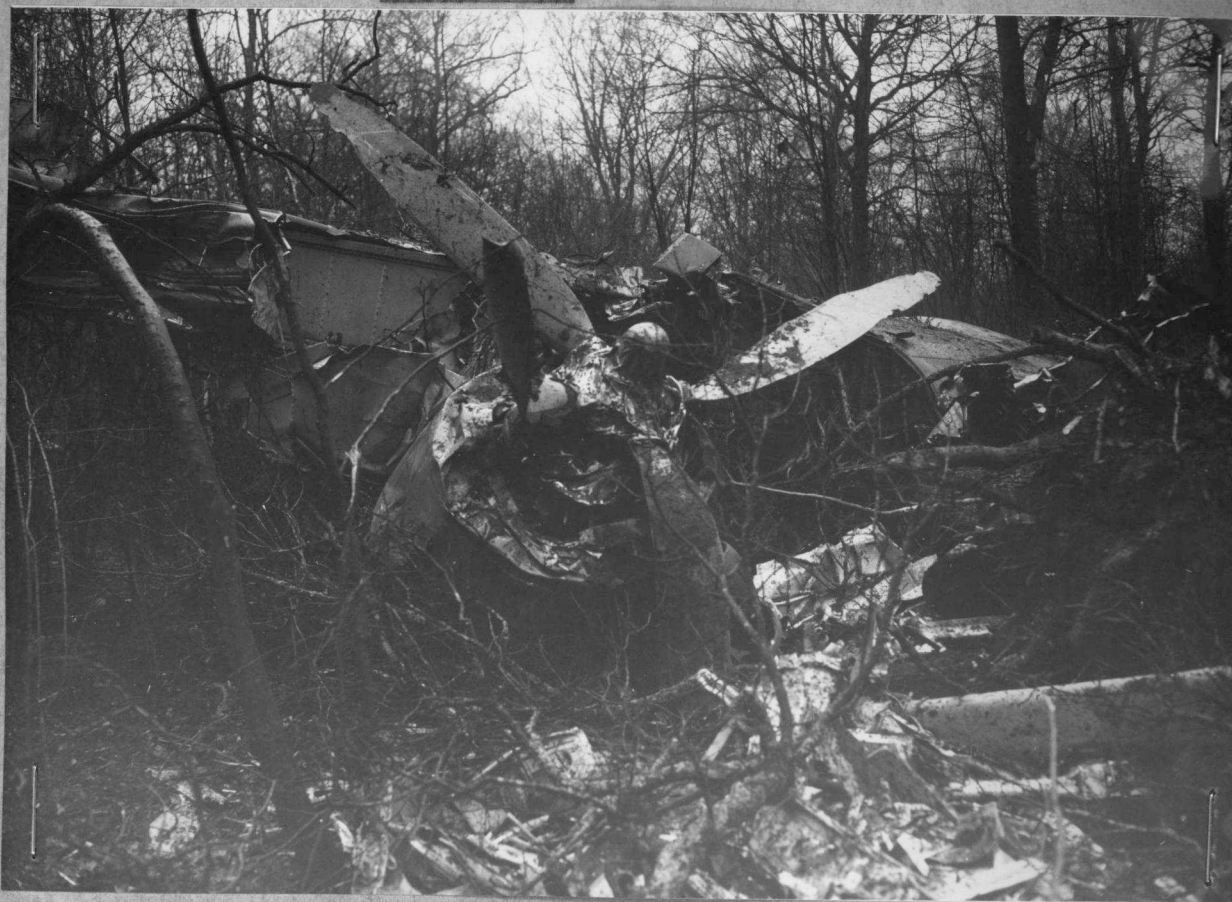
STBD ENGINE AND PROPELLER

The starboard engine had not been subjected to any fire and the propellor was still attached. Except for the oil tank which had been torn off, the power plant was complete, although the rear section had been damaged. The following components were subjected to minute inspection :

- (a) SUMP OIL FILTER - found clean and there were no excessive metal particles on the magnetic plugs.
- (b) FUEL PUMP - free to rotate, quill drive intact, pump contained residual fuel.
- (c) The hold-down studs for all cylinders were found secure.
- (d) PROPELLOR - the spinner was crushed and folded around the propellor blades, which were free to rotate in the pitch angle. All four blades were at different pitch angles. Three blades had the leading edge towards the rear of the engine, one blade had the leading edge forward. The tips of two propellor blades (N°s 3 & 4) were broken off and curled forward. N°s 1 and 2 blade tips had no curl. There was some rotational damage to the cooling fin blade tips. All four propellor blades had broken free from the bevel rotating gear, and the shims were visible from the front and slightly displaced.

The reduction gear casing had cracked and was pulled away approximately 1/2 an inch from the engine on the front inboard side. The propellor reduction gear was driven into the engine housing front at impact, and the teeth marks

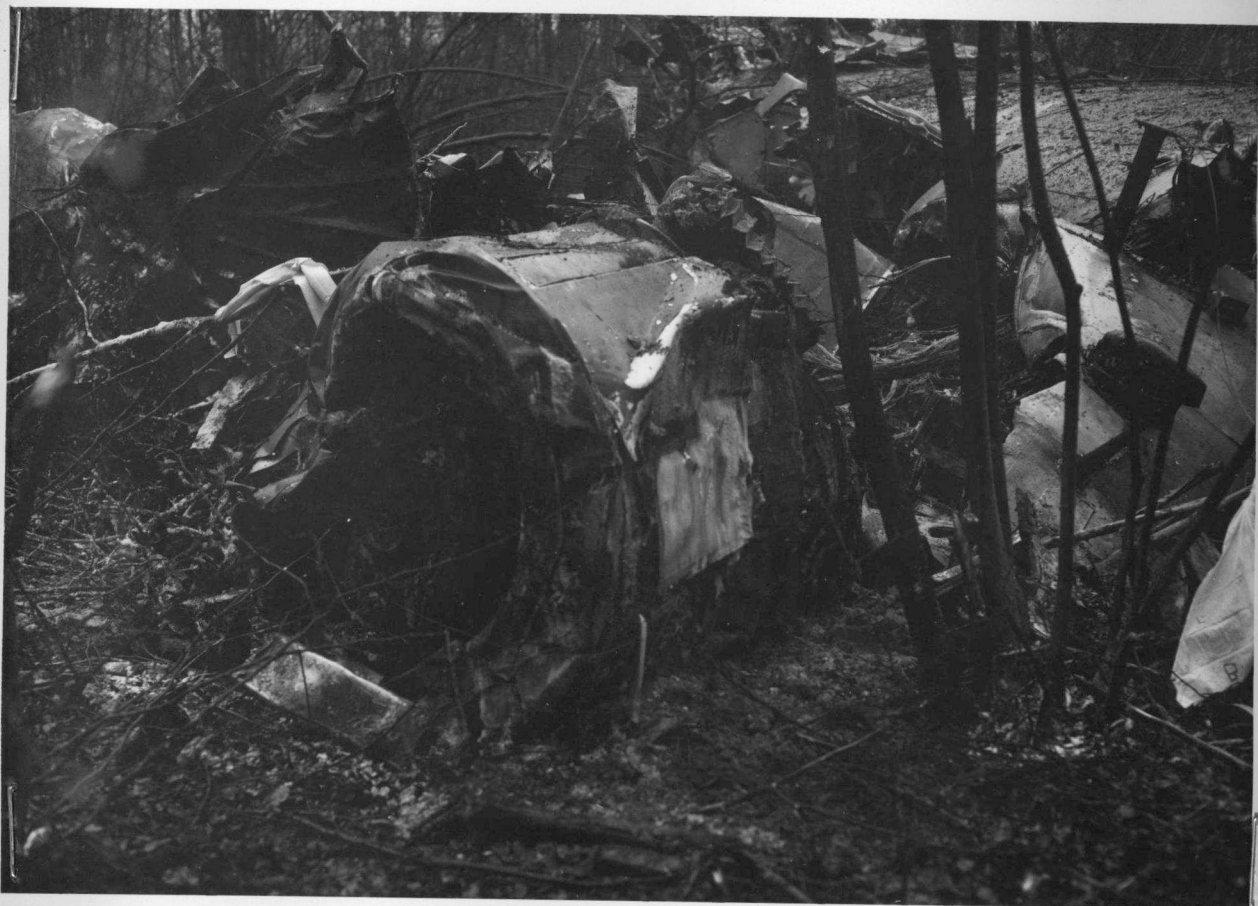
The starboard engine, complete with propellor broke off. The port engine broke away and burnt. On finding the aircraft, 2 hours 50 minutes after the crash, the searchers reported that the engine was glowing red, but no actual fire burning.

PORT ENGINE

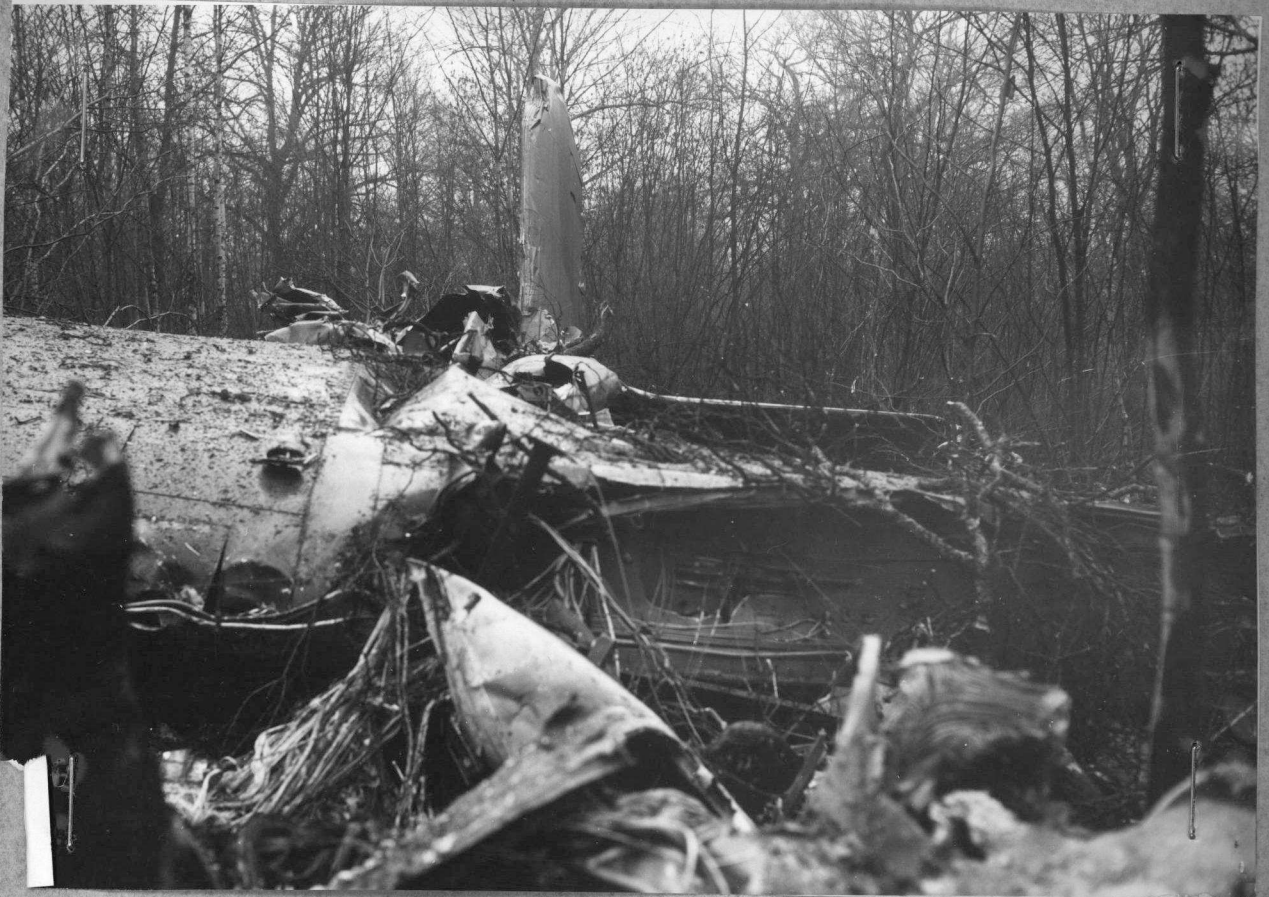
The damage to the fuselage and cargo section was primarily caused from contact with the tree that was uprooted and remained in the main wreckage. The force from contact with the tree apparently broke the fuselage open, snapping the floor into two pieces of 19 feet and 14 feet lengths respectively. This caused the passengers and crewman, who were seated in the after part of the aircraft, to be thrown out to the area behind the aircraft.

VIEW OF WRECKAGE LOOKING AFT

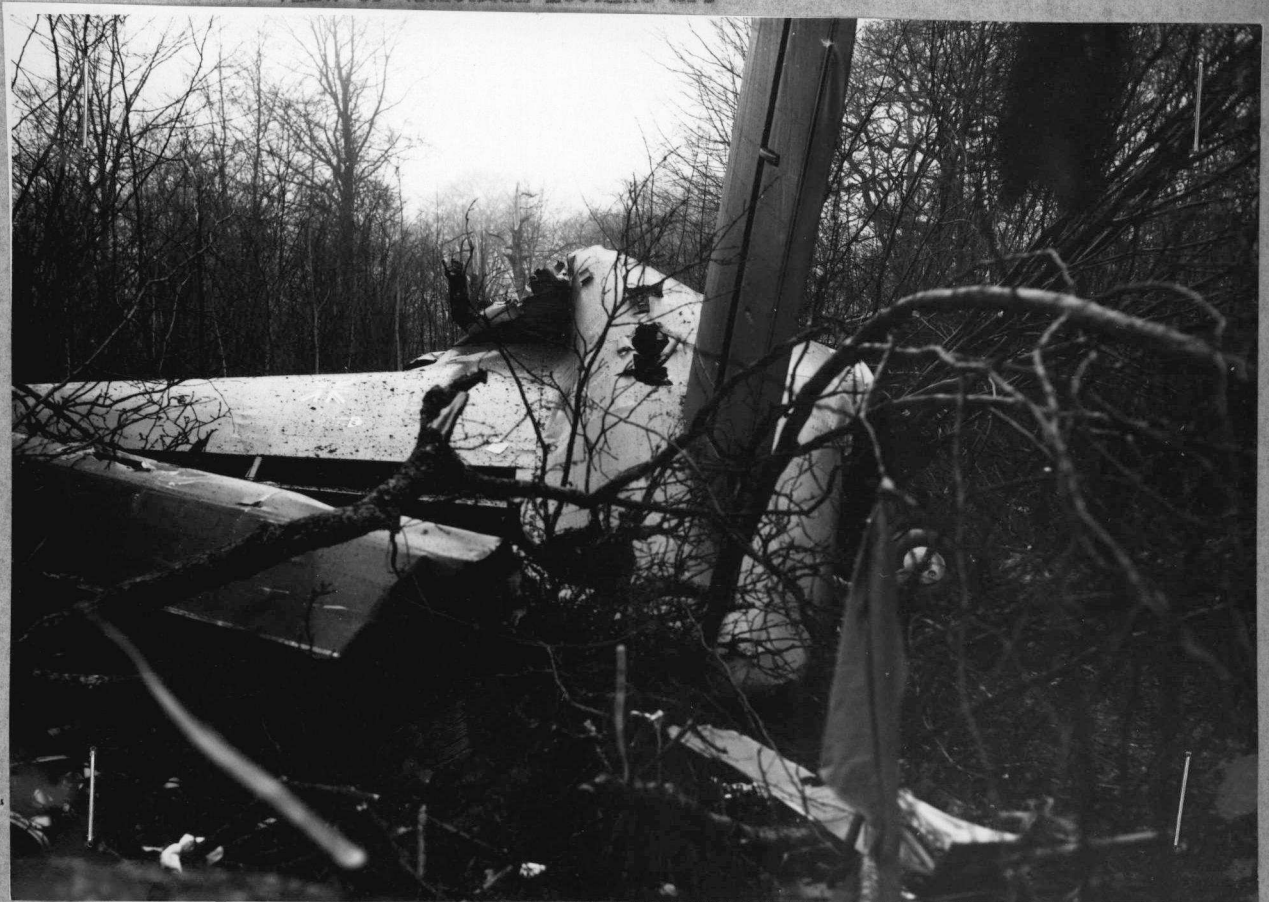
TAIL SECTION OF AIRCRAFT LOOKING FORWARD
