## No. 4

**Airbus Industries A300, AP-BCP, accident near Kathmandu, Nepal, on 28 September 1992. Report released by Nepal.**

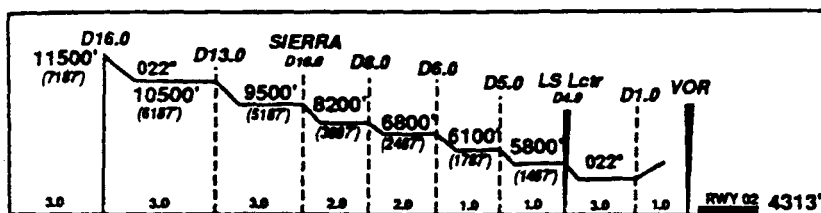
<sup>2</sup> Not an exact copy of the Jeppesen chart altitude profile.

(Please refer to actual chart)

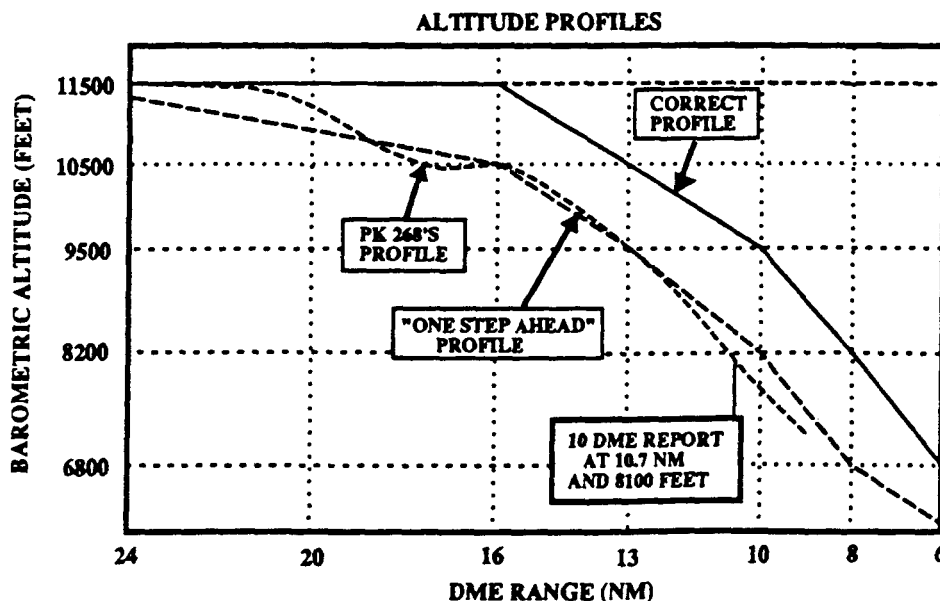
At 16 DME the crew were 'one altitude step' ahead of the correct profile. If this situation had persisted, the crew would have been aiming to be at 9,500 feet at 13 DME, 8,200 feet at 10 DME and 6,800 feet at 8 DME. The correct profile, the misinterpreted or 'one step ahead' profile, and the aircraft's actual flight profile are shown on the diagram below. From the diagram it is clear that the aircraft passed through 9,500 feet at 13 DME but then continued below the 'one step ahead' profile until impact.

The co-pilot reported "WE CROSSED OUT OF EIGHT THOUSAND FIVE HUN - TWO HUNDRED NOW" five seconds after starting his 10 DME position report. However, the crew made their 10 DME report at 10.7 nm from the beacon when the aircraft was passing through 8,100 feet. If, for whatever reason, they thought they were at 10 DME, then they were close to their target altitude of 8,200 feet. The initial reference to "FIVE HUN" which was rapidly amended to "TWO HUNDRED" may have been because the previous target altitude was 9,500 feet; certainly the aircraft was closer to 8,200 than 8,500 feet when the transmission started.

On this misinterpreted profile, they should have expected to be midway between 8,200 feet and 6,800 feet halfway between the check ranges of 10 and 8 DME. This would place them at 7,500 feet at their estimate or indication of 9 DME. At the groundspeed of 168 kts, the time to cover one nautical mile is 21 seconds. The 10 DME call started 32 secs before impact so, if the DME range error was consistent, they would see 9 DME 21 seconds after the R/T call and 11 seconds before impact. Therefore, if they were attempting to regain the 'one step ahead' profile they should have been less than 100 feet below 7,500 feet 11 secs before impact. An FDR "snapshot" 12 seconds before impact showed the aircraft at 7,484 feet which means they were just 56 feet below their target (one step ahead) profile and correcting towards it.

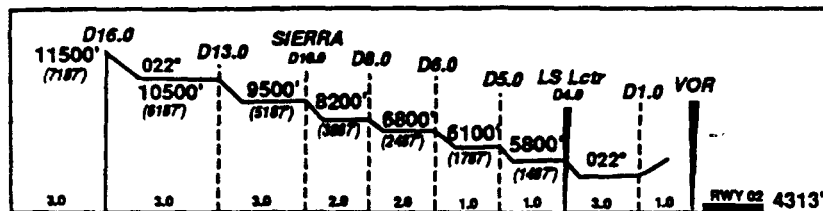
PIA crews use Jeppesen charts for all approaches to airfields within the airline's route structures. Both pilots had been employed by PIA for several years and both would have been very familiar with the Jeppesen chart conventions. Therefore, if the layout of the chart contributed to their mis-interpretation of it, it is likely that some abnormal feature or illustrative technique on this particular chart may have misled them. There was nothing abnormal in the plan portion of the chart apart from the omission of the fan marker and the presence of several notes. On the vertical profile, however, the data was unusually dense when compared to other VOR/DME approach profiles at airfields in PIA's A300 route structure. It too omitted the fan marker. The profile is illustrated below:

The omission of the fan marker from the chart was not a contributory factor in this accident. The descent profile is based on DME range and PK 268 struck a mountain before it reached the marker. However, the correct altitude at 16 DME was not printed on the plan portion of the chart; it was printed only on the elevation profile. Therefore, the initial mistake would appear to be that someone interpreted the elevation profile in such a way that the association between 16 DME and the clearly printed figure of 11,500 feet next to it was lost. As an informal trial indicated, if the altitude of 11,500 feet at 16 DME is obscured by the holder's thumb, the starting altitude is less obvious.
