AIRCRAFT ACCIDENT REPORT #H90002
TRANSPORT CANADA BEECHCRAFT 65-90
REGISTRATION C-FCAS
SHERRINGTON, QUEBEC
MAY 1, 1979

SYNOPSIS

On 1 May 1979 a Transport Canada King Air 65-90 was calibrating a radar antenna located at Dorval airport. While flying a 20 mile orbit at 1700', the right wing separated from the aircraft. The aircraft crashed in open farm land and was destroyed. Both occupants were killed.

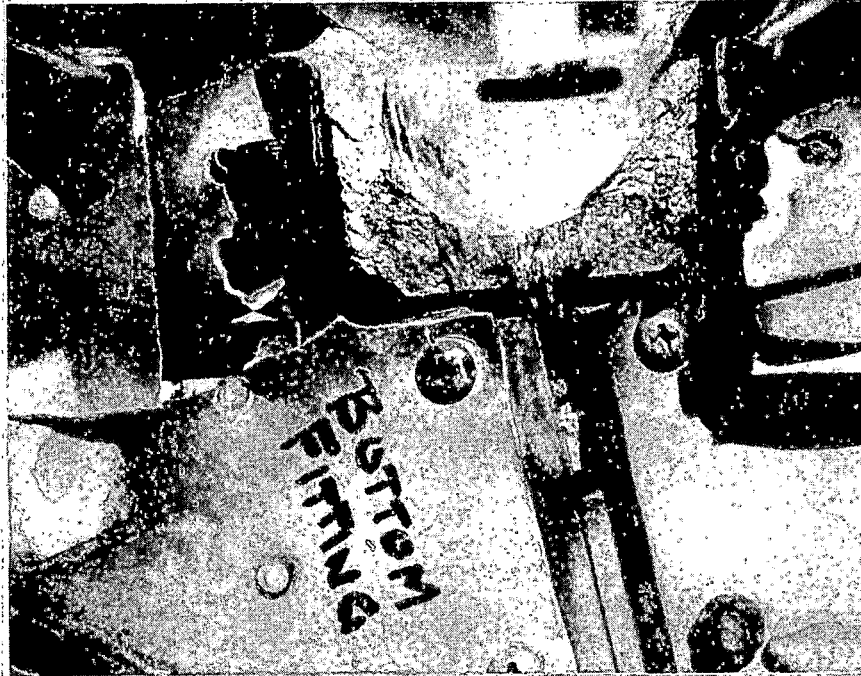
PHOTO 1 - IN-SITU VIEW OF THE OUTBOARD REMNANT OF THE FAILED LOWER FORWARD OUTBOARD WING ATTACHMENT FITTING STILL IN THE SEPARATED WING PANEL.

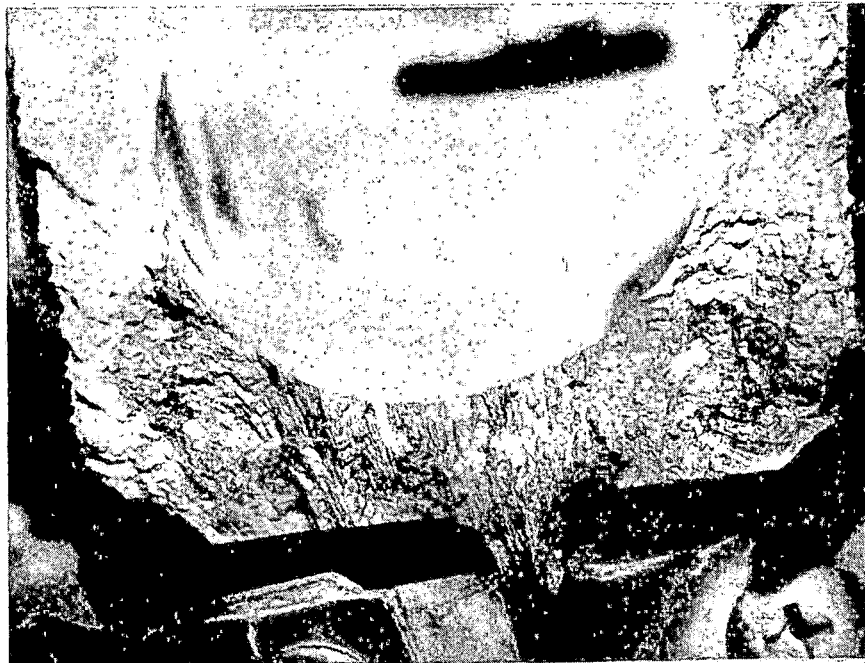
1.12.2 The fracture faces of the attachment fittings had not received any significant fire or post separation impact damage. Examination of the fracture faces showed that the upper front and both the upper and lower rear spar fittings had fractured from overload. The lower front spar fitting fracture surface appeared to be characteristic of a progressive type of cracking.

PHOTO 2 - CLOSE-UP OF PHOTO 1. THE DARKER AREA OF THE FRACTURE FACE DEFINES THE EXTENT OF THE PRECRACKED ZONE.

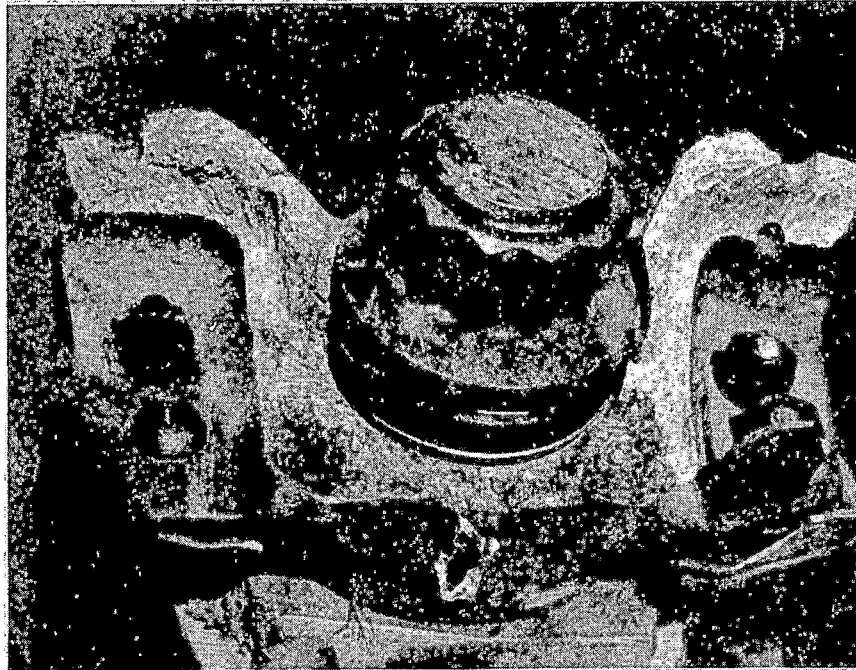
PHOTO 3 - CLOSE-UP OF THE INBOARD REMNANT OF THE FAILED FITTING, SHOWING ALSO THE INTACT BOLT, NUT & WASHER PACK.

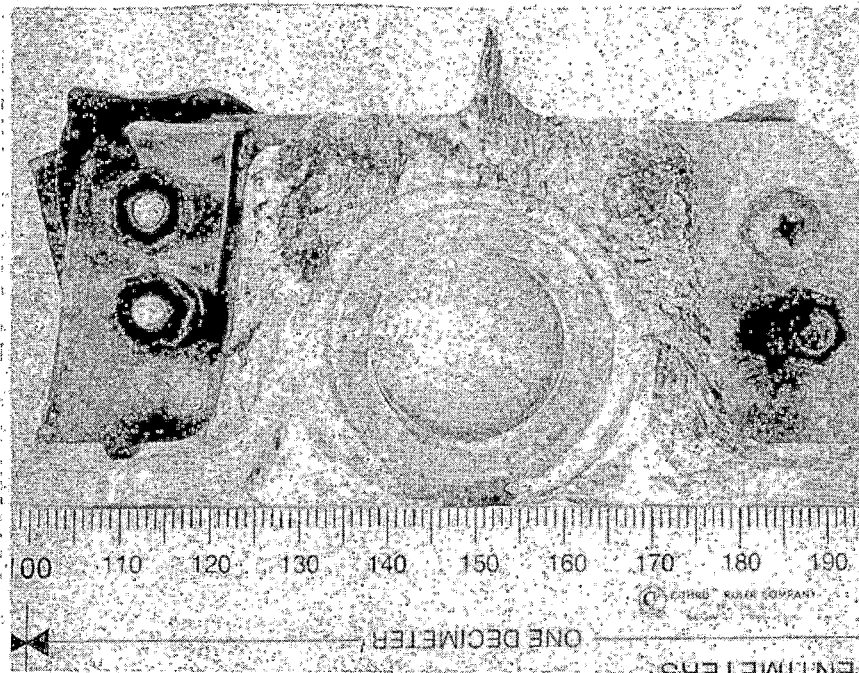
1.16.1.2 The laboratory evaluation initially concentrated on scanning electron microscopic (SEM) evaluation of the inboard fractured remnant shown in Photo 4 to determine the mode and mechanism of cracking. SEM evaluation indicated there were three fairly distinct zones of differing fractographic appearance. In zone "a" of Photo 5, crack growth initiated at a zone of intergranular separation at the crack origin "0", and grew thereafter in a mixed mode of intergranular cracking and transgranular fatigue cracking as illustrated by areas "i" and areas "f" respectively in Photo 6. In zone "b" of Photo 4 the cracking was virtually all intergranular in nature (similar to areas "i" of Photo 6). In zone "c" of Photo 5 the cracking was virtually all characteristic of transgranular fatigue cracking (similar to areas "f" of Photo 6). Photo 7 shows a characteristic area of zone "c" cracking in which it can be seen that the variable crack arrest line spacing was typical of operational loading induced fatigue crack growth. All of the intergranular areas of fracture were characterised by an irregular dispersion of roughly hemispherical holes on the grain boundary surfaces (see areas "i" of Photo 6).

PHOTO 4 - THE FAILED FITTING REMNANT SHOWN IN PHOTO 3, REMOVED AND CLEANED FOR SUBSEQUENT LABORATORY EXAMINATION.

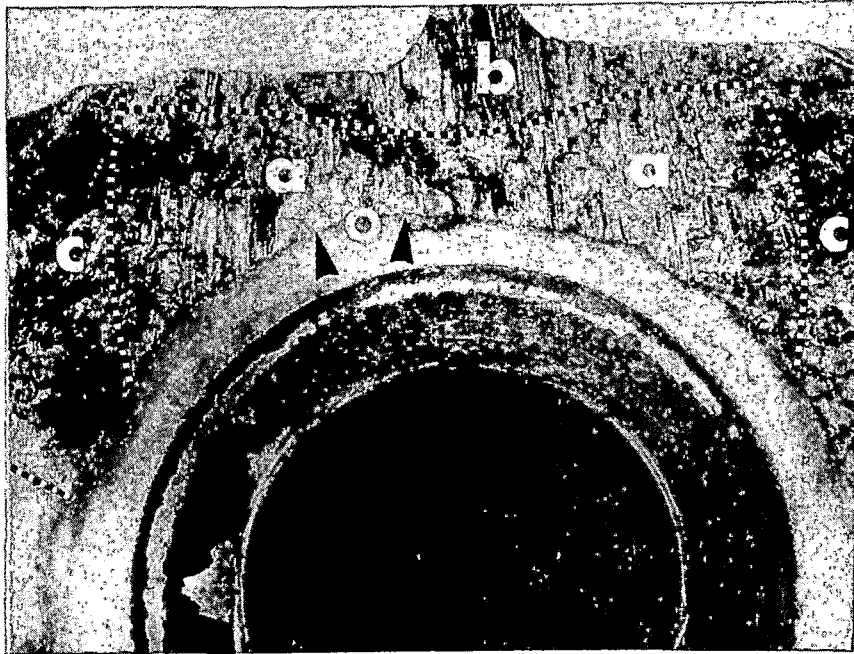
PHOTO 5 - AN OPTICAL CLOSE-UP OF PHOTO 4. THE PRECRACK ORIGIN IS AT "0". ZONES "a", "b", & "c" REPRESENT INTERGRANULAR PLUS FATIGUE, INTERGRANULAR, & FATIGUE CRACK GROWTH RESPECTIVELY.

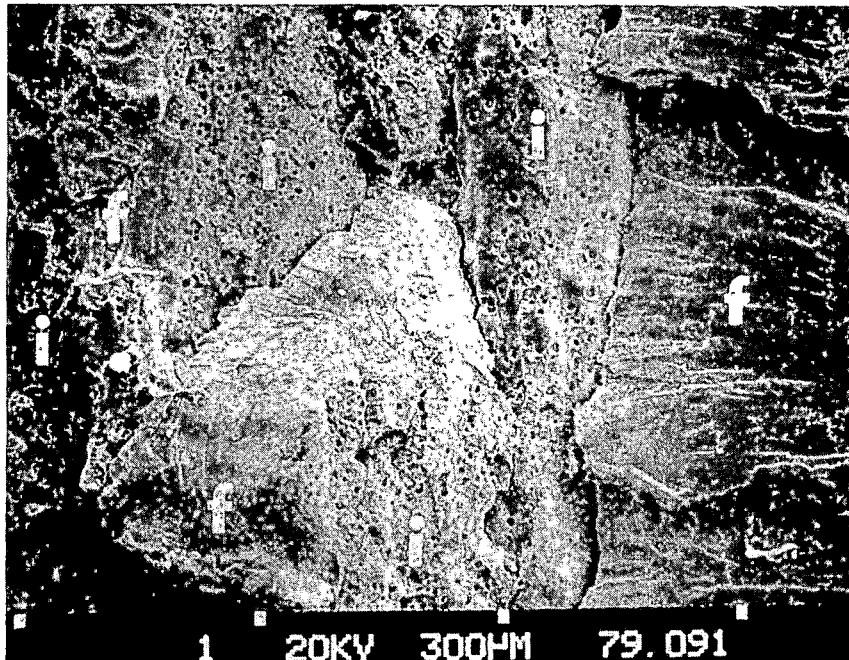
PHOTO 6 - S.E.M. IMAGE OF ZONE "a"(PHOTO 5) A FEW mm. FROM "0". AREAS "f" & "i" ARE FATIGUE & INTERGRANULAR CRACKING RESPECTIVELY. CRACK GROWTH IS RIGHT TO LEFT. x1,00 approx.

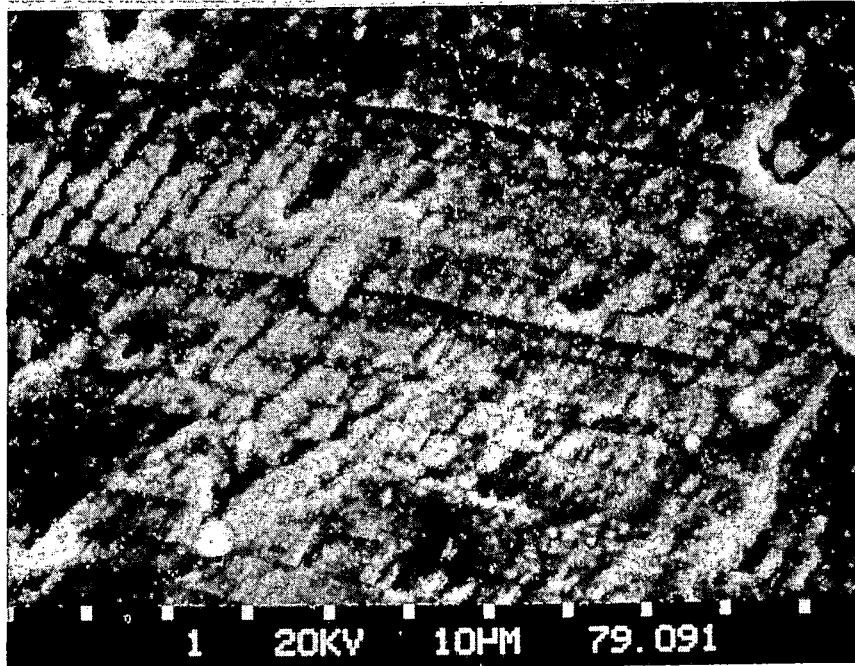
PHOTO 7 - S.E.M. IMAGE OF ZONE "c"(PHOTO 5) SHOWING TYPICAL RANDOM SPACING OF THE FATIGUE CRACK ARREST LINES. x1,000 approx.

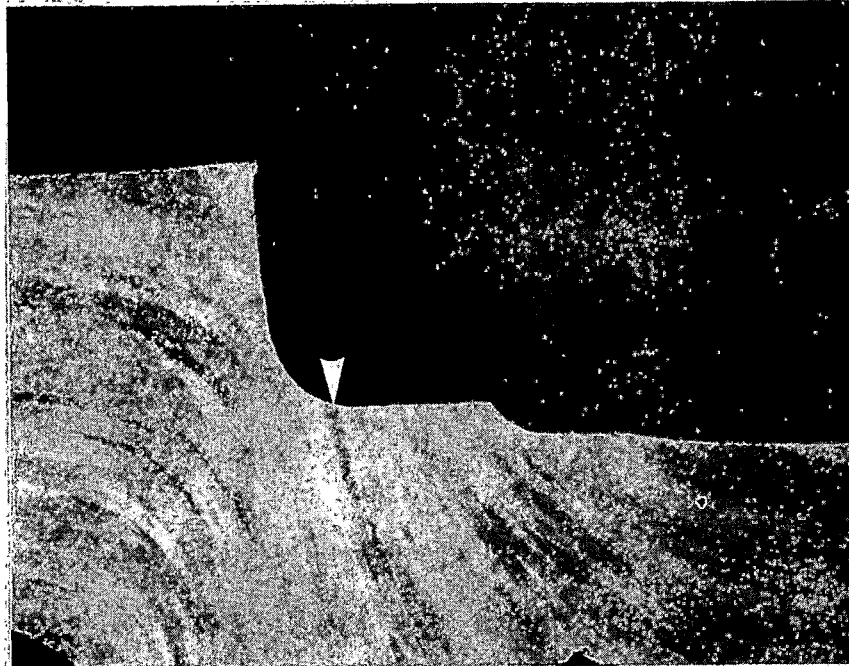
1.16.1.3 Photo 8 shows multiple path intergranular cracking was still occurring even when the crack had grown to the extent of breaking through the outer surface of the "bathtub" (having initiated at the inner surface). Photo 9 shows crack initiation occurred at a location where machining had exposed "end grain" structure (i.e. the predominant forging grain flow was essentially perpendicular to the free surface). Photo 10 shows a typical metallurgical section through the forging in the vicinity of failure. Voids, of essentially spherical shape and of up to 0.001 inch diameter, were found distributed throughout the section along the grain boundaries. These voids were consistent (in size, shape and distribution) with the hemispherical holes observed on the intergranular areas of the fracture surfaces. Further metallurgical and material evaluation indicated the failed fitting was manufactured from the specified 2014 aluminum alloy, had been heat treated to the specified -T6 temper, and appeared to meet all general material property and dimensional requirements.

PHOTO 9 - AN ETCHED MACROSECTION CUT THROUGH THE UNBROKEN LEFT WING LOWER OUTBOARD ATTACHMENT FITTING SHOWING THE INTERNAL GRAIN FLOW. NOTE THAT THE GRAIN FLOW IS NEARLY PERPENDICULAR TO THE MACHINED NUT RECESS SURFACE AT THE ARROWED LOCATION. THIS CORRESPONDS TO THE LOCATION OF THE PRECRACK ORIGIN IN THE FAILED RIGHT WING FITTING.

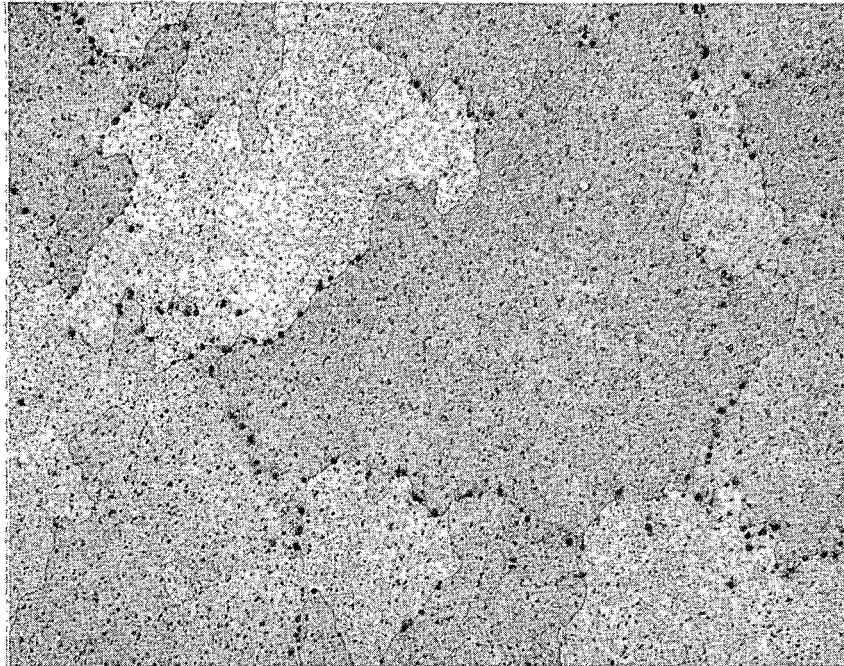
PHOTO 10 - AN ETCHED MICROSECTION, CUT FROM THE FAILED FITTING CLOSE TO AND PARALLEL TO THE FRACTURE FACE, AND PERPENDICULAR TO THE WING SKIN, SHOWING THE DISTRIBUTION OF THE SPHEROIDAL VOIDS ALONG THE GRAIN BOUNDARIES. (N.B. COMPARE SIZE AND DISTRIBUTION OF THESE VOIDS WITH THE SIZE AND DISTRIBUTION OF THE HEMISPHERICAL HOLES IN THE INTERGRANULAR FRACTURE FACE ZONES "i" OF PHOTO 6). X50, KELLERS ETCH.

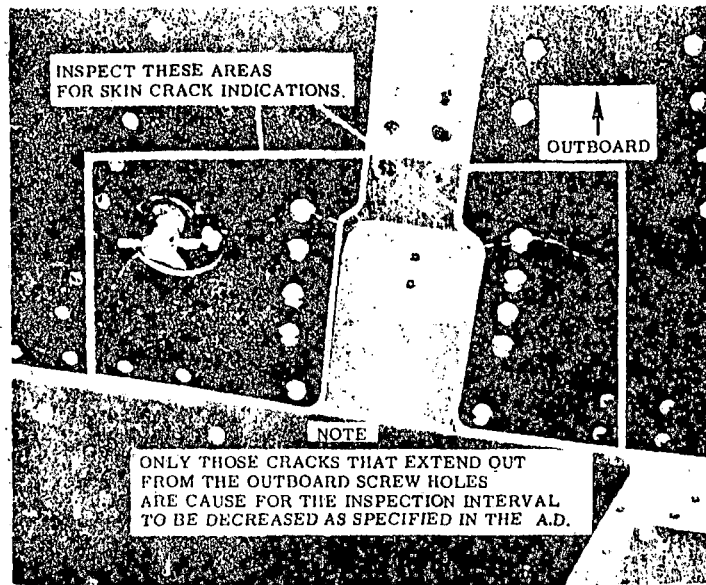
Figure 1. Skin Cracks

The skin area adjacent to each lower forward outerpanel wing attachment fitting should be visually inspected for cracks (see figure 1). Cracks in this area are only considered to be indicators. Their repair has no structural significance, and would not change the inspection intervals. The location and length of any cracks in these areas and the total aircraft hours at the time the cracks are detected should be recorded in the aircraft log book and the information forwarded to Parts and Service Operations, Beech Aircraft Corporation.
