Report No. P90091
Aircraft Accident
West Coast Air Services Limited
de Havilland, DHC6-200 (floats)
Registration C-FWAF
Sechelt, British Columbia
13:00 PDT, September 30, 1979

**AVIATION SAFETY
INVESTIGATION**

SYNOPSIS

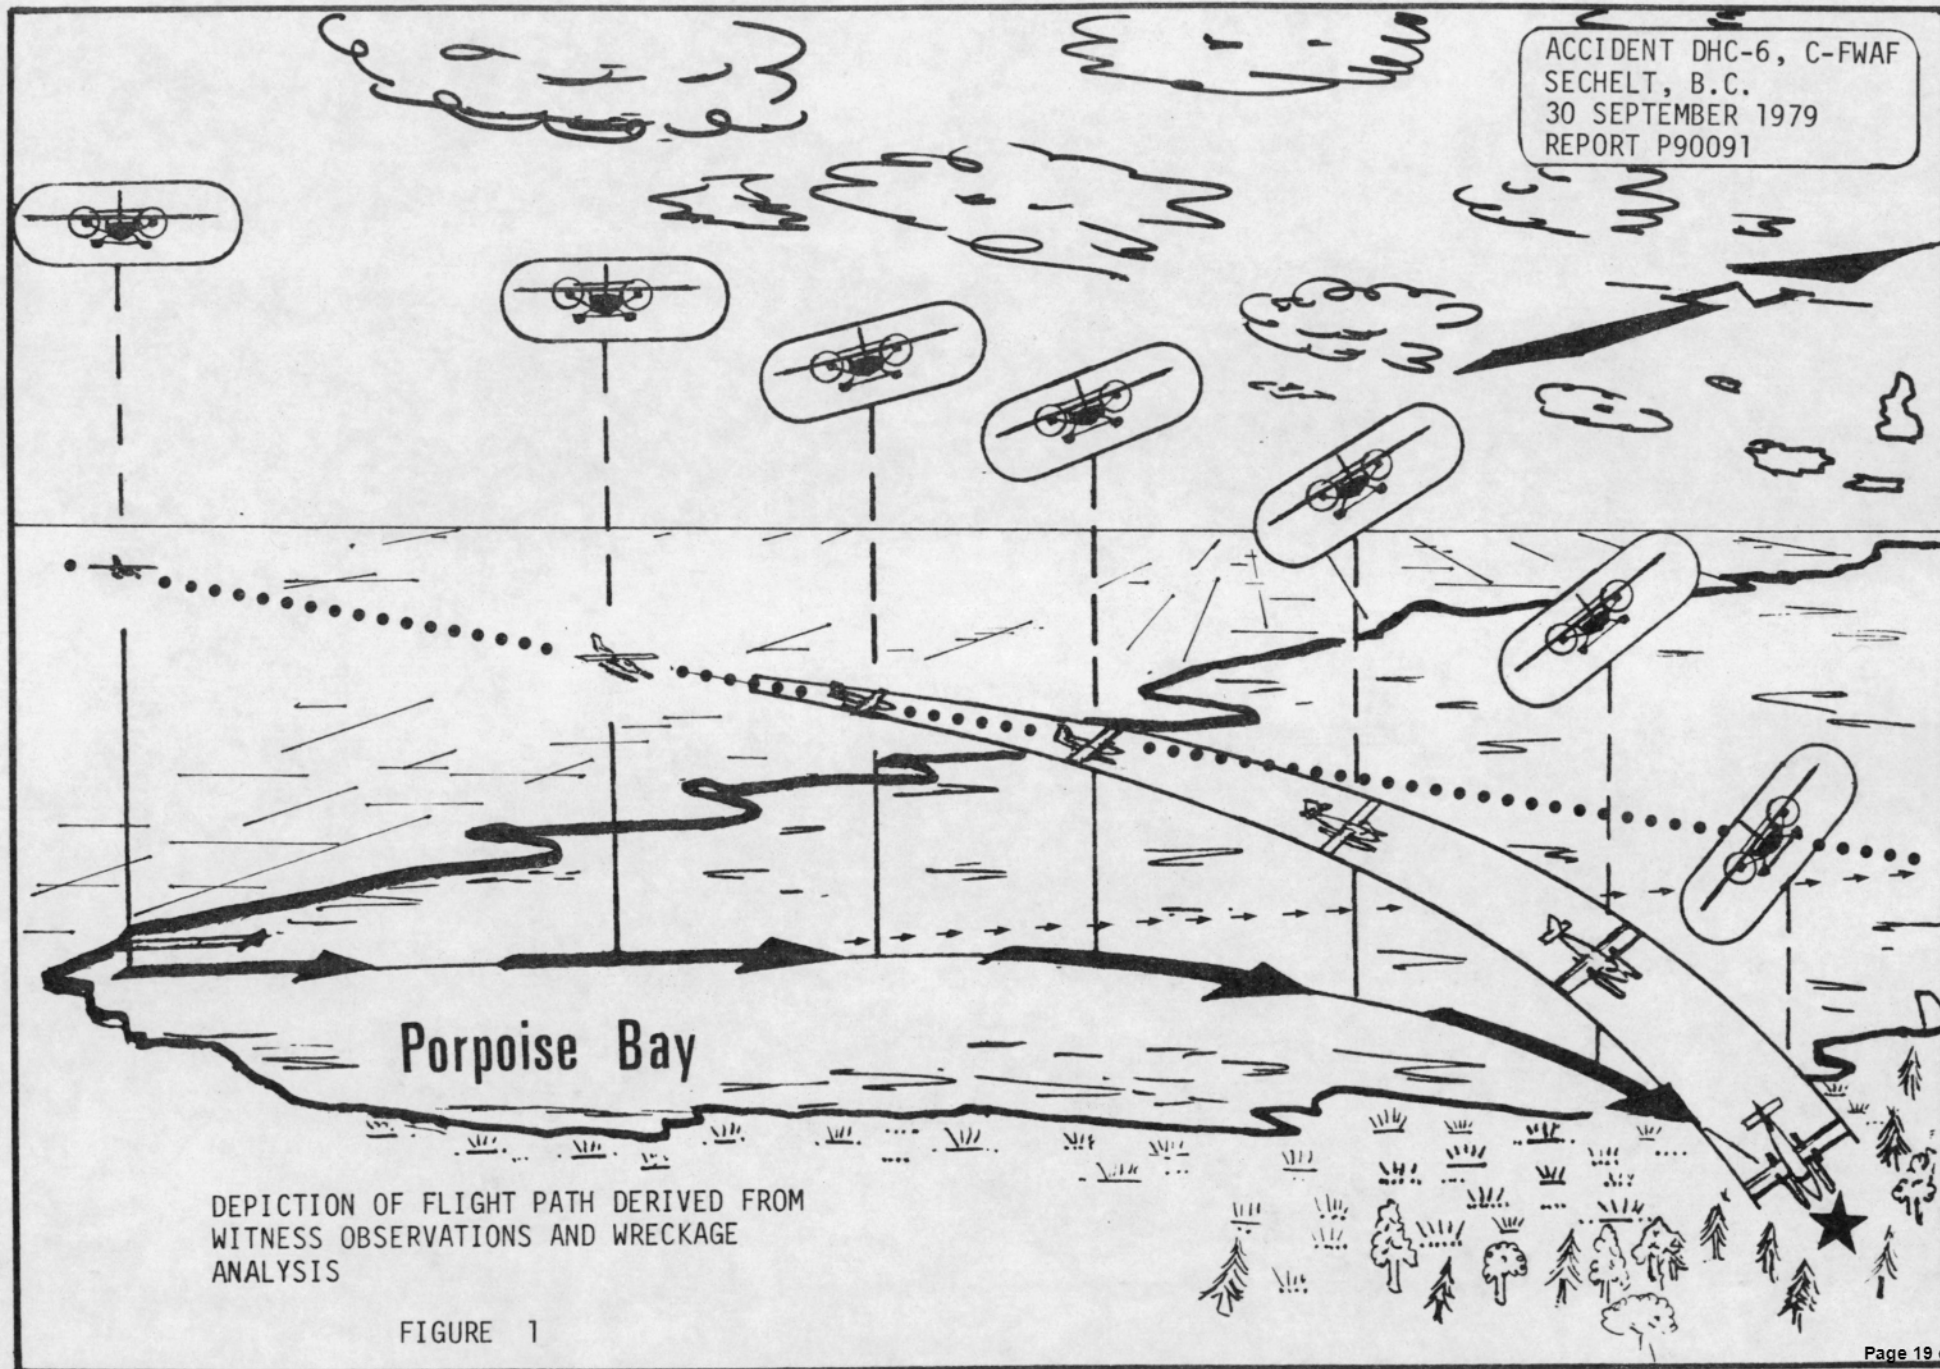
At an altitude of approximately 200 ft on final approach to Sechelt water aerodrome, the aircraft suddenly turned to the right and descended in a right wing-down, nose-low attitude. It crossed the shoreline, struck the ground right wing first and then cartwheeled into a tree-covered area.

The flight was uneventful until it neared Sechelt. Witnesses and passengers described a normal approach to land on the water at Porpoise Bay. As the aircraft passed over the southern shoreline of the bay at about 200 ft. it began to roll to the right. The angle of bank increased "to about 90°", with the nose dropping. The aircraft descended and struck the ground in a right wing-down nose-low attitude on the eastern shore of the bay 165 ft from the water.

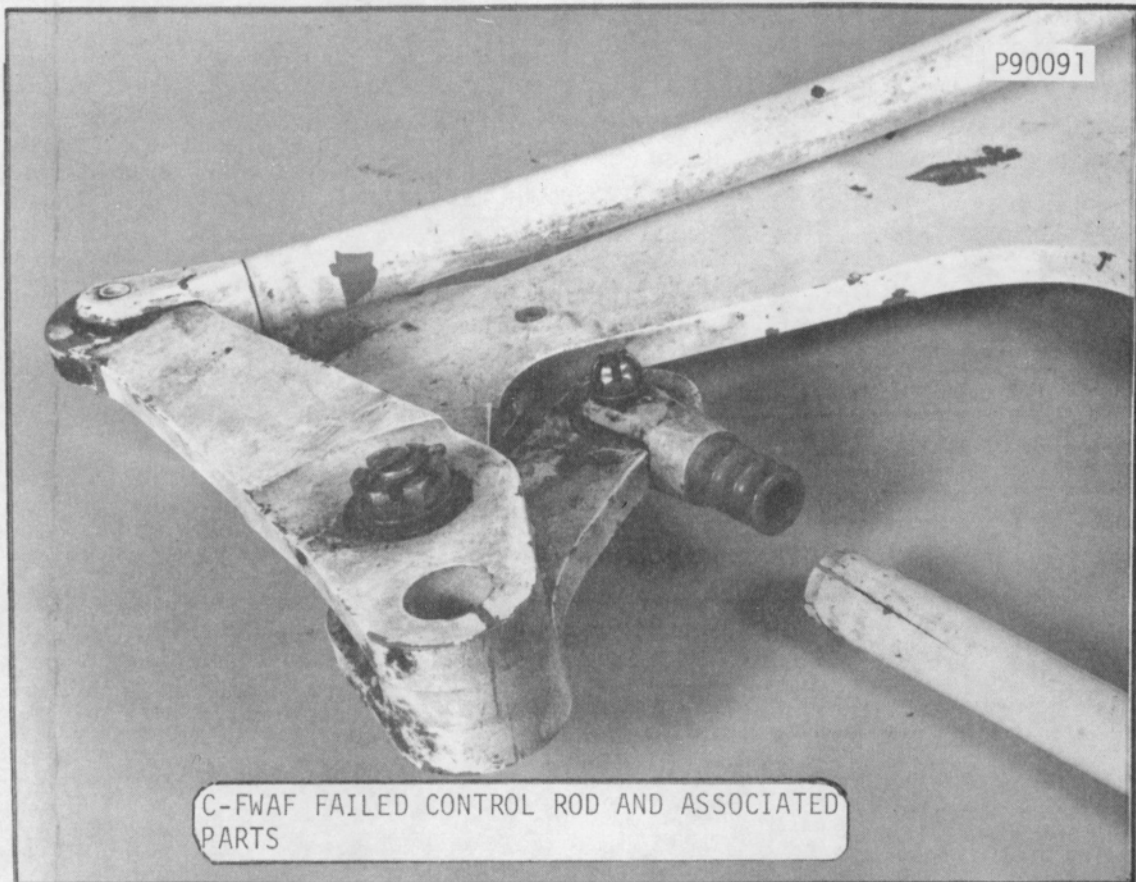
FIGURE 3

Flight control linkages were found to be intact with the exception of the right bellcrank to aileron push-rod P/N C6CW 1019-1. The clevis end fitting had separated from the rod at the bellcrank end. The failed end of the rod was found to have a longitudinal split of approximately two inches in length, extending across the magneformed swage to the rod end and it was suspected that the separation had occurred before the ground impact (see Fig 3).

Field examination of the control systems had identified one possible deficiency; the separation of the right aileron push-rod at the bell-crank end (See 1.12.7). Laboratory examination revealed a 1 15/16 inch longitudinal crack across the swaged portion of the rod end. The failure mechanism was identified as stress corrosion except for a small (.01 by .03 in.) overload shear lip at the end of the rod. It was concluded that

the crack had progressed sufficiently to allow separation of the rod and end fitting under normal operational loads for the approach configuration (Engineering Facility Report LP 254/79 refers - see also section 1.16.3).

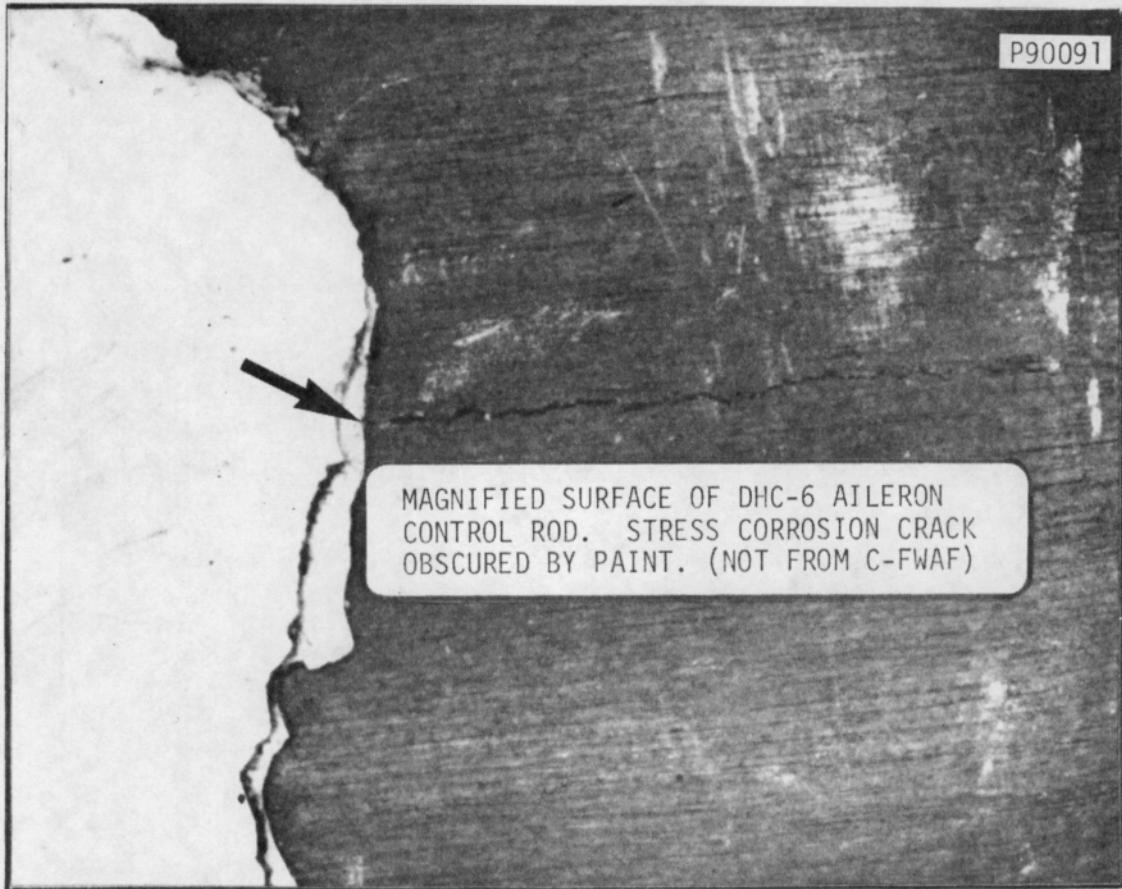
FIGURE 4

The three essential ingredients for stress corrosion: a susceptible material; the presence of residual stress; and a corrosive environment were all present. Operational loads do not have a significant effect on stress corrosion crack growth rate. Thus, in this case, the crack may have existed at the time of the last relevant EMMA check, but was undetected because visual inspection is inadequate for this purpose and no other type of inspection was required. Previous experience has demonstrated that removal of paint and application of dye penetrant is essential for the detection of this type of failure mechanism (see Fig 4).
