AIR TRANSPORTATION SAFETY INVESTIGATION REPORT A24C0057

LOSS OF CONTROL AND COLLISION WITH TERRAIN

Canadian Fly-in Fishing (Red Lake) Ltd.
De Havilland Aircraft of Canada Limited DHC-2 Mk. I, C-GBZH
Red Lake (Howey Bay) Water Aerodrome (CKS4), Ontario, 2.2 NM SE
16 June 2024

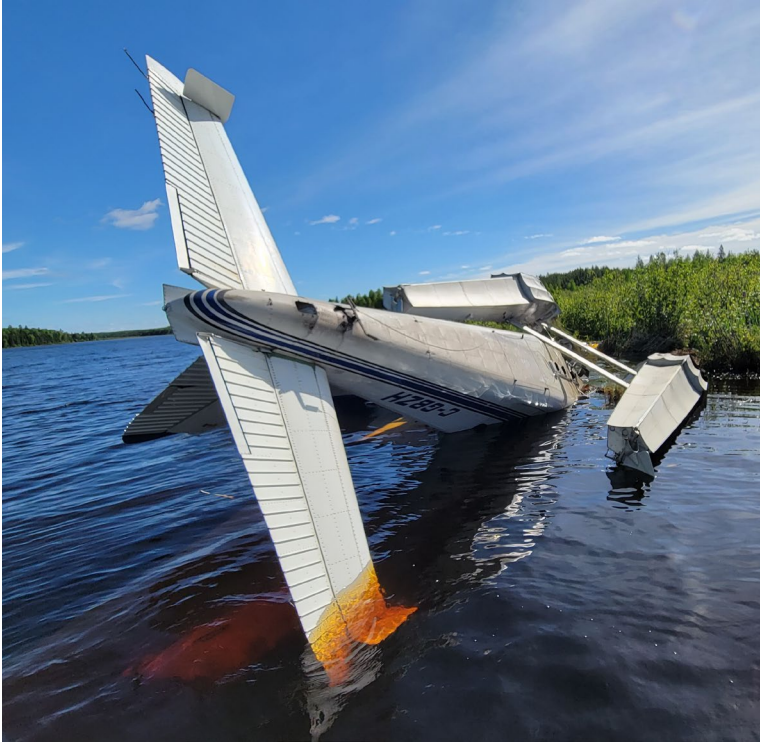
The aircraft came to rest on its left side, partially submerged in approximately 1.5 m of water, 5000 feet from the start of the take-off run (Figure 2).

Figure 2. The occurrence aircraft following impact with terrain (Source: TSB)

The aircraft was substantially damaged. There was no post-impact fire. The emergency locator transmitter activated.
