AIRCRAFT ACCIDENT REPORT

**NORTH AMERICAN ROAD LTD.
MITSUBISHI MU-2B-35, C-GLOW
EDMONTON, ALBERTA
6 DECEMBER 1981**

REPORT NUMBER 81-W10137

SYNOPSIS

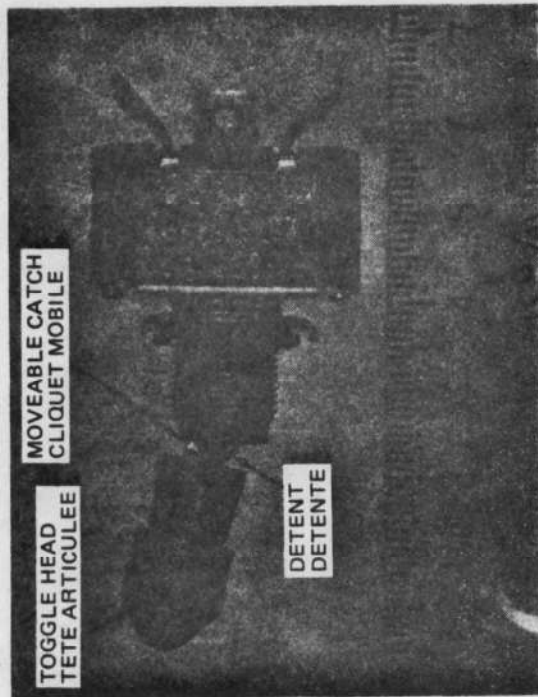
Photo 2 — Identical Type Switch for Comparison Purposes
Contacteur de type identique pour fins de comparaison

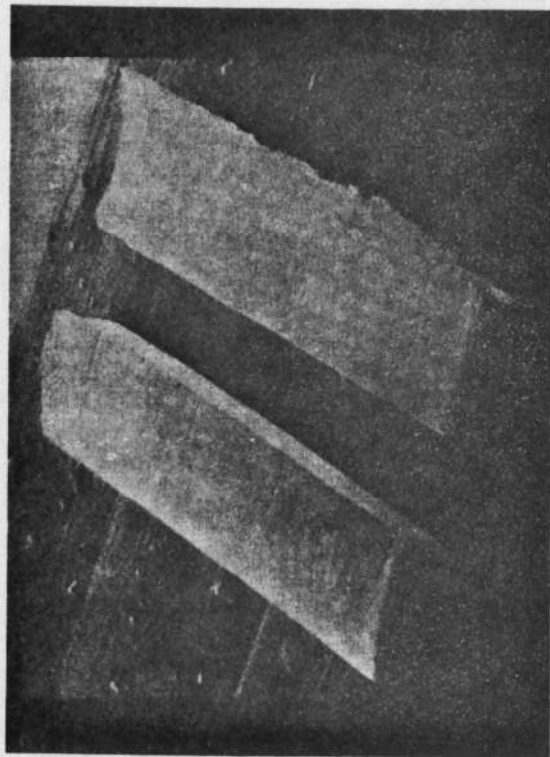
The owners of the aircraft obtained the services of a private accident investigation consulting firm, Waldron and Co. During the consultant's examination of the left torque sensor assembly, it was noted that some internal damage had occurred, but the gears could be turned freely, and there did not appear to be any discontinuity in the drive train. However, there seemed to be some bearing roughness, and the module was disassembled for a closer look at the bearing. When the spur gearshafts were separated, an examination revealed that the key which locks the two gearshafts together had been sheared (Item 80, Appendix D). The sheared key halves showed smear marks obliterating the fracture surfaces. The smear marks resulted from the gearshaft of the driving gear rotating within the hollow shaft of the gear it normally drives (Photo 1, Appendix F). Rotational wear on the faces of the key halves indicated a number of revolutions by the driving gear after the key had sheared.

On 16 January 1986, an MU-2, C-FOUR, had an in-flight engine failure. It was determined that a bolt had come loose and jammed the spur gear (Item 65, Appendix D), stopping the gear train. The drivekey failed and there was relative rotation between the male and female gearshafts resulting in severe scoring and metal transfer between the two gearshafts in the interference fit area. The examination revealed that the smearing on the key fracture was not as pronounced as observed on the key from the left torque sensor assembly on C-GLOW.

Photo 1 — Key Halves from Left Engine
Moitiés de clavette en provenance du moteur gauche

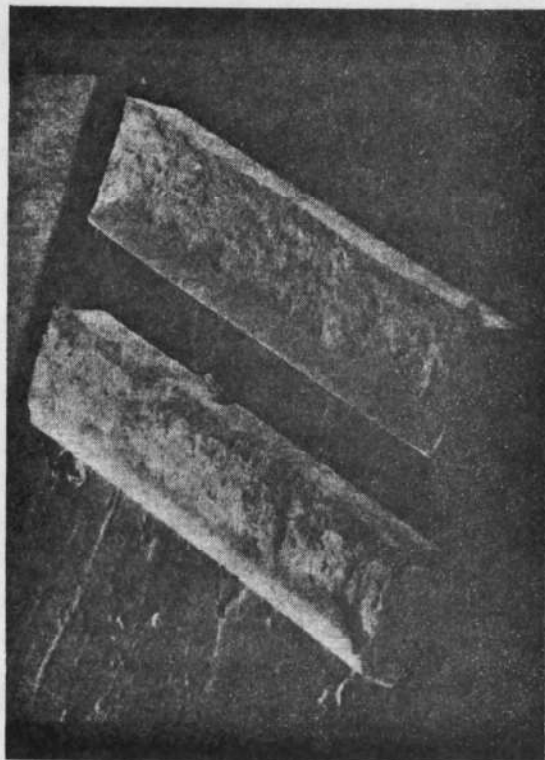
Photo 2 — Key Halves from Right Engine
Moitiés de clavette en provenance du moteur droit

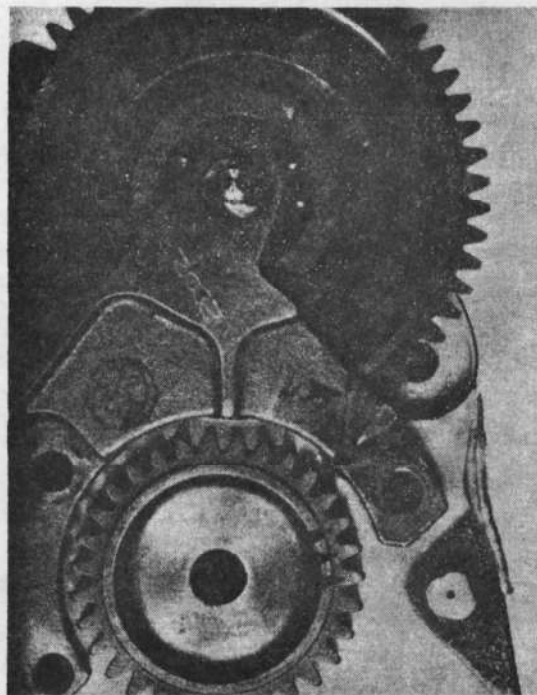
The Board's technical investigators examined the torque sensor assemblies from both engines from C-Glow for impact marks and other signs of distress, which would indicate whether the assemblies was rotating at impact. This was done to determine whether pre-impact failure of the left unit had occurred. Impact damage to both assemblies was very similar. The major difference was the damage to the drivekeys (Item 80, Appendix D). Both keys were sheared, but the one from the left engine had extensive smearing that was caused by the rotation of one gearshaft within the other. The drivekey from the right engine was essentially unmarked by rotation (Photos 1 and 2, Appendix F). The spur gearshaft rotates 8.6 turns for every revolution of the propeller.

Photo 3 — Imprint Marks on Left Torque Sensor Assembly
Empreintes sur le détecteur de couple gauche

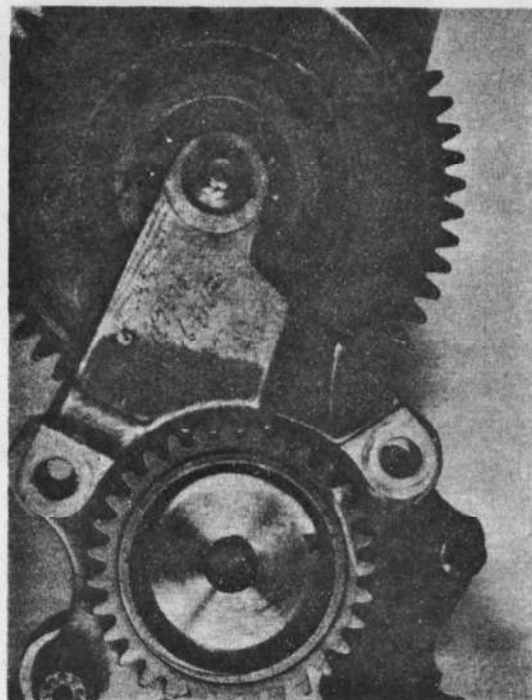
Photo 4 — Imprint Marks on Right Torque Sensor Assembly
Empreintes sur le détecteur de couple droit

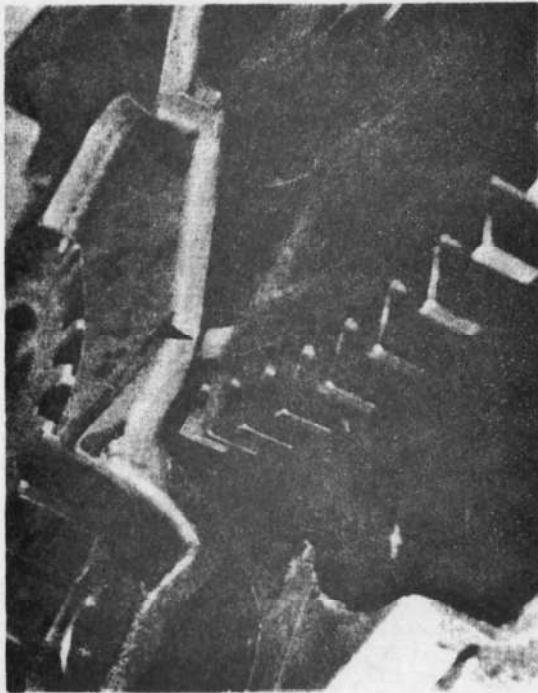
The impact forces bent both support brackets (Item 5, Appendix D) against the right and left spur gears (Item 65, Appendix D). Both gears and brackets, show similar imprints. Scoring, found on the underside of both brackets, was caused by contact with the rim of the spur gears which were rotating against the bent bracket (Photos 5 to 8, Appendix F). The lesser amount of scoring on the underside of the

Photo 5 — Bent Support Bracket on Left Assembly
Ferrure de support de l'ensemble gauche déformée

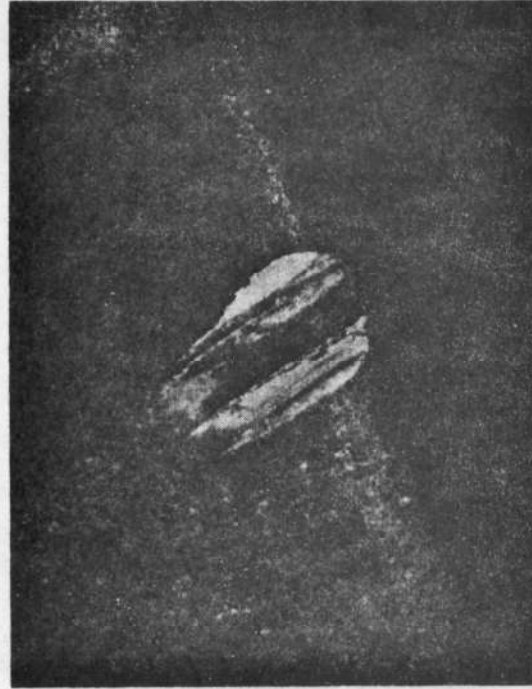
left support bracket was attributed to the difference in the material composition between the two brackets. The left is constructed of stainless steel and the right of aluminum alloy. The severity of the scoring indicated that there would have to have been significant resistance to the rotation to cause the deformation. Thus, it is unlikely that hand turning caused the scoring as the assembly was described to turn freely. The impact marks were similar in nature on both the left and right assemblies. The scoring on the underside of the bent support brackets on both assemblies indicates that both spur gears were rotating at impact. If the left assembly drivekey had failed prior to impact, this scoring should have been evident only on the right torque sensor assembly support bracket.

Photo 8 — Scoring on Underside of Right Support Bracket
Rayures sous la ferrure de support droit
