ENGINEERING REPORT
RAPPORT TECHNIQUE

FI 127/87

FIELD INVESTIGATION - CALM AIR

DC-4, C-GPFG
17 June 1987

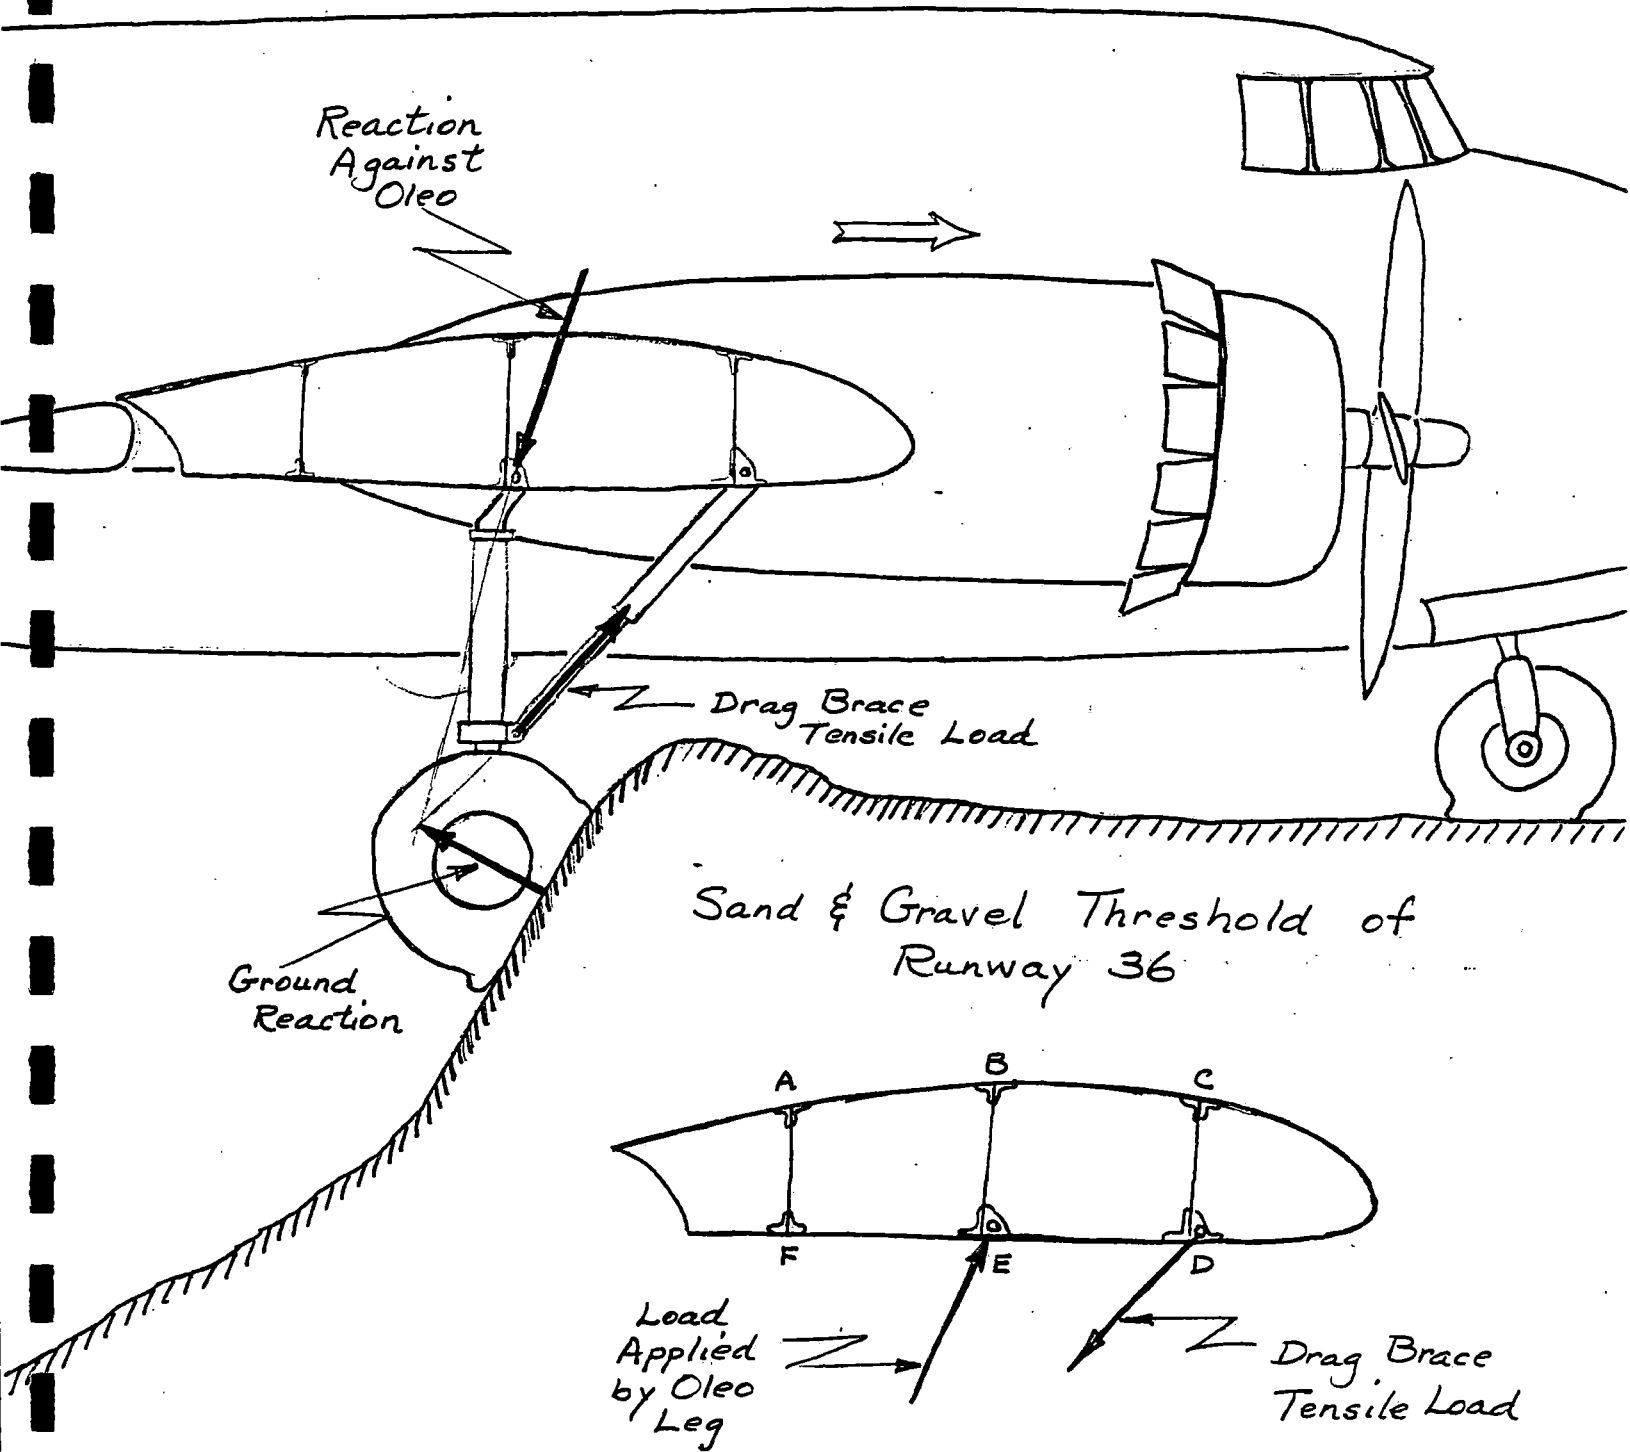
speed of the aircraft, was an extreme rearwards and up impact load on the axle. While the oleo leg was able to react to some of the upload component, the rearwards load had to be and was reacted by deformation of the structure to which the gear pivot points are attached, see Figure 1.

- 3.4 Considering the right main gear leg as a free body, the loads applied to it by impact and pivot reactions had to be approximately as shown in Figure 1 by the vectors. It is then apparent that the resultant loads imposed on the wing section consisted of a large nose-down moment on the wing box and a compression load on the chordwise structural members between E and D. Figure 15 shows the results of this compression load imposed by the oleo leg trunnion and drag brace - the chordwise reinforcing members are buckled. Figure 18 shows how the load at D of Figure 1 buckled the rib-web at the bottom and tore it at the top. Figures 22 and 23 show classic evidence of wing nose-down moment torsional failure with compression buckling of the centre spar web and tensile failure at 90 degrees to the buckle.

- 3.6 All of the damage found fitted the loading scenario of Figure 1. The evident wing twist and structural damage suggest that even if it were possible to make temporary repairs strong enough for a "one flight" ferry under ideal conditions to a repair base, the aircraft would be unbalanced in the aerodynamic sense to the point of probably being uncontrollable in roll. Even minimal temporary repairs would be exceedingly difficult to make at Hidden Bay, as there is absolutely nothing at the runway - no power, no buildings, no people.

Right Main Gear Impact Loading & Wing Twist

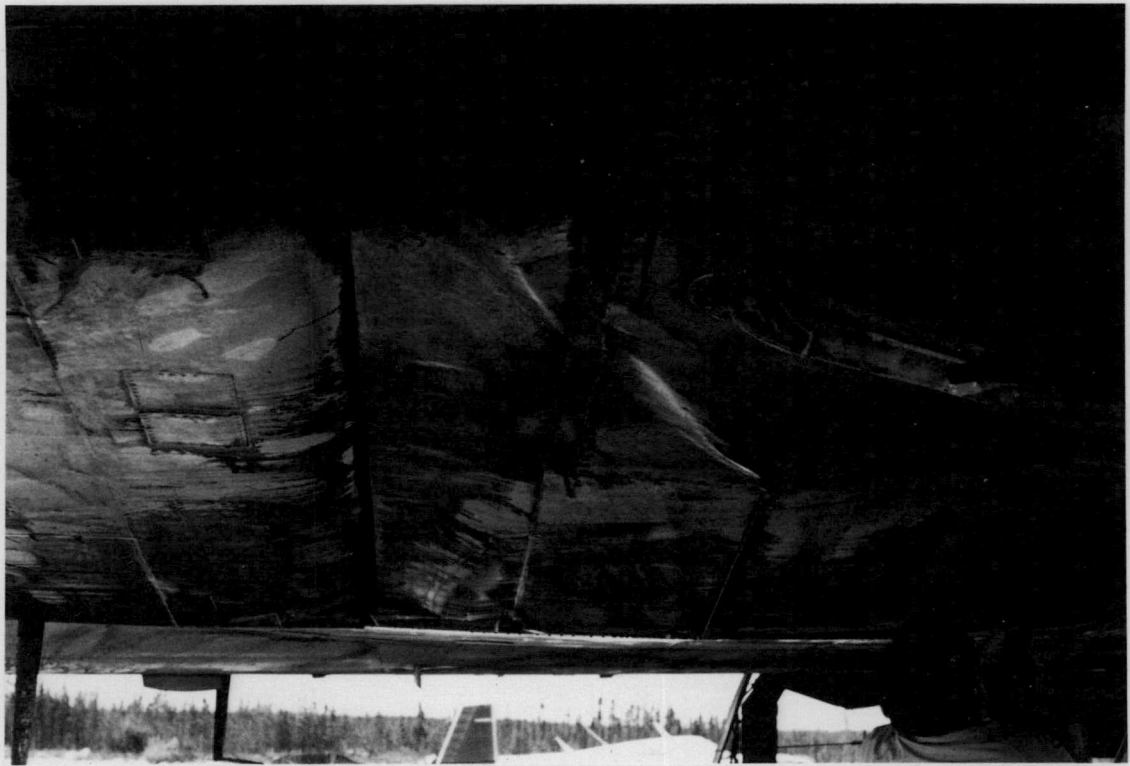
Figure 3

- 3.5 Figures 3 to 6 depict torsional buckling of the wing lower surface again reflecting the nose-down sense of the moment on the wing generated by the right main gear impact.

*Right Wing Spanwise View of
Underside Looking towards
Fuselage*

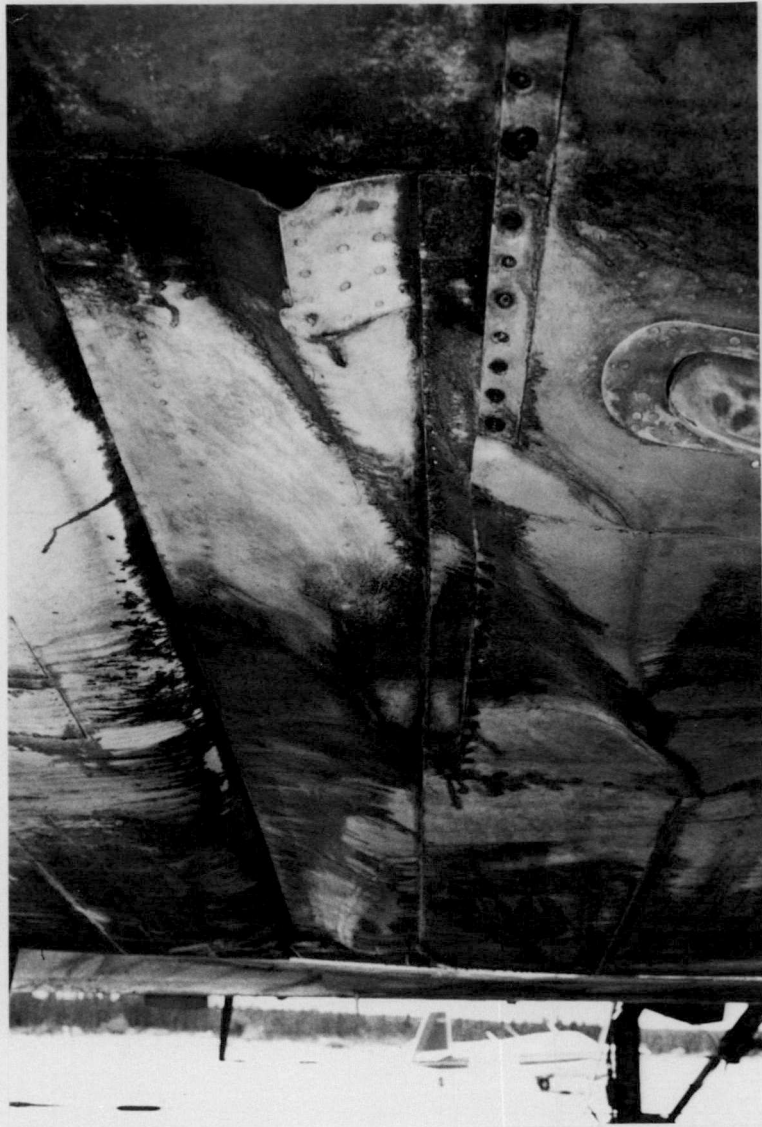
Figure 4

*Close-up of Damage to
Right Wing Undersurface and
Flap Fairing*

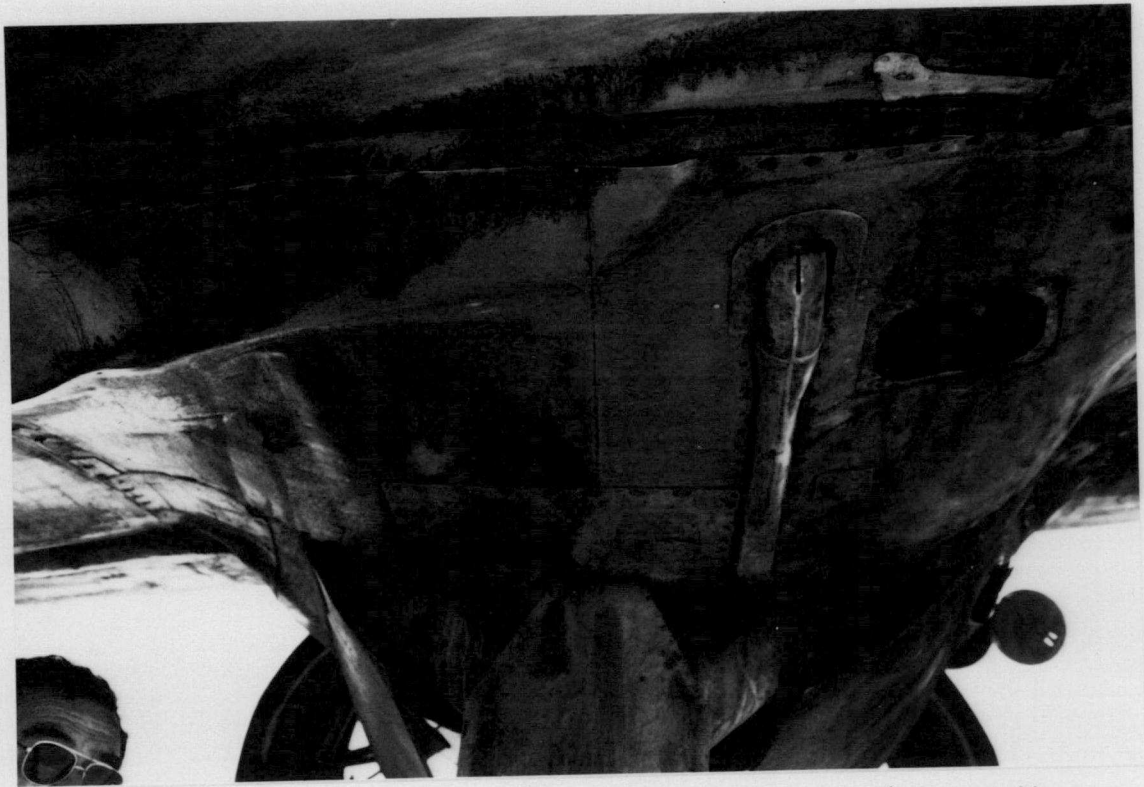
Underside of #3 Engine Nacelle
Looking Forwards
Figure 5

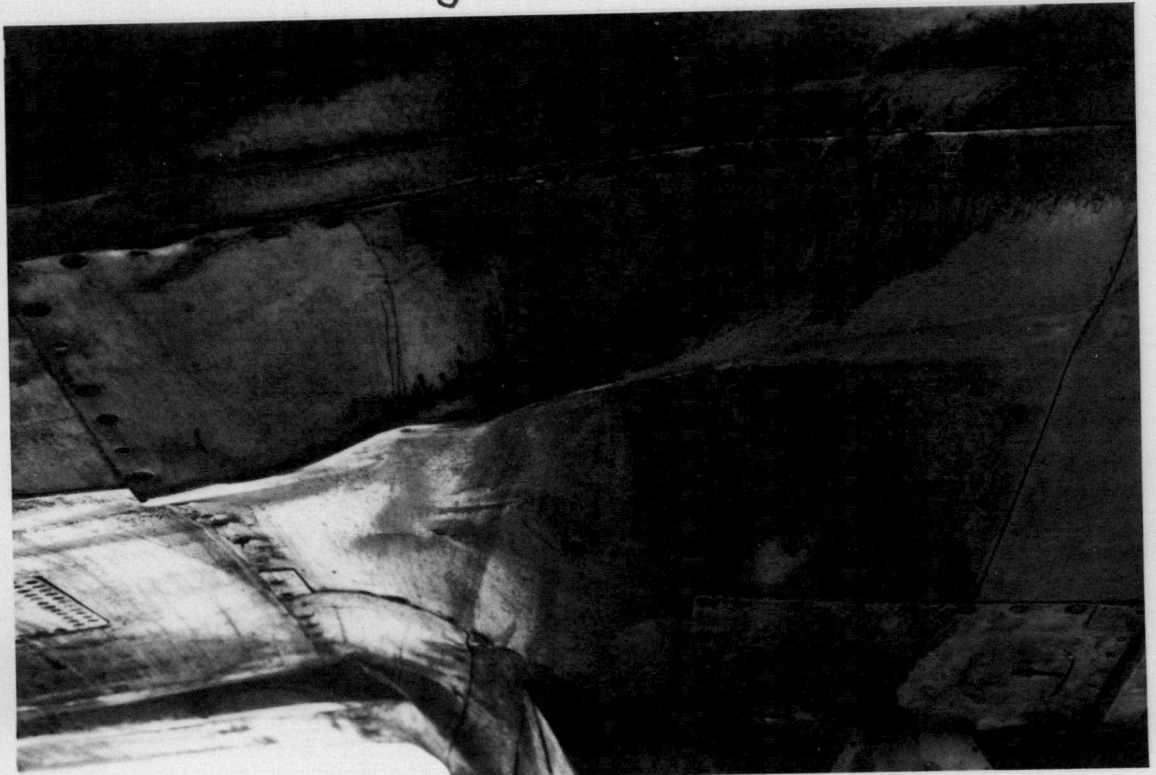
A Closer View
Figure 6

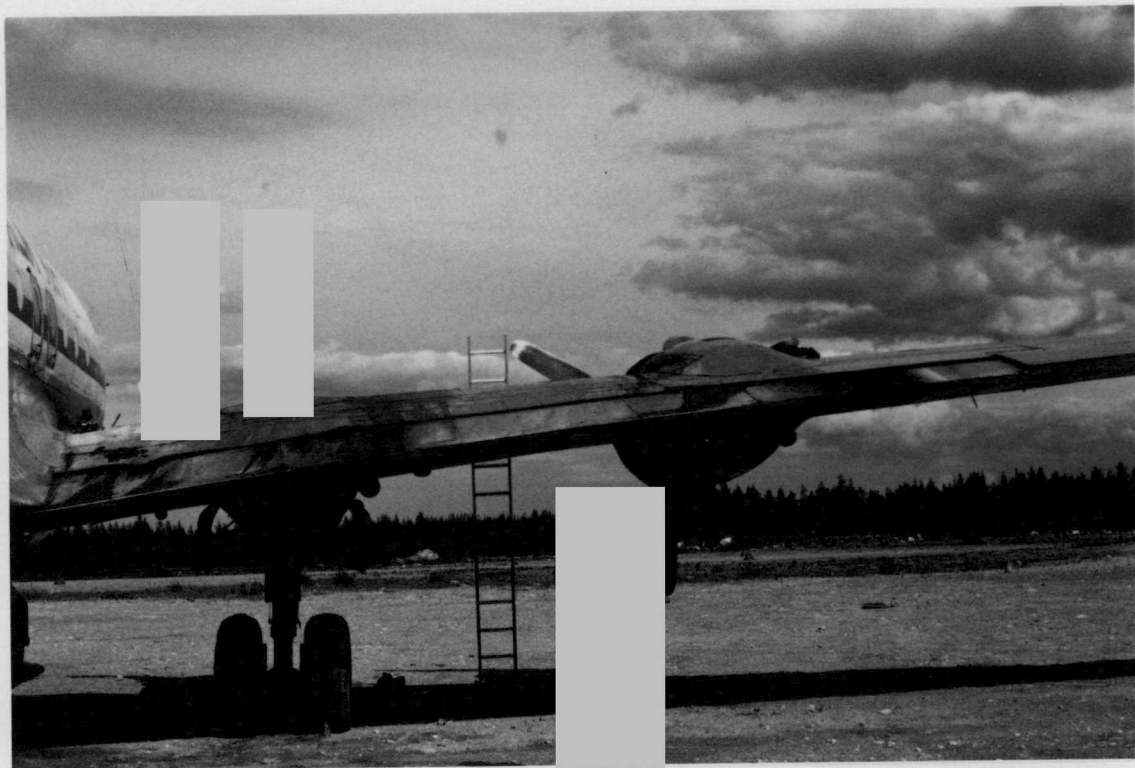
*Upper Surface Buckles at Flap Fairing
Figure 7*

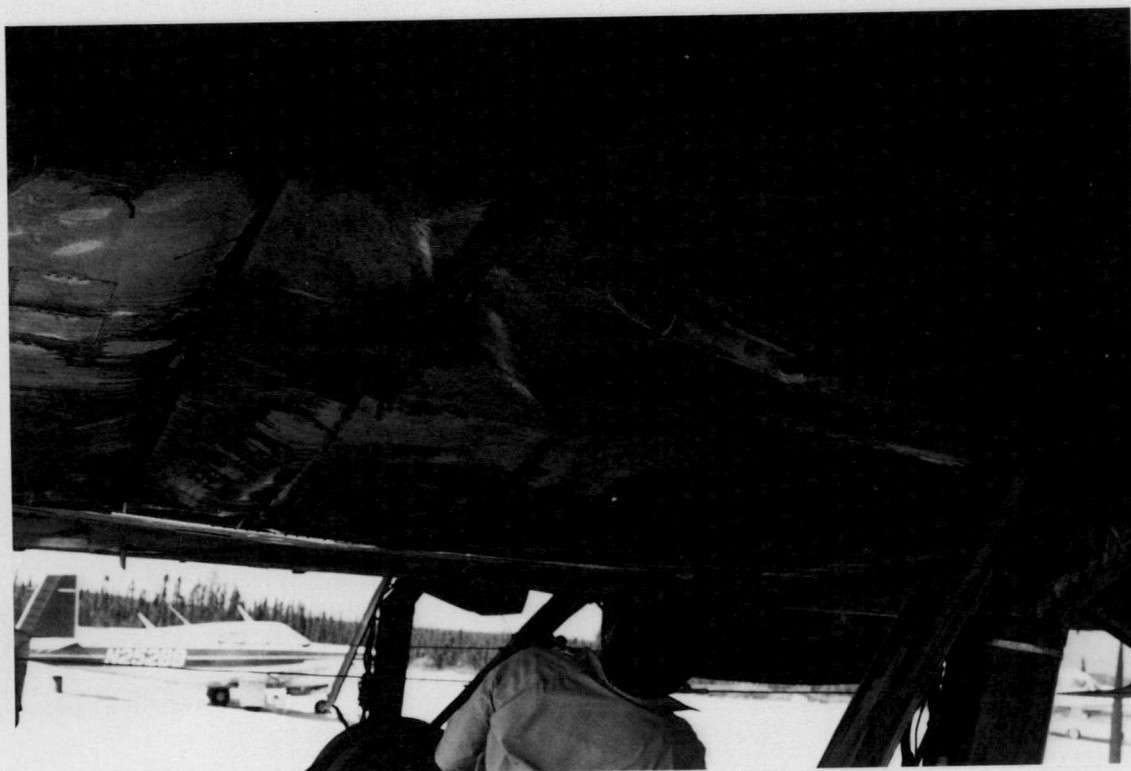
*Buckle Reflecting Nose Down Twist of
Right Wing
Figure 8*

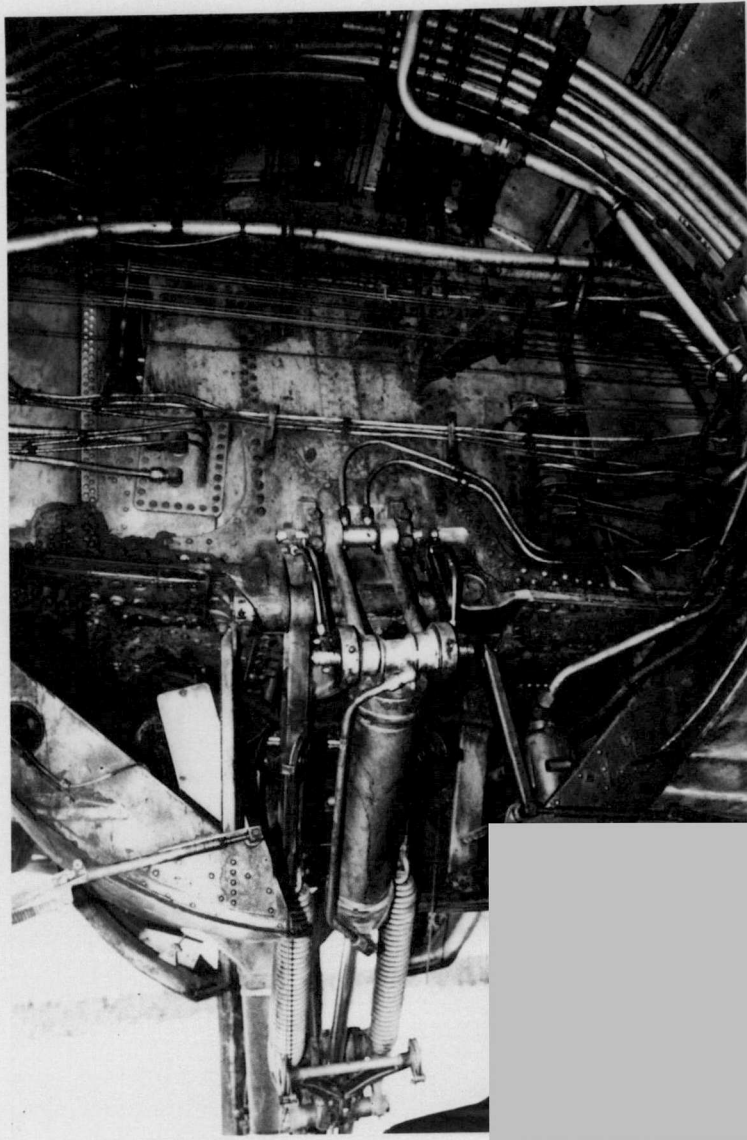
Figure 9

*Right Main Gear Drag Brace
Connection to Front Spar*

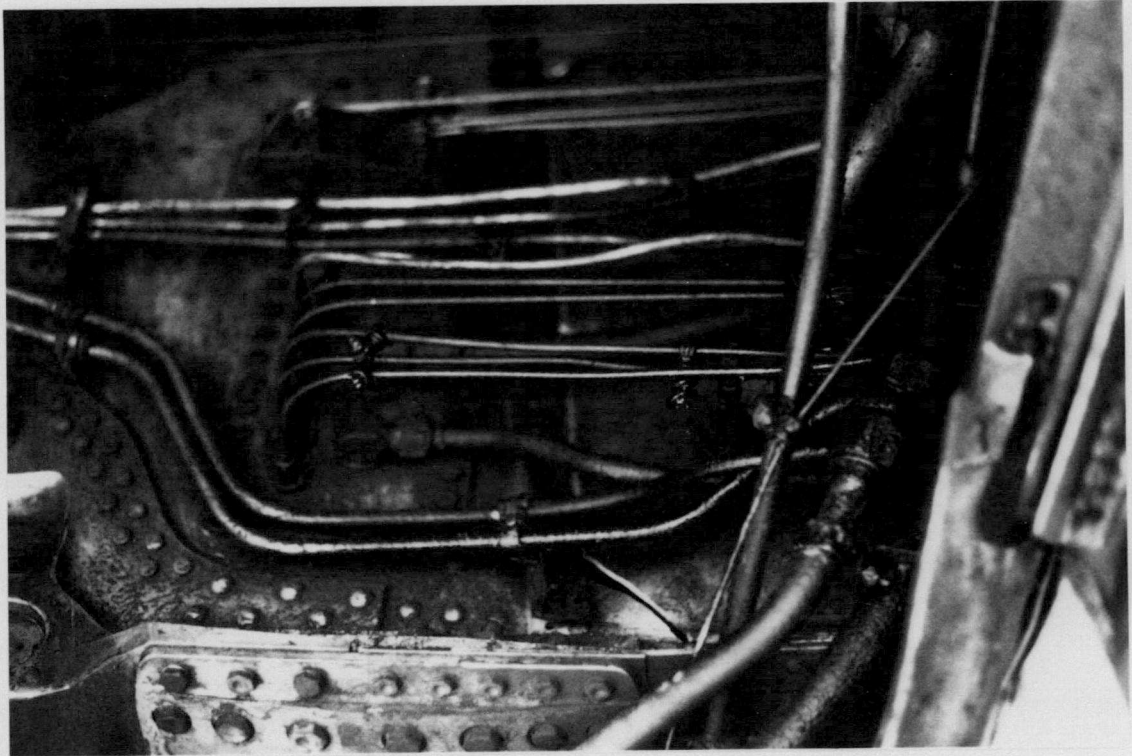
*Front Spar Web of Right Wing
Just Inboard of Main Gear Drag Brace
Figure 10*

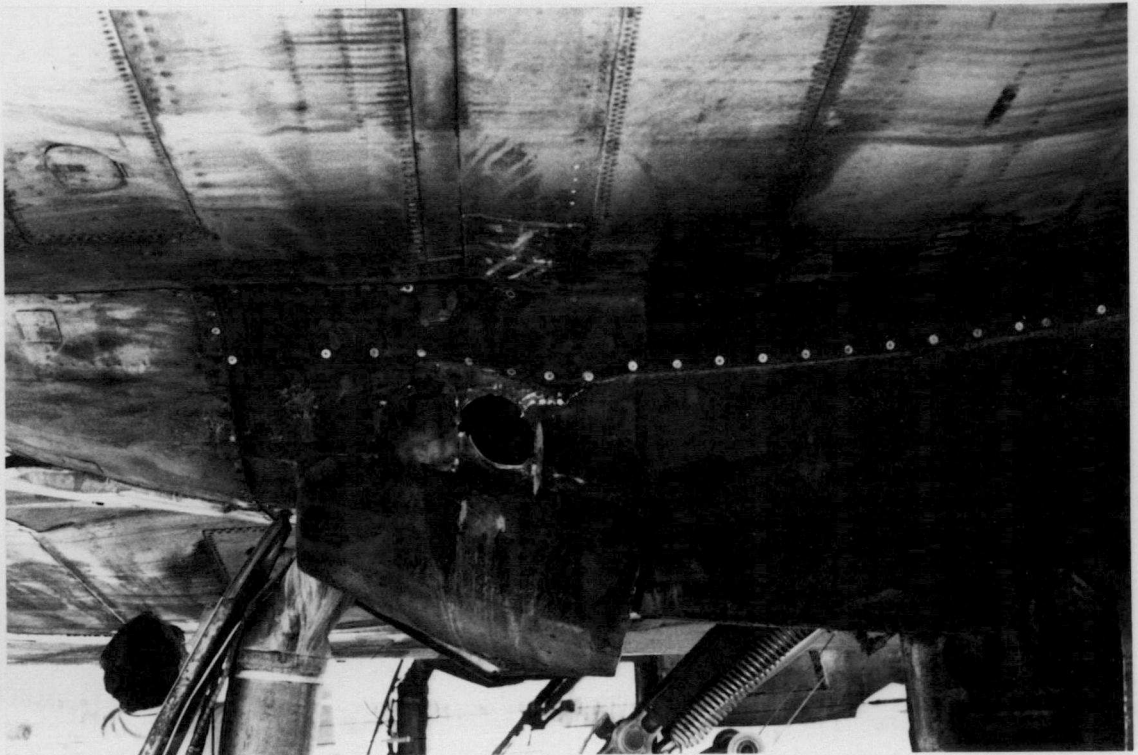
*Outboard Underside of #3 Nacelle
Figure 11*

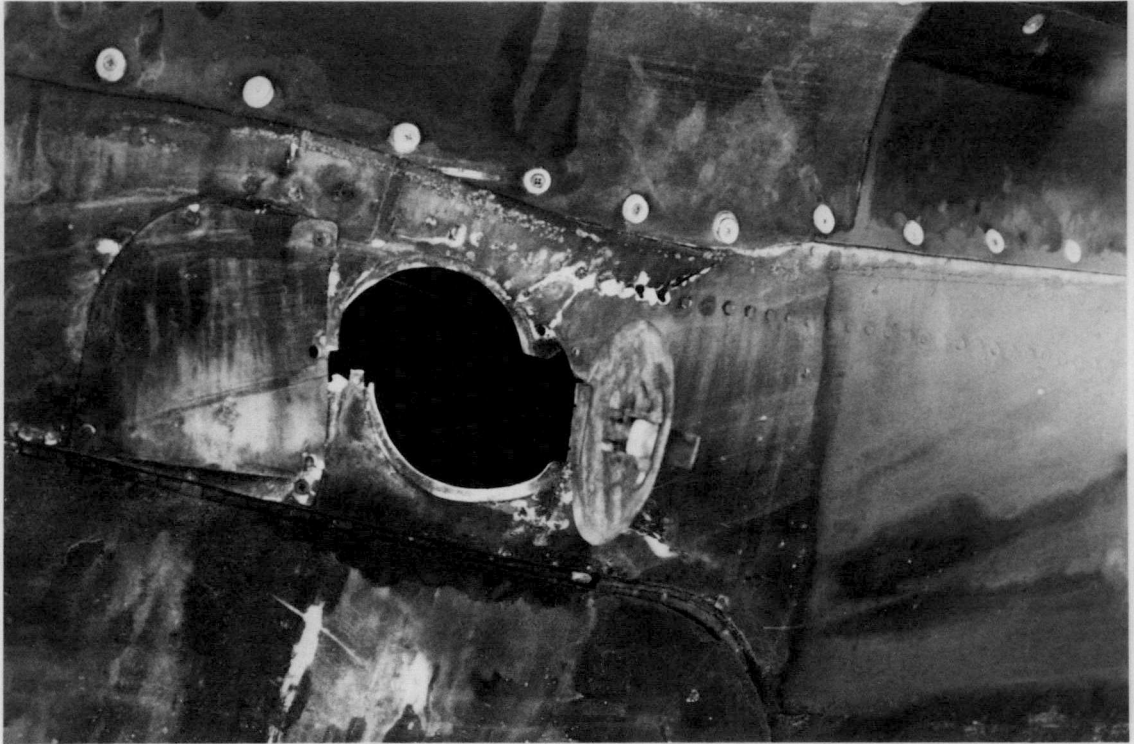
#3 Engine Nacelle Rear
Figure 12

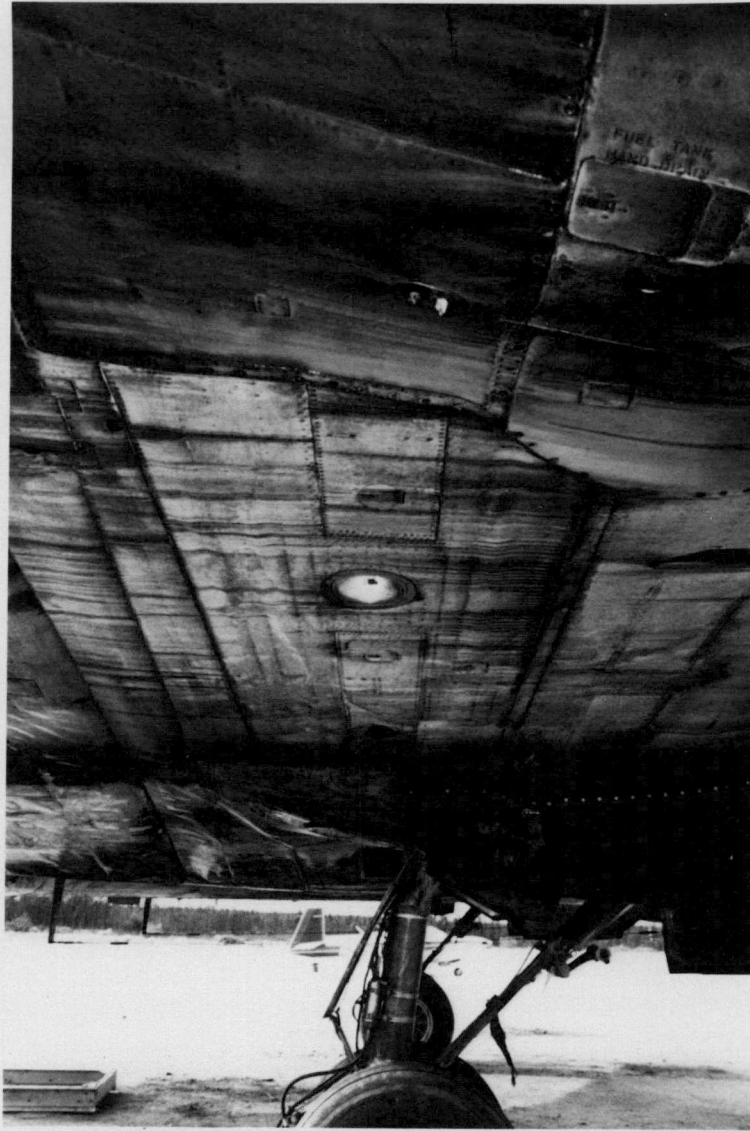
Figure 14

3.2 Extensive damage was found in the right wing between the #3 engine nacelle and the wing root. The damage is photographically recorded in Figures 3 to 31 which follow. The aircraft landed short striking the cliff-like threshold on Runway 36 with the right main gear. It was clear from an examination of the threshold, see Figures 32 to 35, that the right main gear was low, hitting several feet below the lip. The right main gear was probably low in response to a cross-wind from the east at 8 to 12 knots. The right gear acquired a permanent set backwards estimated at 8°. To acquire this degree of permanent set the gear would have to have been bent considerably further back on impact than it presently shows in Figure 14. Springback on release of the impact force would have put the gear in the final position shown.

*Right Main Gear Exhibiting
Rearwards Inclination*

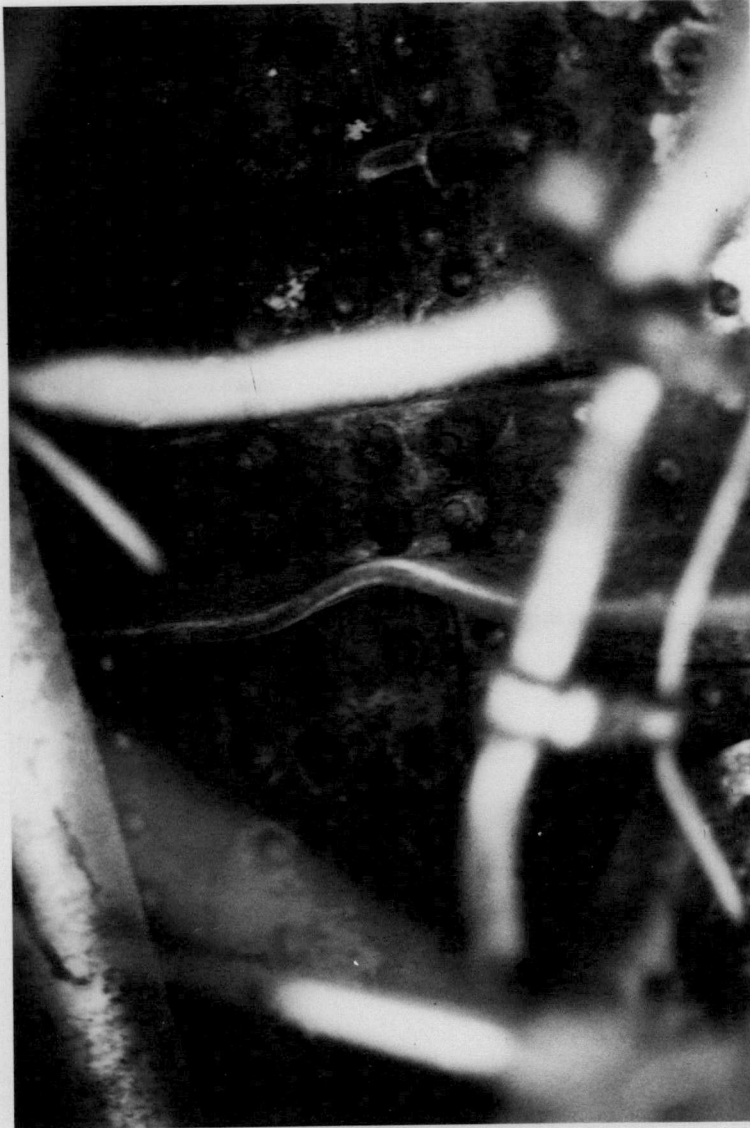
Figure 15

Right Wheel Well
Just Ahead of Oleo
Leg Trunnion

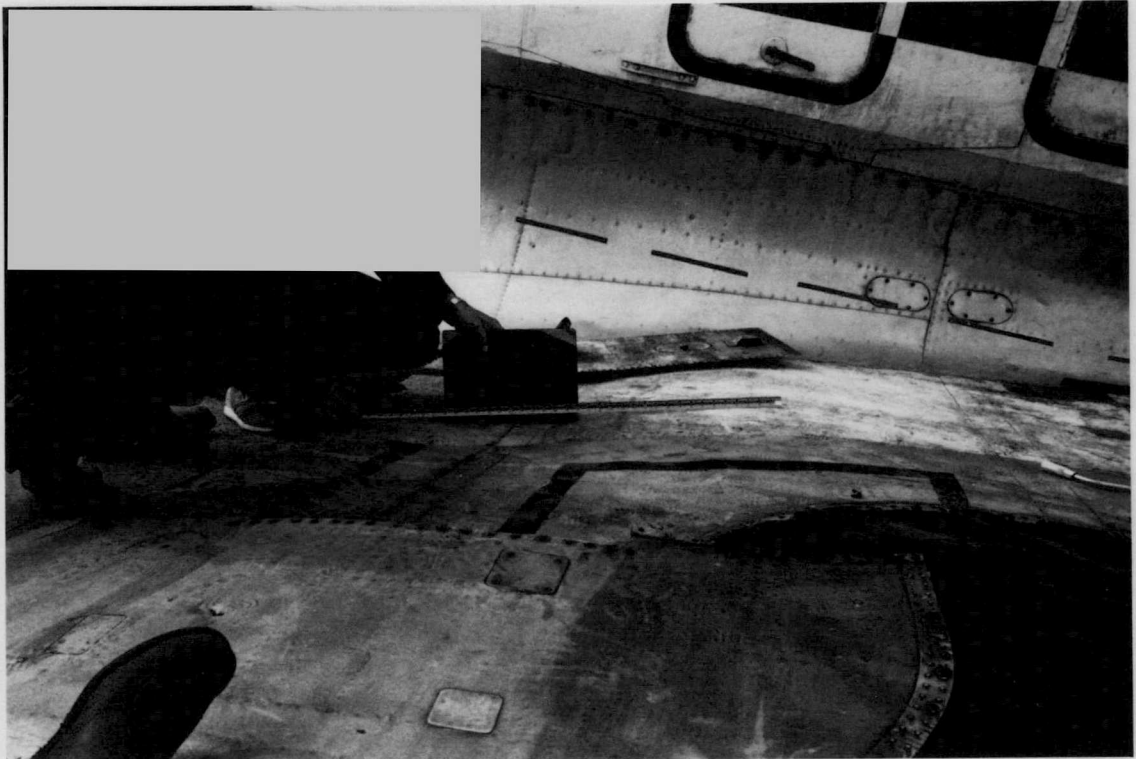
*Deformation of Upper Surface of Right
Wing Inboard of #3 Nacelle
Figure 16*

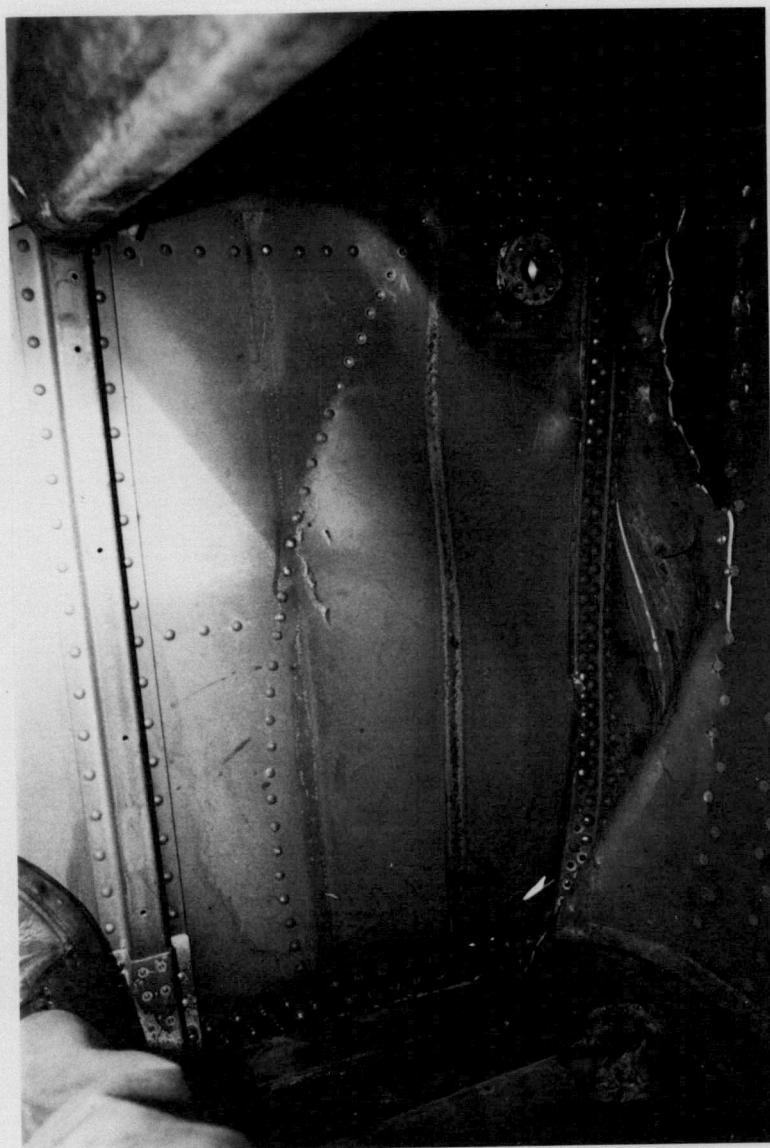
Figure 18

View of Front Spar Web from
Inside Auxiliary Tank Showing Sheared
Rivets, Buckles and Torn Rib

Note: Arrows on Figures 18
and 19 Correspond

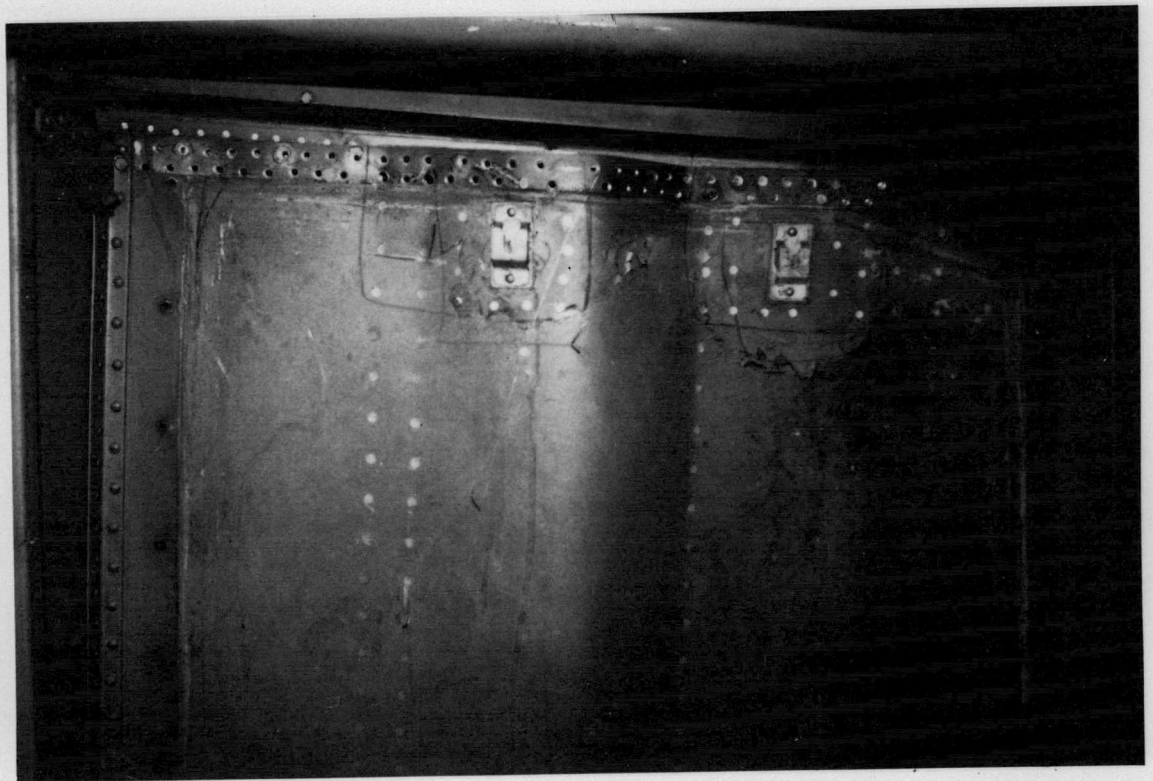
Inboard Wall of Auxiliary Tank Bay
Figure 20

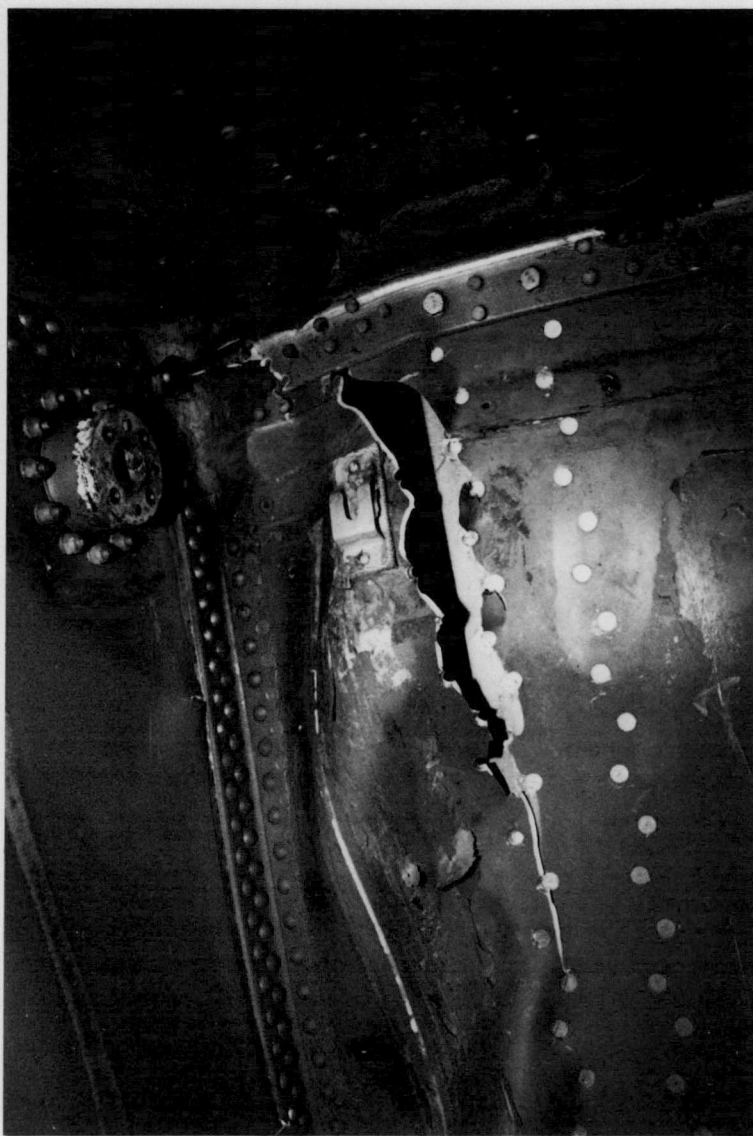
Figure 21

Outboard Wall of Auxiliary
Tank Bay

Note: Rib Cap is Broken

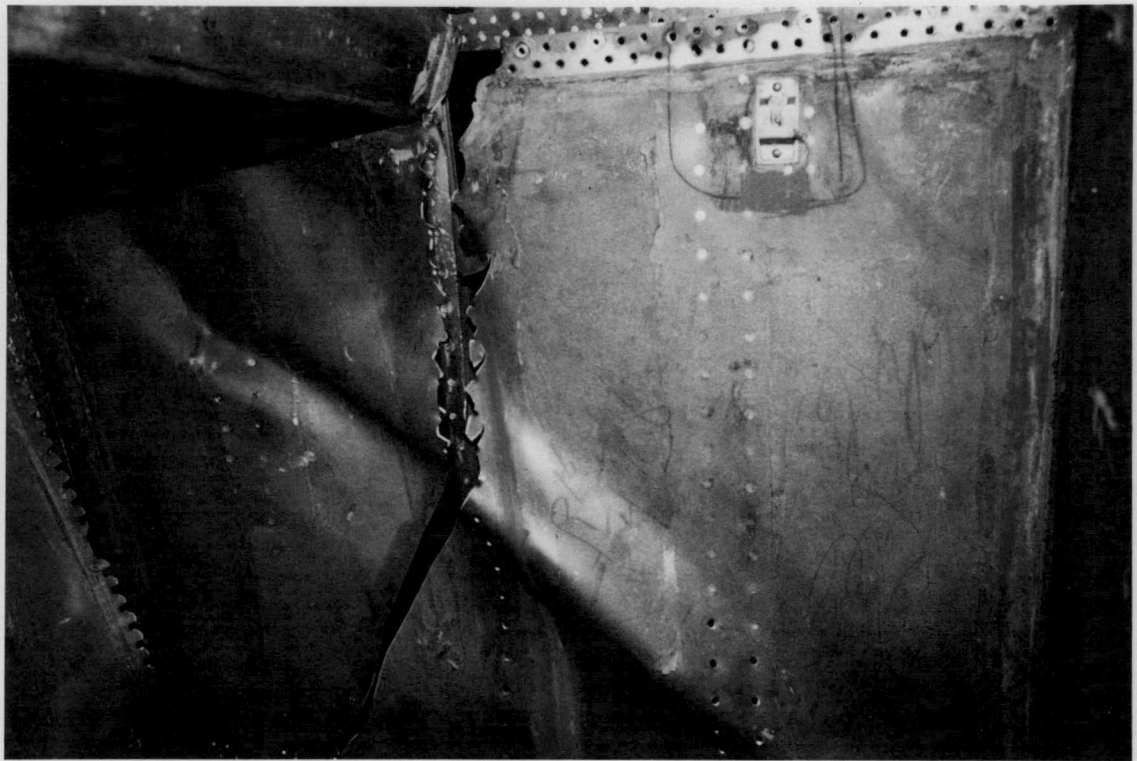
Figure 22

*View of Centre Spar Web Forming
Rear of Auxiliary Tank Bay*

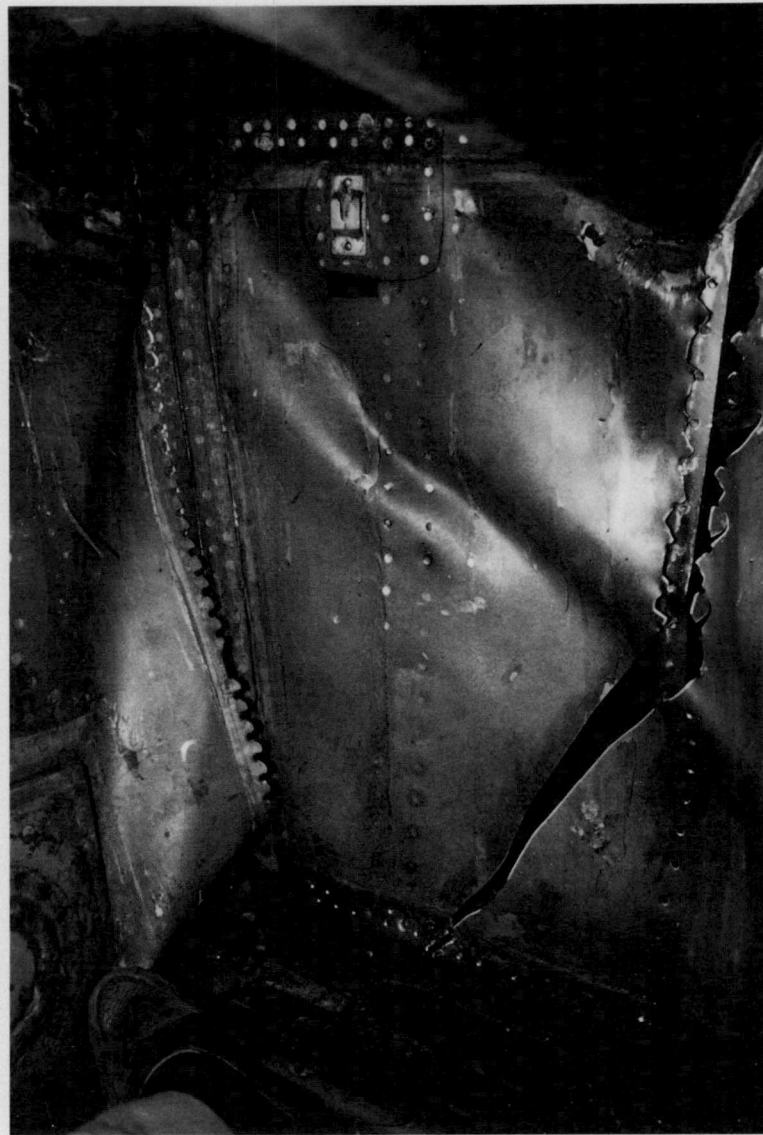
Figure 23

*Another View Showing Torsional
Failure of Centre Spar Web*

*Note: Corner by photographer's foot.
has been driven upwards by
force at E in Figure 1.*

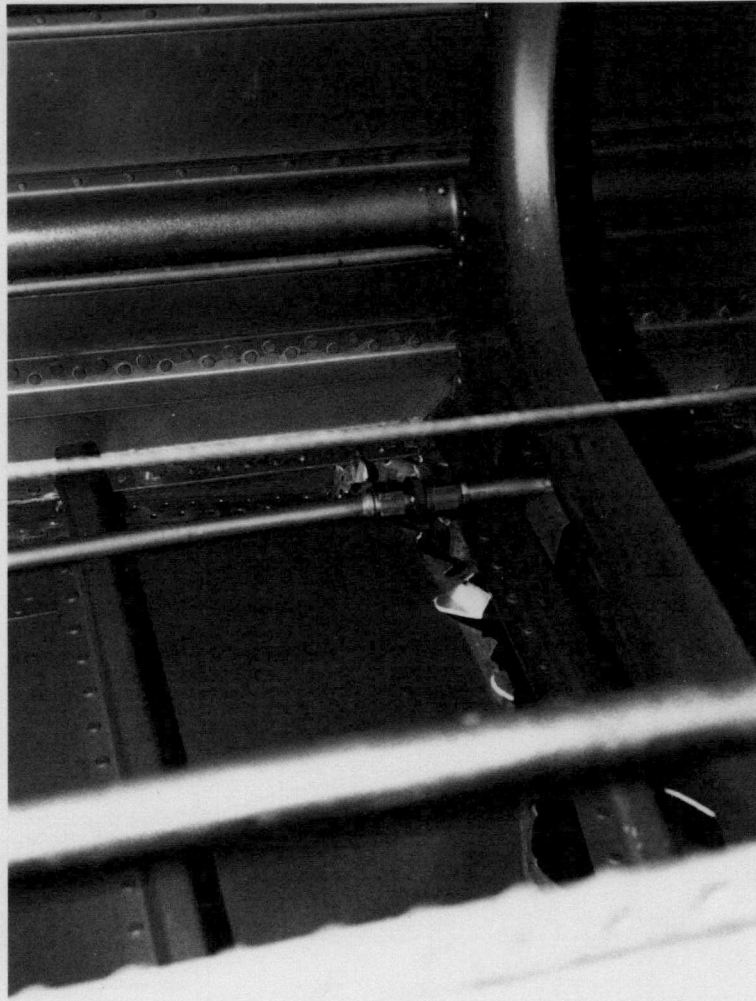
*View of Centre Spar at Figure 23
from Behind
Figure 24*

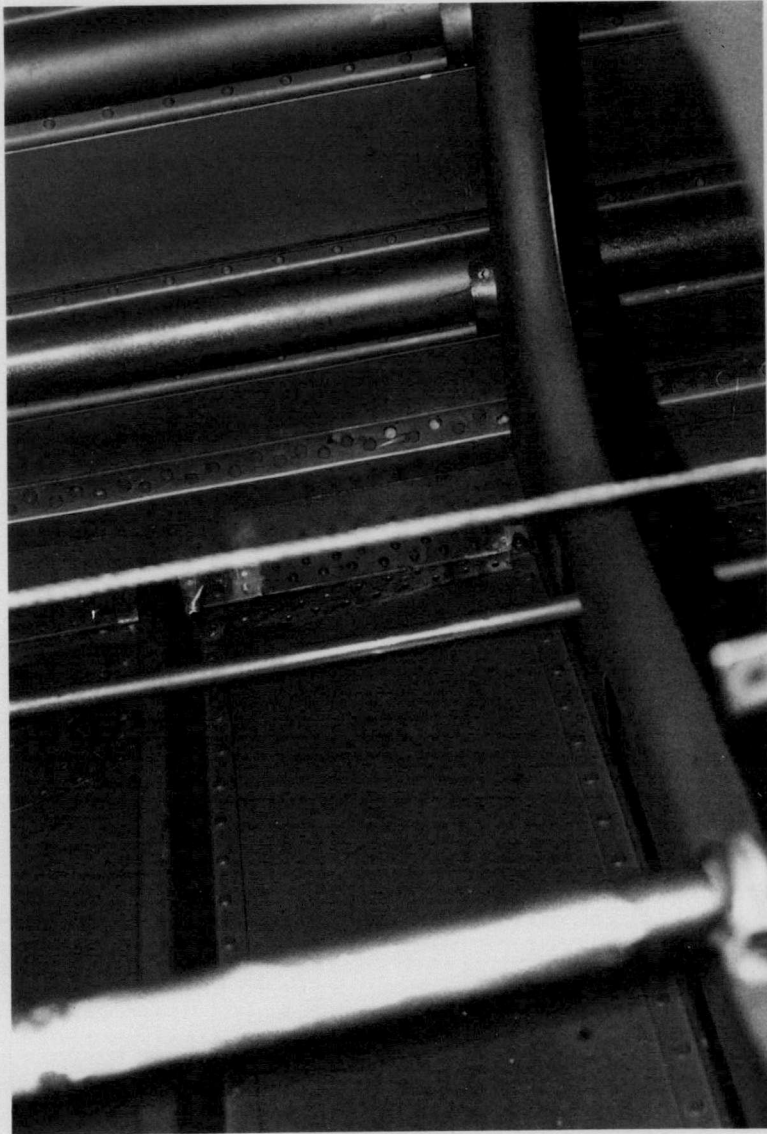
Figure 25

Centre Spar Rivet Shear

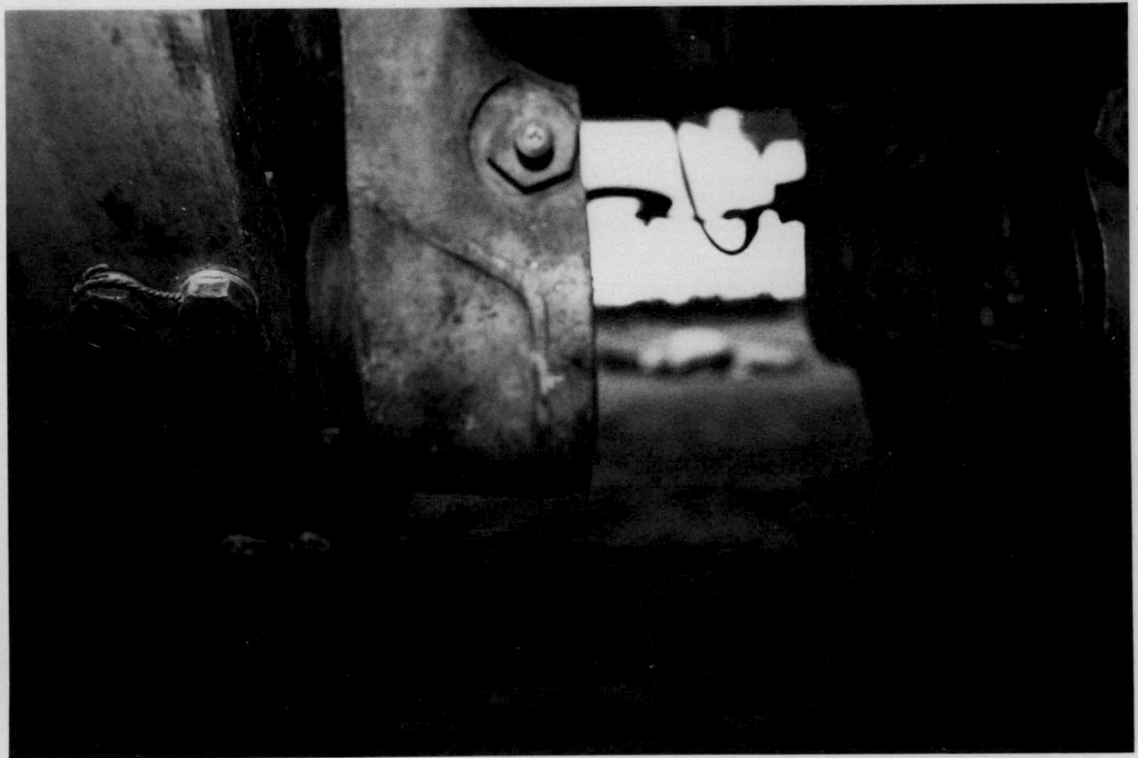
3.3 Fresh scrapes and gouges on the bottom of the right outside brake caliper show that it made contact with the sandy gravel of the threshold lip. The result, given the landing

Right Main Gear Outboard Brake
Caliper Showing New Gouging on Front
Figure 27

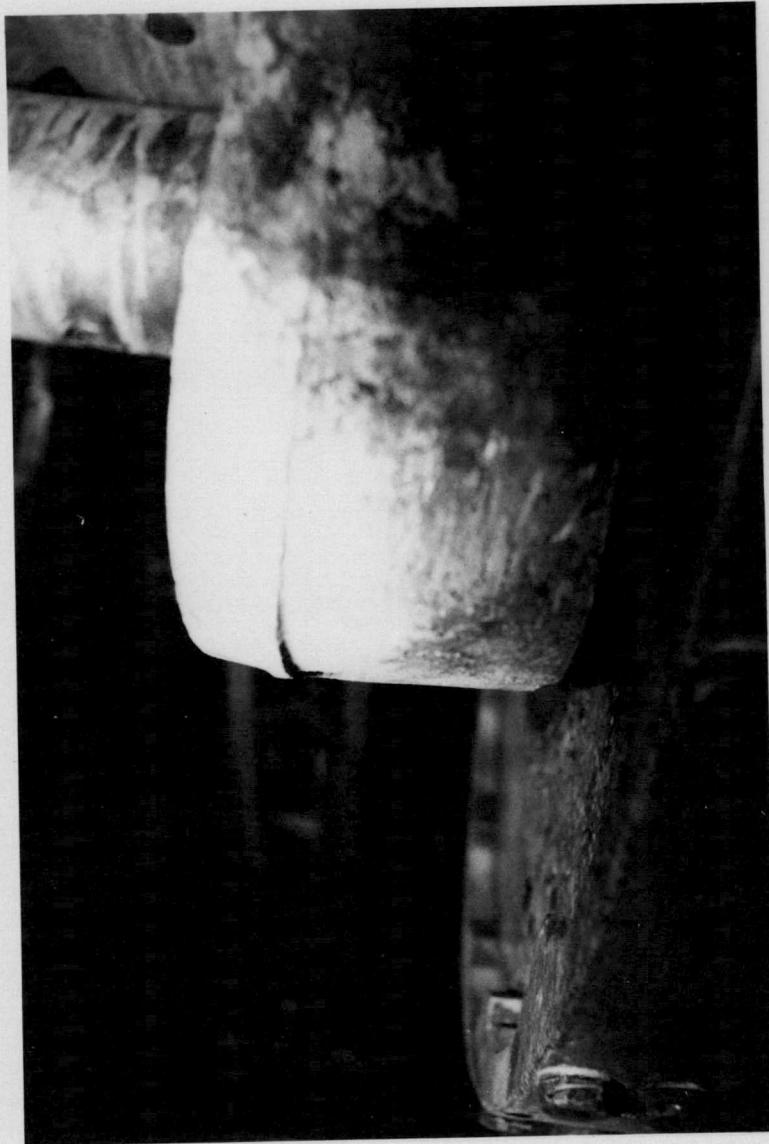
Figure 28

Right Main Gear Outboard Brake
Caliper Showing Scrape Marks on
Bottom
