ENGINEERING REPORT
RAPPORT TECHNIQUE

FI 127/87

FIELD INVESTIGATION - CALM AIR

DC-4, C-GPFG
17 June 1987

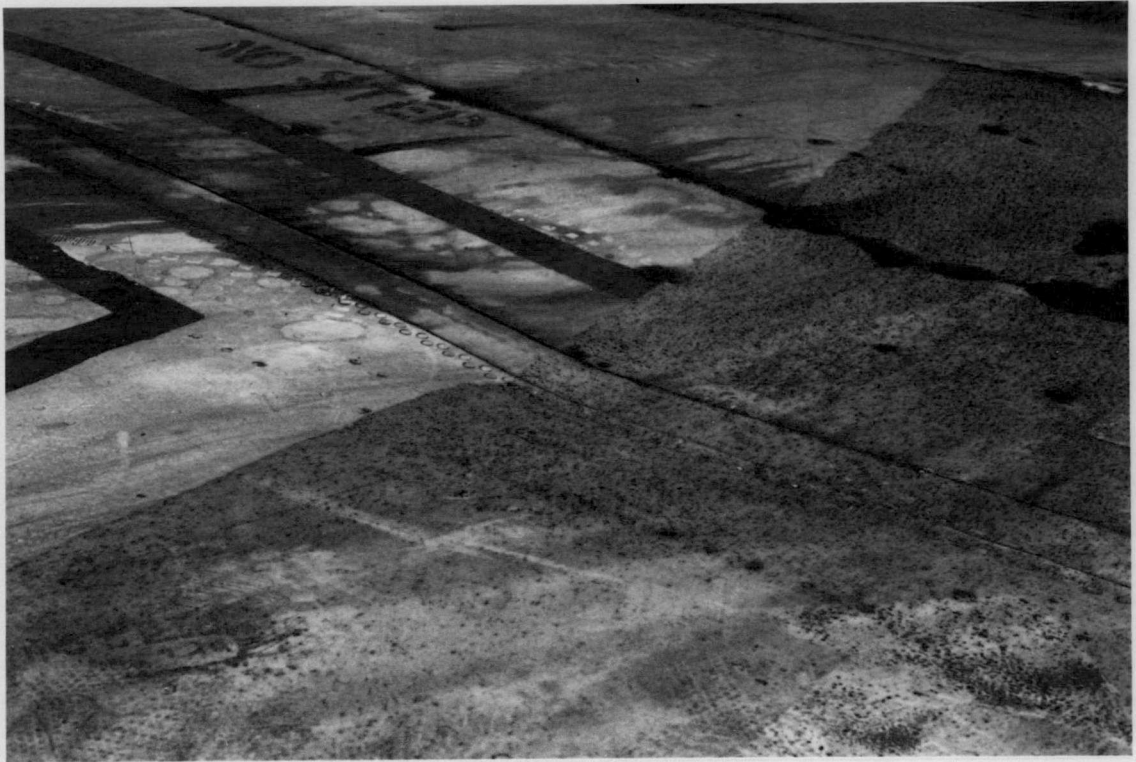
*Bend in the Rear Spar Cap
Figure 29*

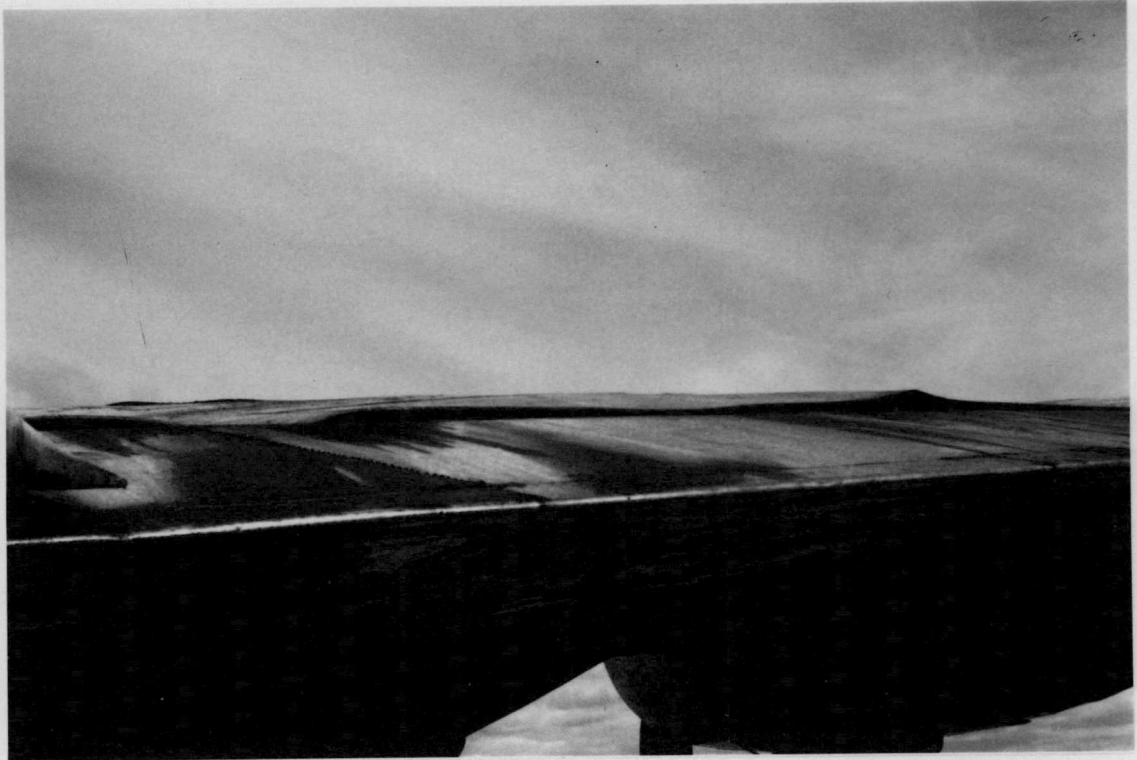
*A Better View of the Buckles
Figure 30*

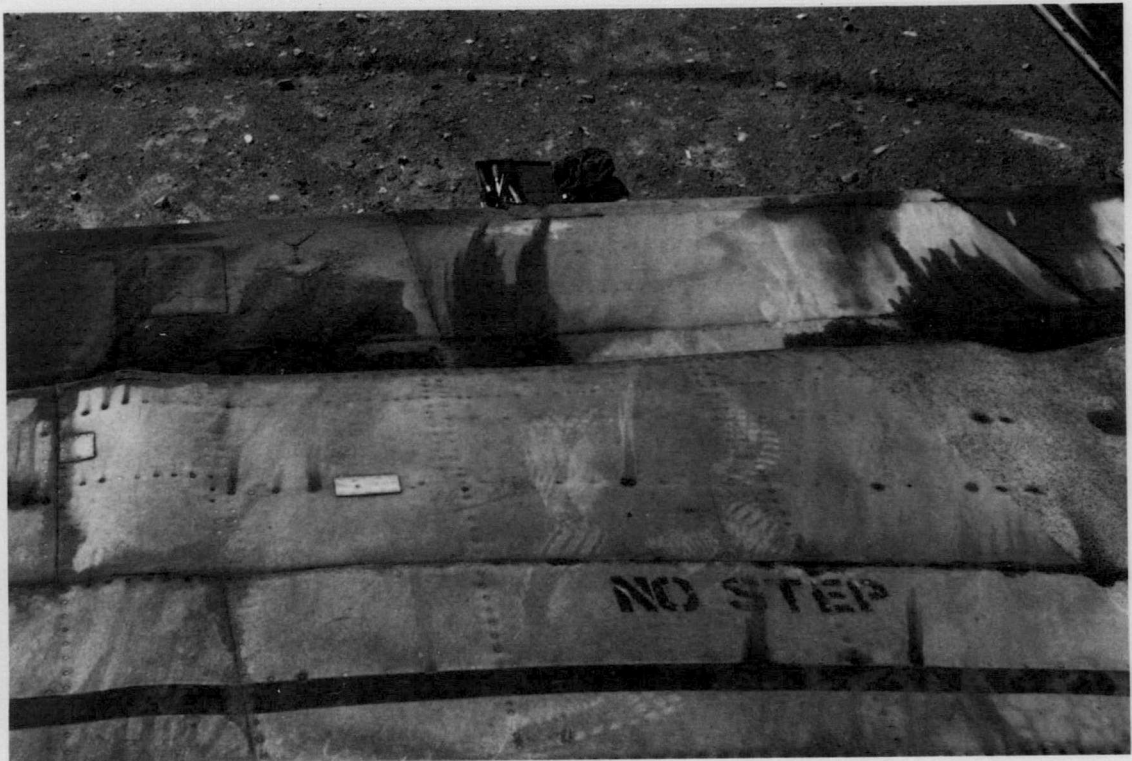
*Same Area Viewed from On Top
of the Wing
Figure 31*

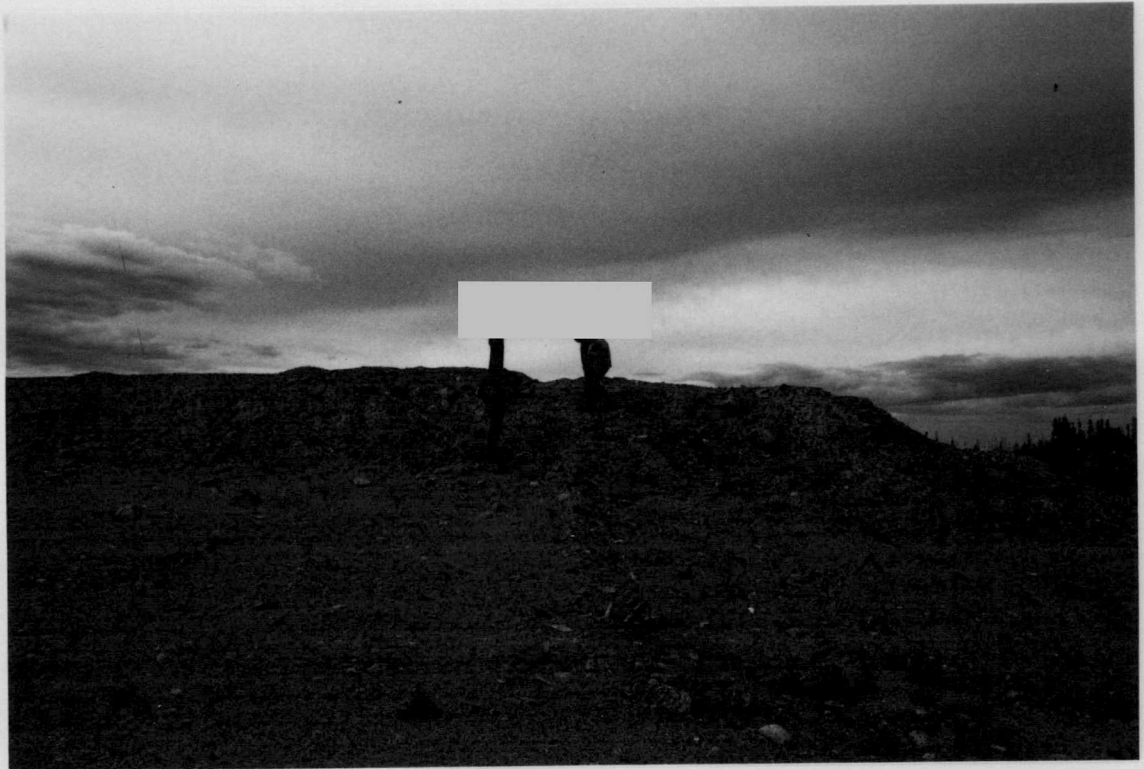
Threshold of Runway 36, Hidden Bay.
Groove Marks Right Gear Passage
Figure 32
