AVIATION OCCURRENCE REPORT

**SIoux NARROWS AIRWAYS LTD.
DE HAVILLAND DHC-2 MK. I BEAVER C-GUJY
TALTHEILEI NARROWS, NORTHWEST TERRITORIES
21 AUGUST 1989**

REPORT NUMBER A89W0205

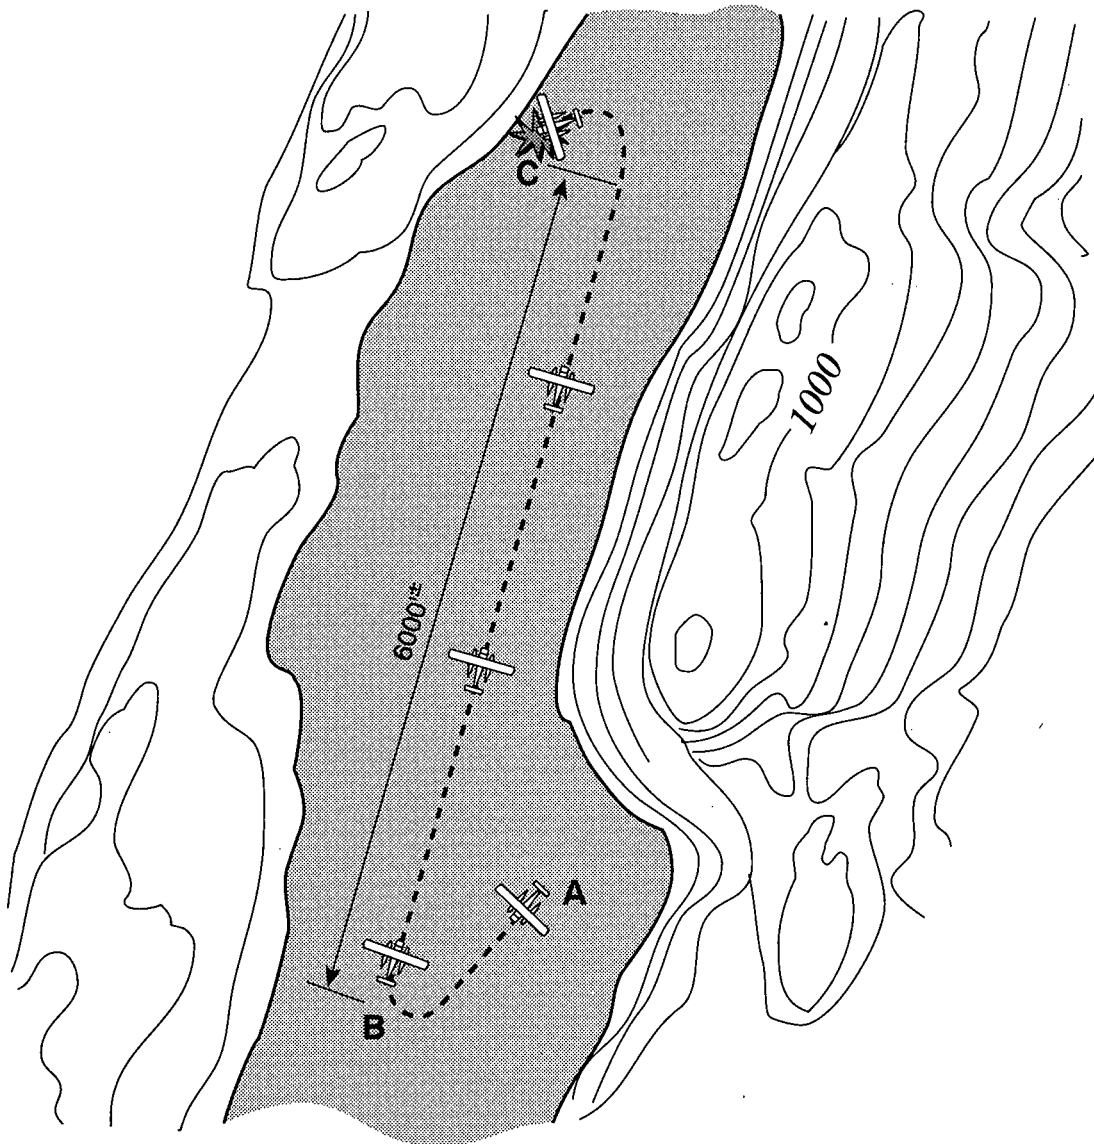
PLAN VIEW OF ACCIDENT FLIGHT

- A Passengers boarded the aircraft from fishing boats.
- B Approximate start of take-off run.
- C Crash site 60 feet from shore line.
