AIRCRAFT ACCIDENT INVESTIGATION DIVISION

# AIRCRAFT ACCIDENT REPORT

DE HAVILLAND 125 CF-CFL  
NEAR WABUSH, LABRADOR  
11 NOVEMBER 1969

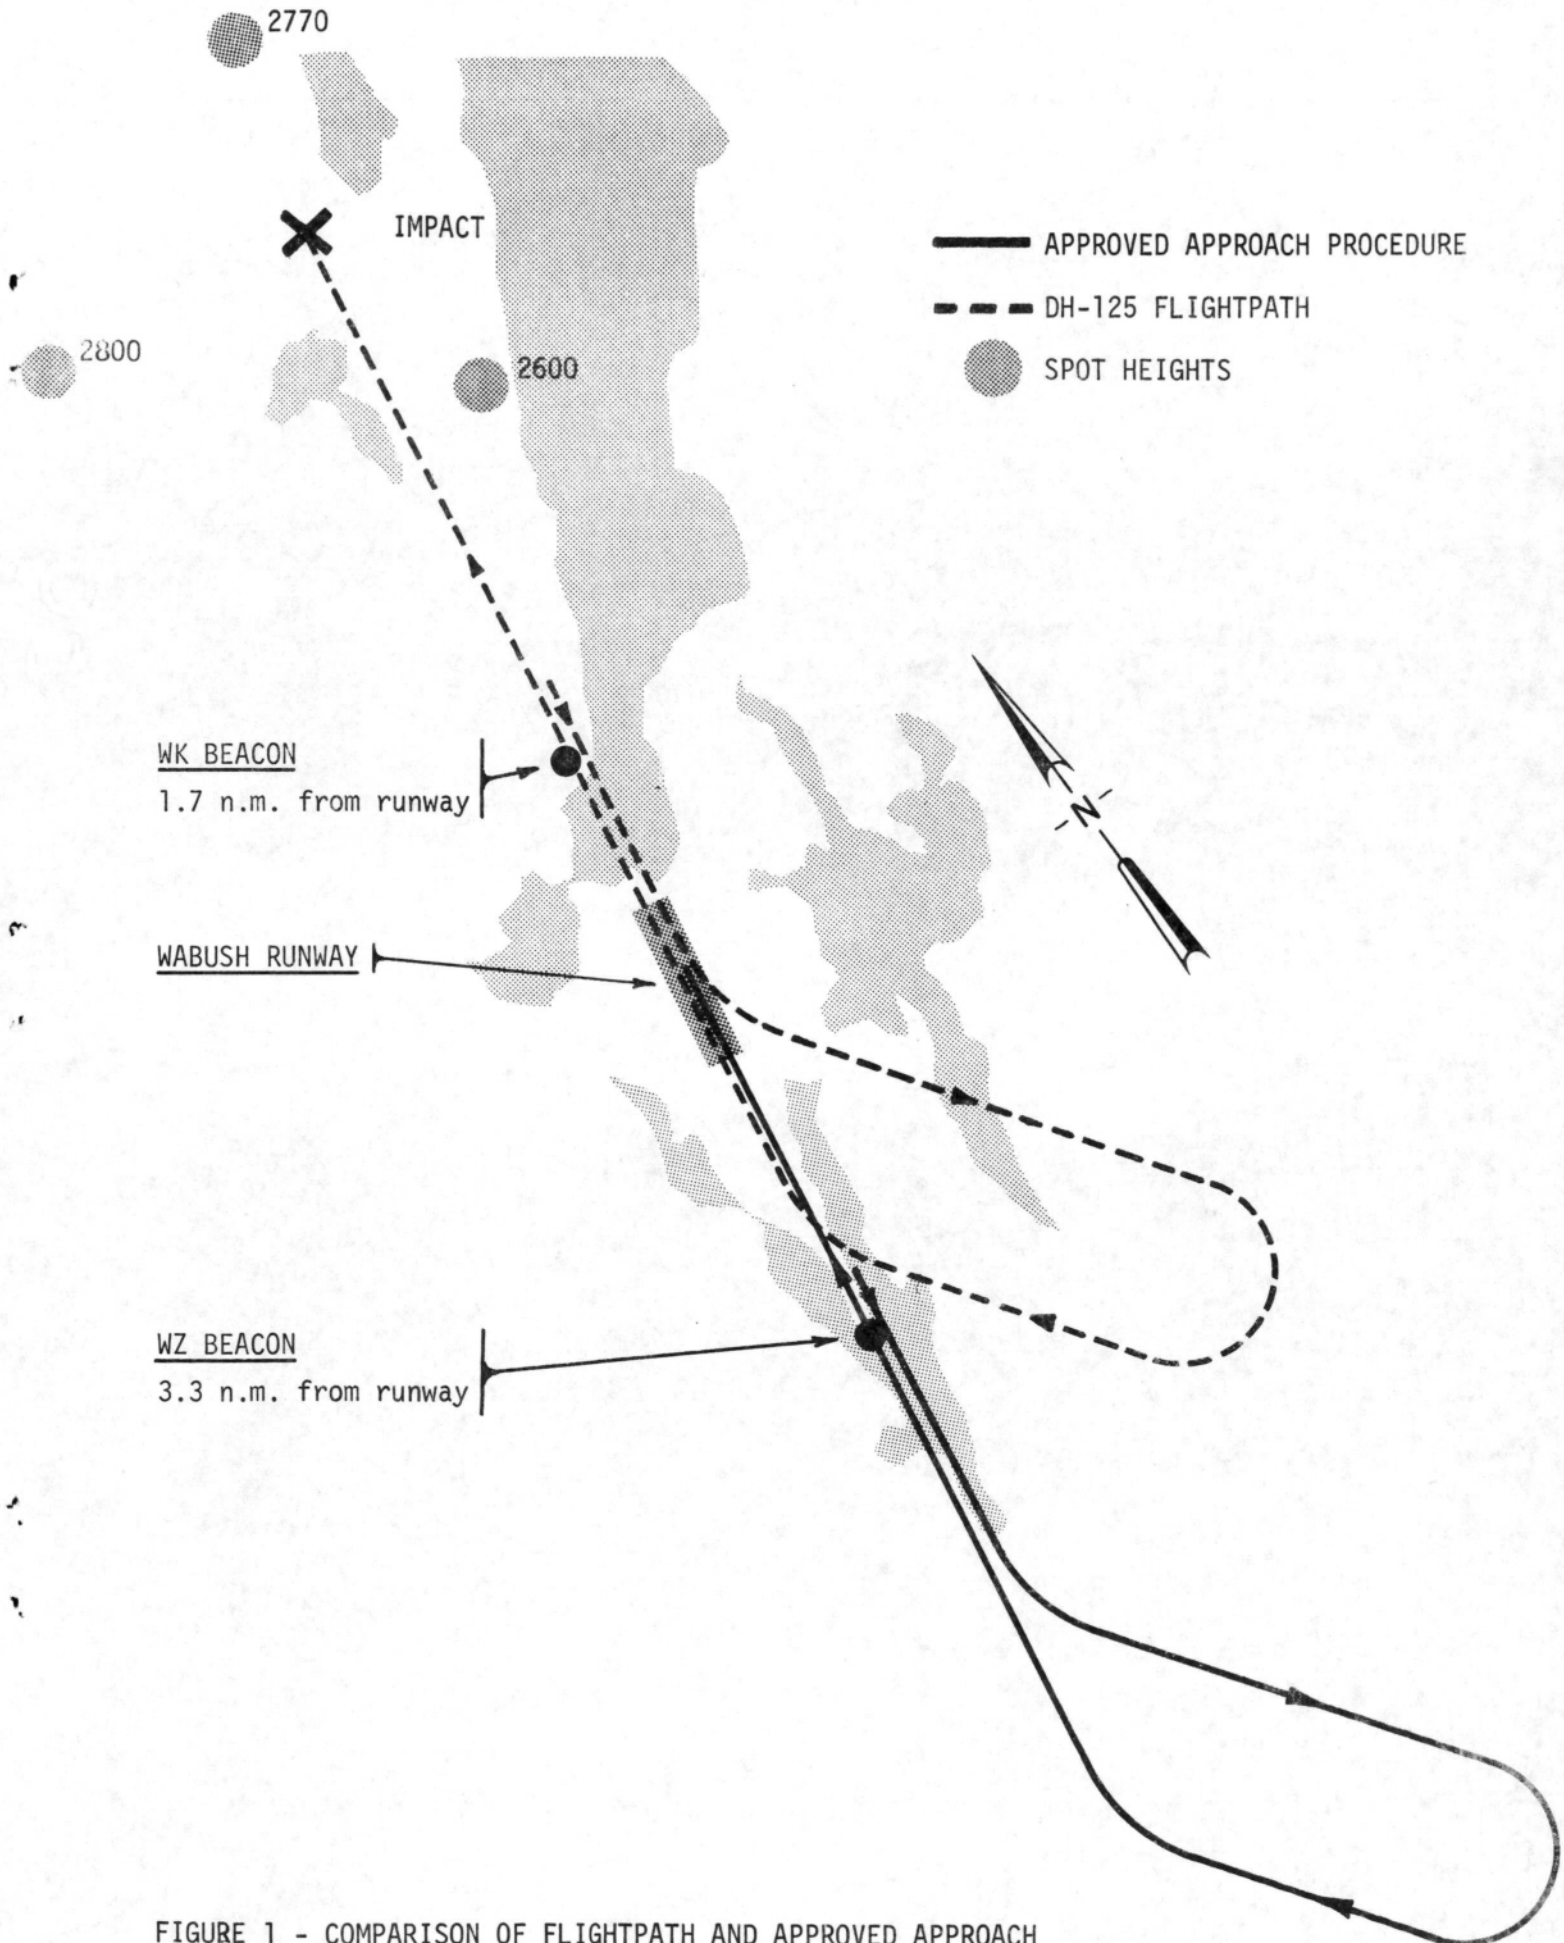
FIGURE 1 - COMPARISON OF FLIGHTPATH AND APPROVED APPROACH

As it neared destination, Moncton Centre cleared the aircraft to the Wabush airport to perform an ADF approach on the "Whiskey-Kilo" beacon - a cancelled procedure. This clearance was acknowledged and read back by the copilot. Figure 1 shows the locations of the two Wabush beacons - WK and WZ. The WK is an airway beacon; however, the only currently approved instrument approach procedure at Wabush was based on the WZ beacon.

Figure 1 shows that flying the approved approach procedure on the WK beacon rather than on the WZ resulted in a 6-mile northward displacement of the approach pattern. Having crossed over a beacon that the pilot apparently assumed incorrectly to be south of the field, he was now flying at his minimum approach altitude expecting to see the runway ahead. Routine transmissions from the aircraft were heard moments before the impact. The aircraft crashed 5.5 miles north of the WK beacon into the rock face of a lighted open-pit mine, killing all eight persons on board.

The evidence indicates that the pilot performed the current WZ approach procedure on the WK beacon. In reporting outbound, the crew gave their altitude as 4100 feet during this phase. Had the approach been flown on the WZ beacon south of the airport, it is likely that the tower controller would have seen or heard the aircraft pass by at minimum altitude. The flightpath and timing - as noted by witnesses - are consistent with the approved approach pattern having been performed on the northerly WK beacon.
