**FINAL REPORT**  
**OF**  
**DC - 10**  
**HL 7328**

# FINAL REPORT OF DC - 10

## AIRCRAFT ACCIDENT FINAL REPORT

KOREAN AIR MCDONNELL DOUGLAS DC-10-30 KOREAN REGISTRATION  
HL-7328 CRASHED NEARBY TRIPOLI INTERNATIONAL AIRPORT SOUTH  
-EAST OF RUNWAY 27 ON JULY 27TH 1989.

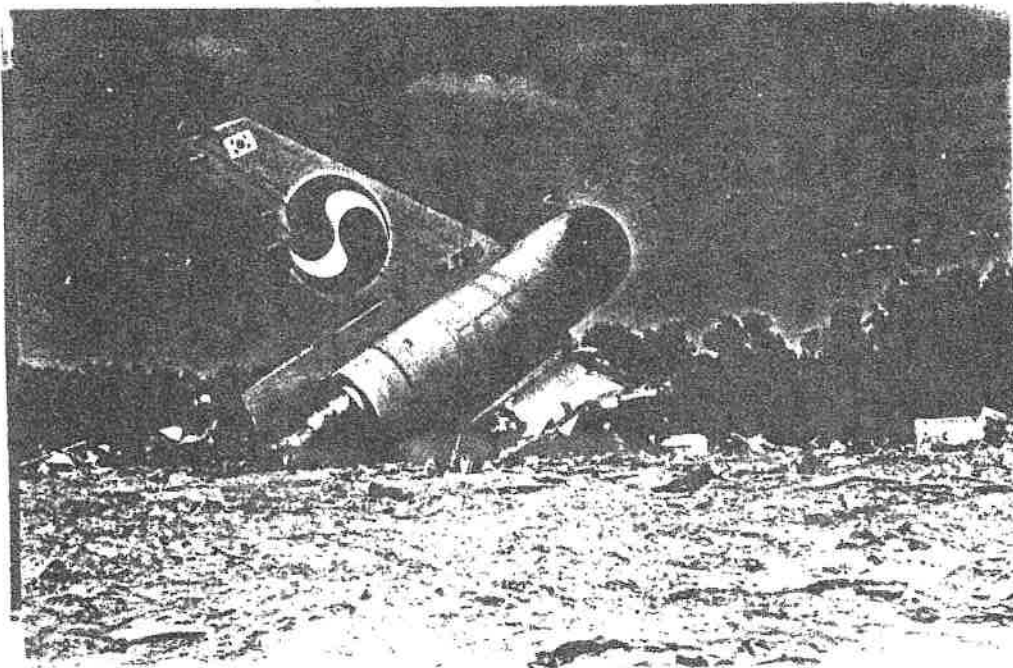
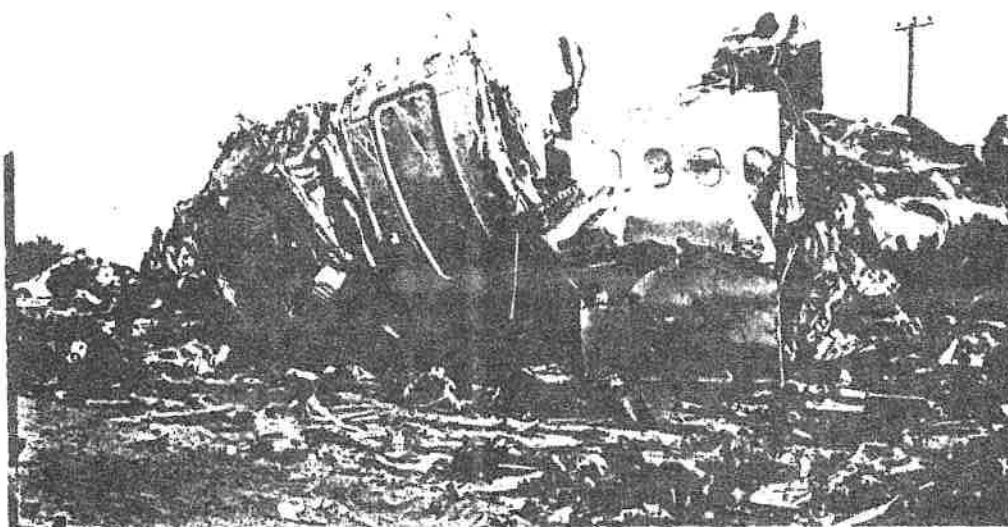
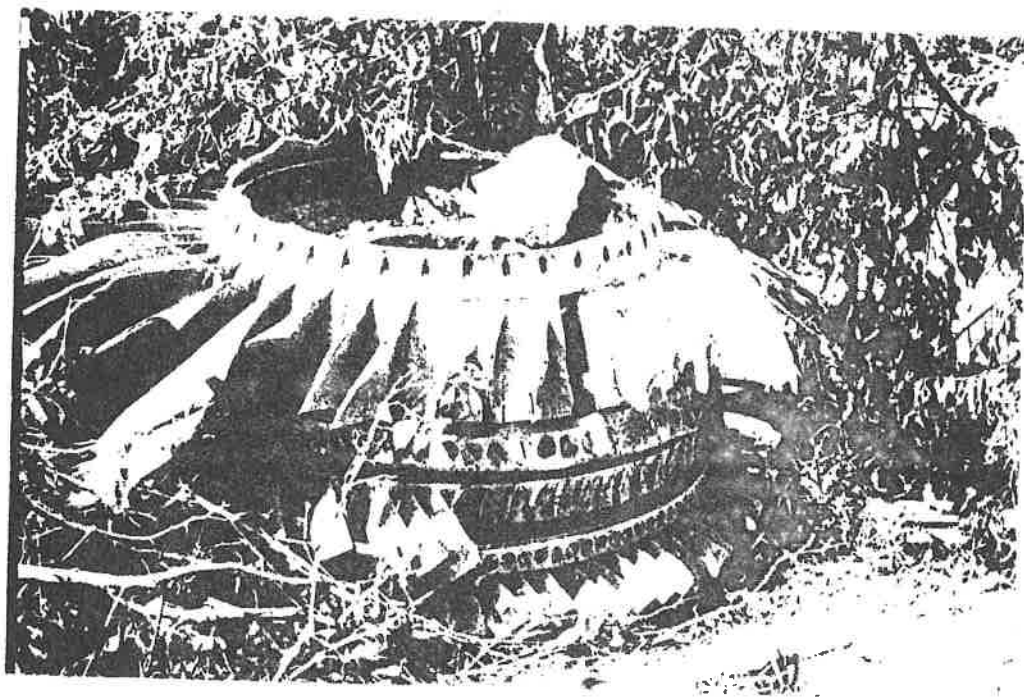
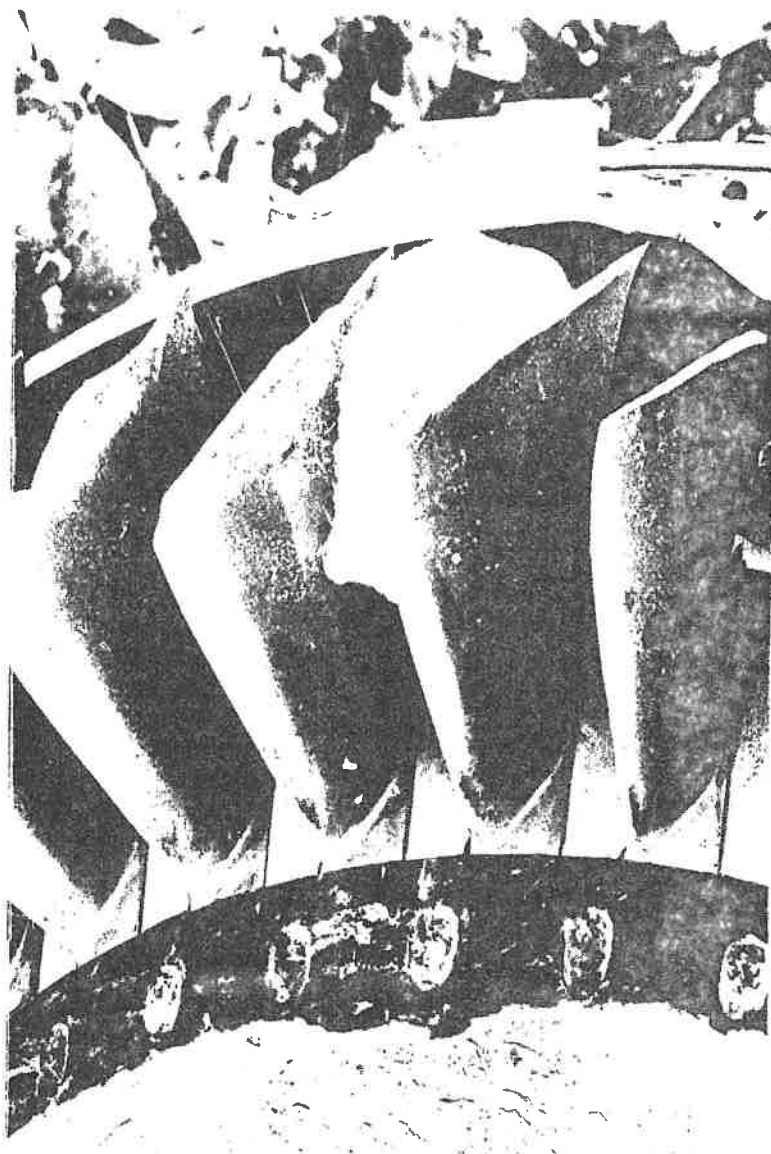
SELECTED PHOTOS FOR A/C WRECKAGE

The first impact was made by the left hand main landing gear with the Northern corner of the first house, at a point 4M above the ground level, 50cm below the roof level, tearing part of the flat inforced concrete roof and causing heavy damage to the house. The wheels broke off from the strut and remained in the house. The strut detached from the aircraft and lay on the roof. The flap scrapped off a part of the 75cm high parapetle.

The main wreckage shows the aircraft has disintegrated. The centre part of the fuselage turned over about  $50^{\circ}$ , and the forward fuselage with the cockpit upside down and heading South-East. The left wing was broken into two pieces and separated from the centre box, but was not damaged by fire. The right wing separated from center-box and was completely destroyed by fire. The fuselage was also destroyed by fire except for about 10m of the forward part including the cockpit. The empanage and engine number two were in one piece and only part of the lower cowling was damaged by the fire. The tail was pointing to the North-West. The right hand main and nose landing gears were found with the main wreckage. The right hand wheels separated from the strut. The nose landing gear was a complete unit but detached from the aircraft.

Engine No. 1 was lying with the top "12 O'Clock" position on the ground. Fan blades, disc and 2-4 stages of the low pressure compressor, the forward and aft fan case separated from the main engine. All blades bent or broken. The forward mount bolt sheared, the left hand forward lug of the rear mount was broken and missing. Right hand lugs are intact with bolt in place. Cowlings, reversers, and tailpipe all separated. Lube and scavage pump not located. Guidance of heavy rub marks on the spool of the H.P.C. sand dirt and small pebbles in the L.P.T. Turbine blades from 10 O'Clock position to 1-30 position broken and bent. No evidence of fire or uncontained failure.

Engine No.3: The fan forward casing missing probably buried with the rubble of the stone was found near the engine. The fan aft casing and frame separated to the fan frame and compressor front case, locating pin still in place. 24 blades were broken above platform. 7 blades bent in the direction of rotation, and 7 more in the opposite direction. A large stone was impeded between two fan blades. The aft rotor attached to the LPT shaft. No damage to the HPC casing.

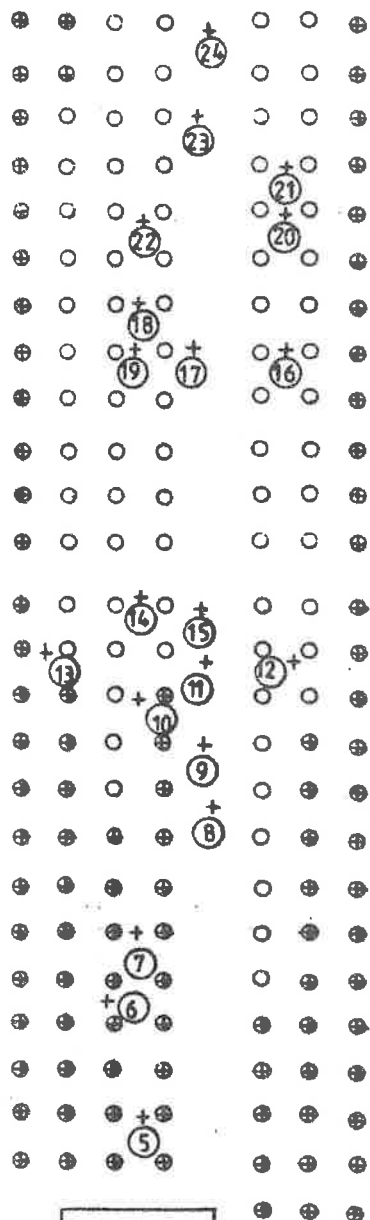
- 1- First Impact & Left Landing Gear Wheel
- 2- Left L/G Strut on Roof.
- 3- Impact of Centre Gear and Centre L/G.
- 4- Impact of Left Hand Trailing Edge Flap and No 1 engine transfer gear box.  
part of the flap,  
main gear box  
engine control.

- 5- Part of flap
- 6- Outboard left aileron
- 7- Engine cowling (inlet lip)
- 8- Lower part of tail cone .
- 9- Upper " " " " .
- 10- Left engine pylon
- 11- Control Quadrant .
