# Aviation Investigation Final Report

| <b>Location:</b> | Londonderry, New Hampshire | <b>Accident Number:</b> | ERA24FA097 |
| <b>Date &amp; Time:</b> | January 26, 2024, 07:26 Local | <b>Registration:</b> | N53RP |
| <b>Aircraft:</b> | Beech C99 | <b>Aircraft Damage:</b> | Substantial |

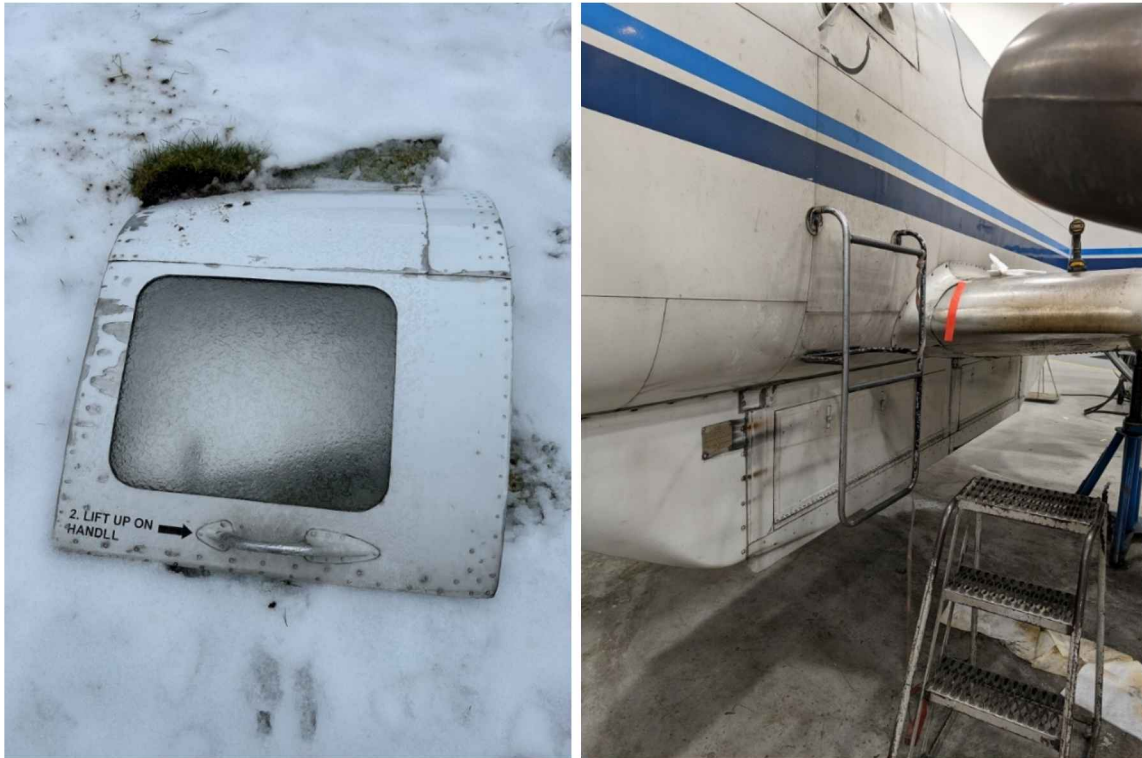
**Figure 1.** Cockpit hatch as found. **Figure 2.** Exemplar ladder and hatch above.

The airplane's left (pilot) side cockpit door/hatch was subsequently found in a residential yard about 10 miles north of the main wreckage (see figure 1). Additionally, the airplane was equipped with a portable ladder for pilot entry, which secured to the fuselage under the cockpit door/hatch and was supposed to be stowed inside the cockpit before takeoff (see figure 2). The portable ladder was found outside and aft of the cockpit, resting against the left engine

nacelle. The fuselage remained intact with both wing roots attached and the empennage partially attached. There was a hole in the upper left side of the cockpit where the door/hatch had separated.

The wreckage was further examined at a recovery facility. The left side cockpit hatch/door and portable ladder were staged during wreckage examination for orientation purposes. The left side cockpit door/hatch handle (inside and outside handle) operated normally when moved by hand.
