FINAL REPORT
A-066/CENIPA/2022

OCCURRENCE:	ACCIDENT
AIRCRAFT:	PT-SHN
MODEL:	EMB-110P1
DATE:	20MAI2022

This Final Report pertains to the accident involving aircraft PT-SHN, model EMB-110P1, which occurred on 20 MAY 2022, typified as “[SCF-PP] Powerplant system/component failure or malfunction” and “[LOC-I] Loss of control in flight.”

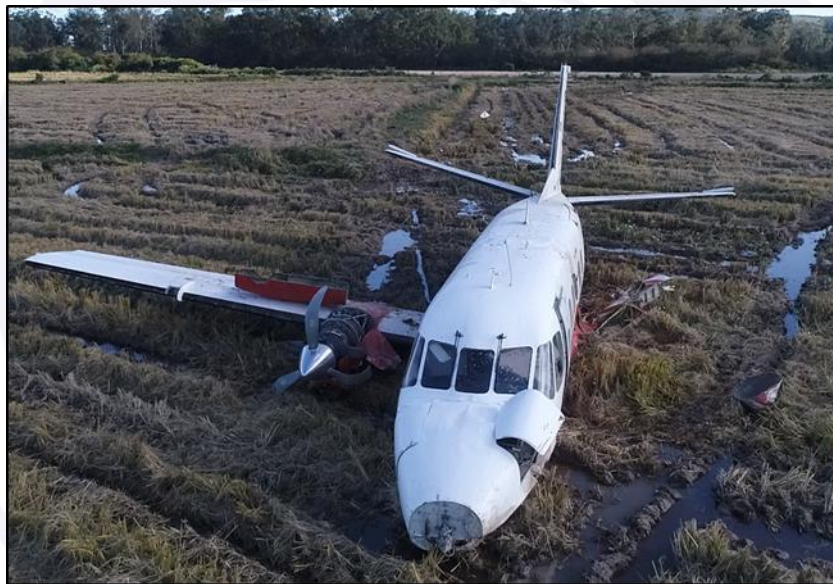
Figure 1 – View of the aircraft at the accident site.

The aircraft sustained substantial damage. The left wing was severed at the wing root during impact. There was damage to the hydraulic system and to the lower portion of the

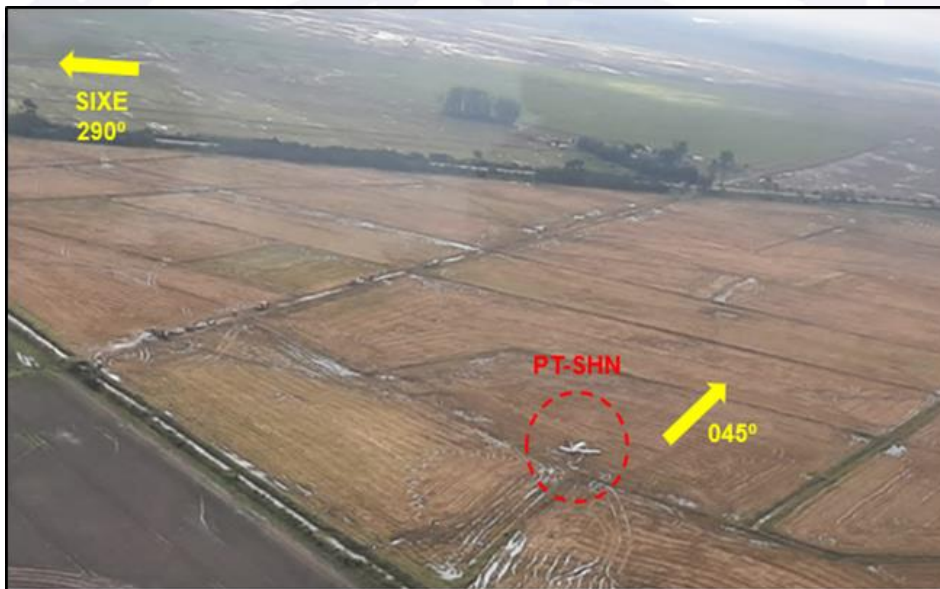
Based on the physical evidence at the impact site, one determined that the aircraft followed a descending left turn trajectory until colliding with the ground. The descent profile began on the runway heading of *Eldorado do Sul* Aerodrome, magnetic 290° . After the shutdown of the left engine, aircraft PT-SHN deviated from the straight-in path, entering a 245° left turn and impacting the ground on a magnetic heading of 045° (Figure 4).

Figure 4 – Information on the accident dynamics.

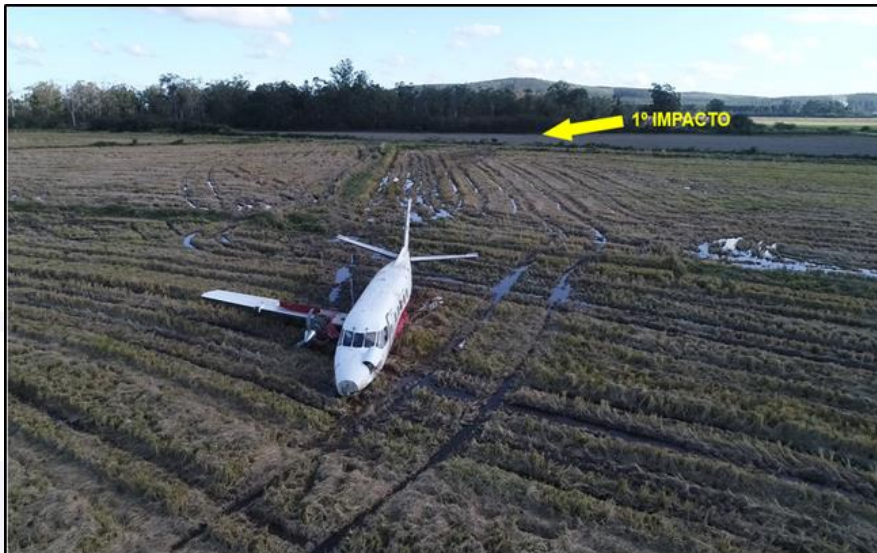
The aircraft's first impact occurred approximately 124 meters before its final stopping point. The aircraft was banked, with the left wing lower than the right. The initial impact occurred against an earthen embankment that separated the flooded fields and served as a crossing path between them.

Upon striking the embankment, aircraft PT-SHN lost the entire structure of the left wing, which was destroyed and scattered along the impact trajectory (Figure 5).

Figure 5 – Final wreckage position with emphasis on the initial point of impact.

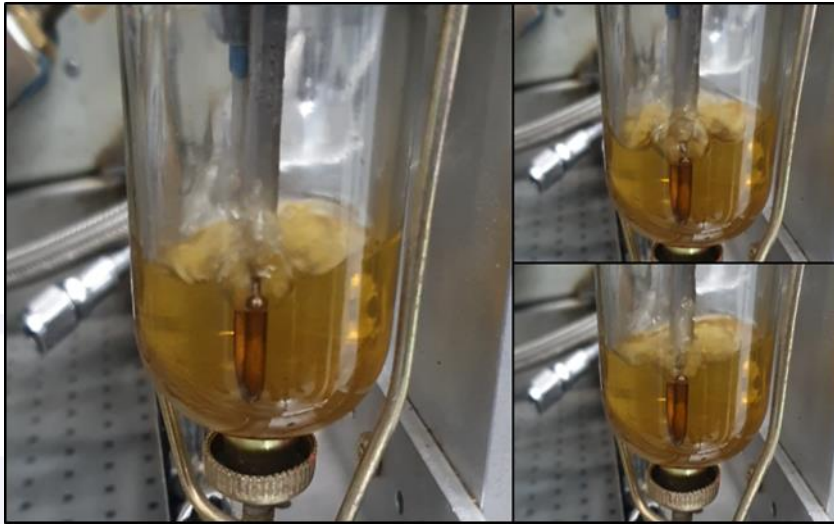
Finally, the bellows component was analyzed by means of the procedure described in Component Maintenance Manual 3244777, Section 73-20-27, dated 05 MAY 2008, issued by the manufacturer Honeywell. During testing, it became evident that the component exhibited a leak (Figure 6).

Figure 6 – Bellows test performed in accordance with the manufacturer's manual.

The identified leak was consistent with a condition in which P_x and P_y pressures would have equalized during aircraft operation, resulting in fuel flow commanded to the maximum – consistent with the condition reported by the crew.

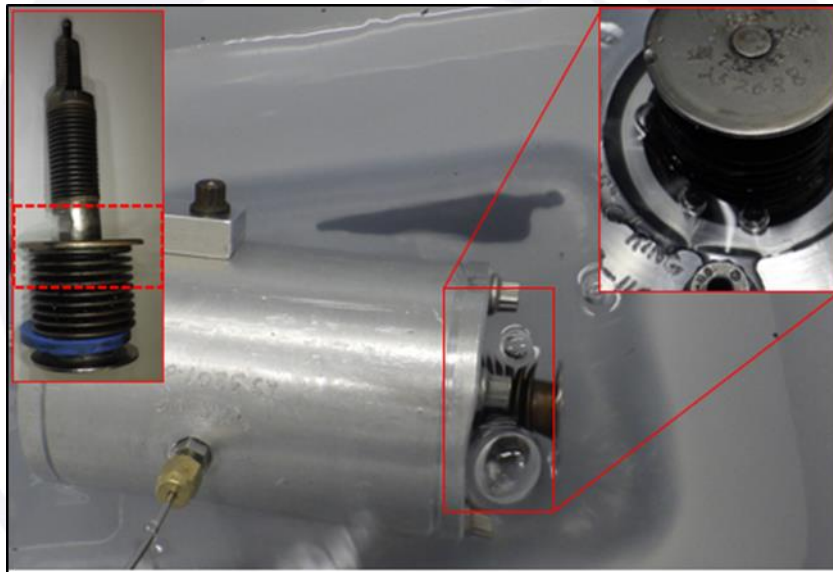
In order to determine the failure mechanism, the bellows was subjected to laboratory testing. An initial visual inspection was performed, followed by a helium leak test under submersion, which detected that the failure region was located between the first and second spiral segments of the bellows (convolutions), as shown in Figure 7.

Figure 7 – Helium leak test.

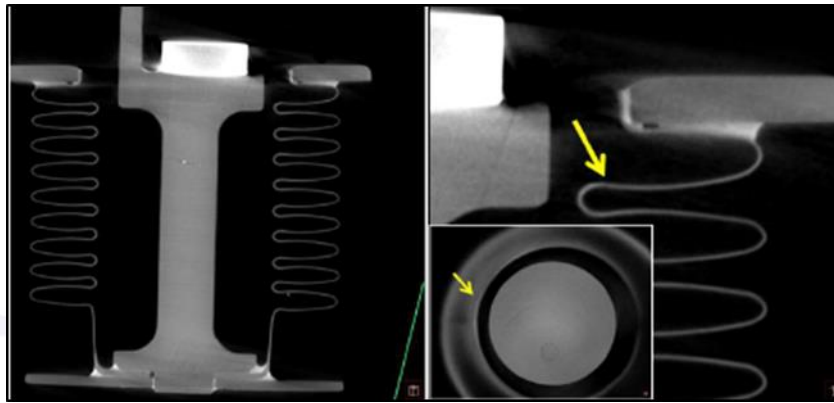
After one determined the location of the leak, the component underwent computed tomography (CT scan), which identified the precise position of the leakage point (Figure 8).

Figure 8 – Computed tomography image highlighting the crack location (in yellow).

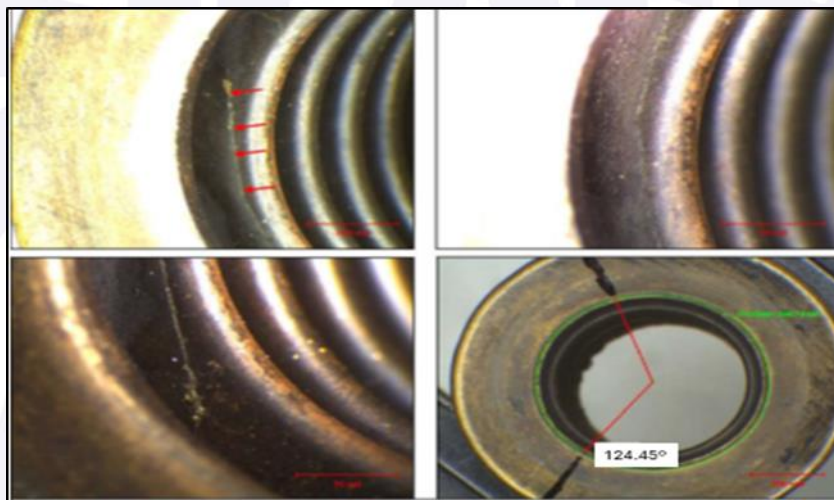
With the exact location of the crack identified, a new visual inspection was carried out, allowing the precise extent and location of the defect to be confirmed (Figure 9).

Figure 9 – Visual inspection results after CT scan.

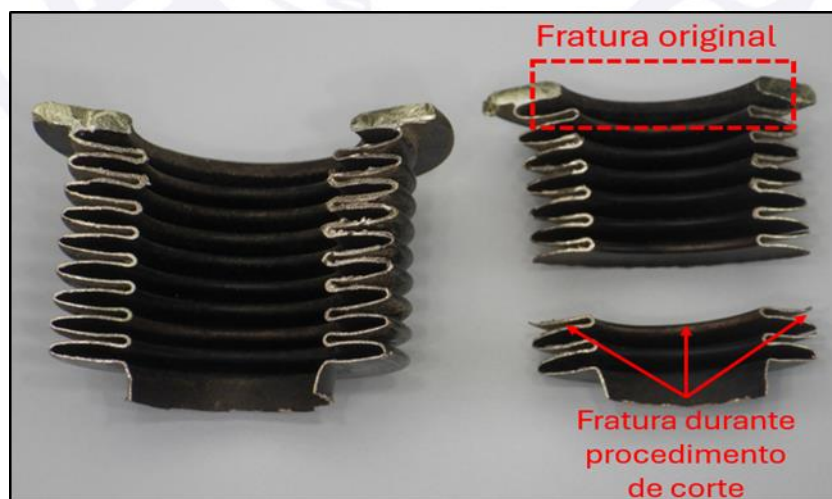
Figure 10 – Bellows after sectioning, highlighting the location of the original fracture and the new fracture that occurred during the procedure.

The examination of the new fracture that occurred during the separation process showed that its extremities exhibited characteristics of an overload fracture, caused by the manual force applied at the time of separation.

The pre-existing fracture exhibited a worn surface, on which, for the most part, the features that characterized the type of fracture had been damaged, rendering its fractographic evaluation imprecise.

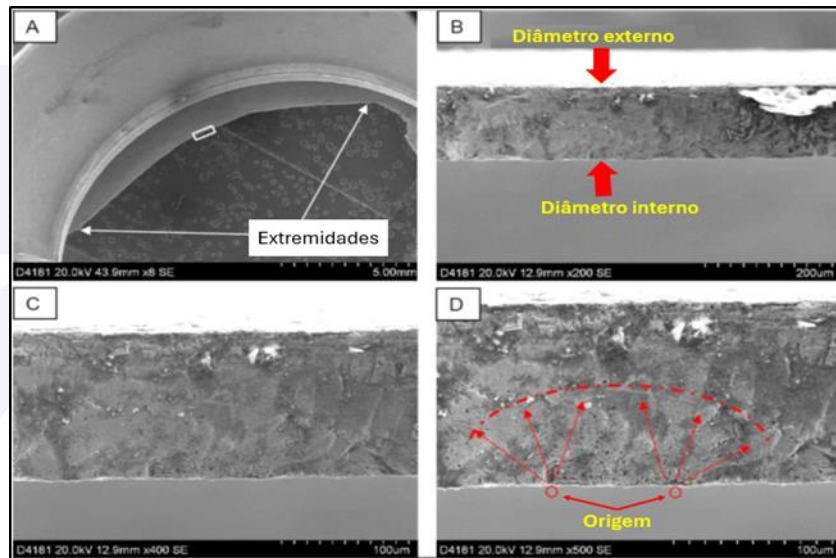
A detailed examination of the entire crack length revealed, near its midsection, a region exhibiting characteristics consistent with a fatigue fracture. Radial marks (beach marks) were identified, originating from the internal diameter of the component (Figure 11).

Figure 11 – Analyzed area exhibiting characteristics of fatigue failure.

Due to the degraded condition of the crack surface, likely caused by friction between the two faces after the occurrence of the fracture, it was not possible to determine the extent of the fatigue-affected area, preventing a qualitative assessment of the nucleation and propagation mechanisms involved in the formation of the discontinuity.

After examining all components and operational characteristics of the FCU, a leak was identified in the bellows, originating from a crack located between the first two convolutions of the component. Subsequent examinations identified features consistent with a fatigue failure process, including radial marks originating from the inner diameter of the component.
