**REPORT ON THE ACCIDENT
B707 - REG. 5N-VRG AT OSTEND
AIRPORT ON 14TH NOVEMBER 1998**

REPORT

Engine Inspection Report IAT B707 Engine Separation, Brussels, Belgium, 14 November 1998

SUBJECT: B707 - INVESTIGATION ON SEPARATED ENGINE

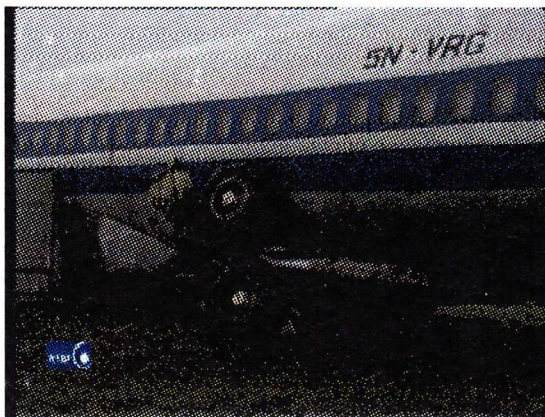
Landing Gear Damage

On 14 November 1998, a B707 cargo aircraft, powered by Pratt & Whitney JT3D-3B engines and operating as IAT flight RCN302, experienced the separation of the Number 3 engine and pylon structure from the aircraft during climb. Having departed Osstend, Belgium at 02:28 UTC, flight RCN302 reported a hydraulic failure about 30 minutes after departure. At an altitude of roughly 23,000 feet and during moderate turbulence, the pilot reported an audible bang, an engine surge, and the loss of all instrument readings for number 3 engine. The aircraft returned to Osstend, Belgium and landed. During landing, the emergency braking system was employed. The aircraft departed the runway into a grass field where all landing gear collapsed. No injuries were reported. Aircraft inspection found that engine number 3 and pylon had separated from the aircraft. It was reported that the tailpipe of engine number 4 showed severe impact damage and the wing leading edge between engines number 3 and number 4 showed minor damage.

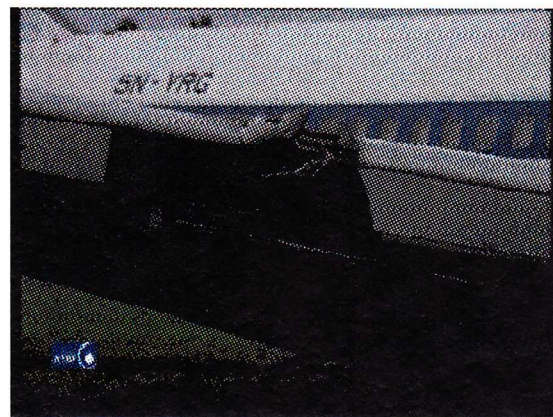
Engine Number 3 Position

Engine number 3 was located and transported to a warehouse of the Belgian Civil Aviation Authority. Components of the pylon structure were removed under the authority of Belgium investigator, Mr. Richard Taverniers and analyzed by the Materials Lab of Sabena Technics. The remaining engine and pylon were examined on 14 January 1999 by Mr. Jim Sunamoto – P&W, Mr. Michael Barron – P&W, Mr. Michael Holland – Boeing, and Mr. Richard Taverniers – Belgian CAA.

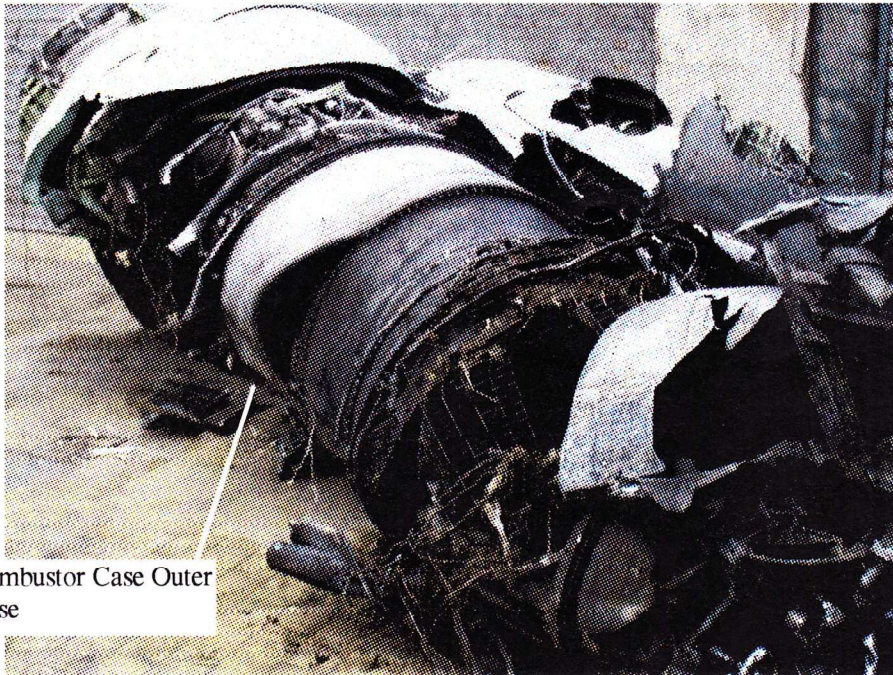
The Combustor Case Outer Case was intact. However, it was deformed radially outward, centered at the 5:00 o'clock location, with the rear flange bolt strap torn out.

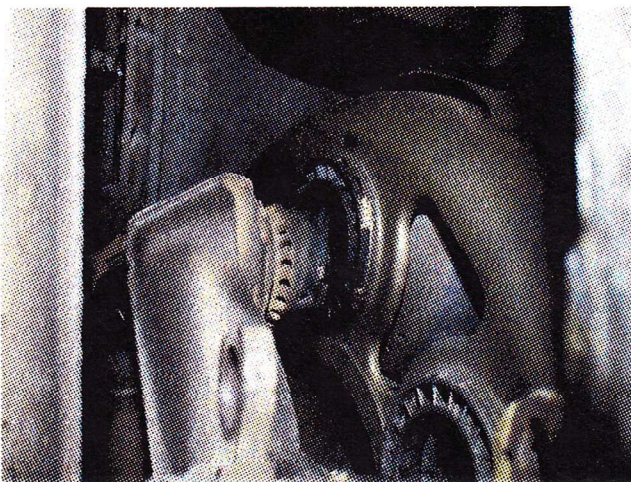
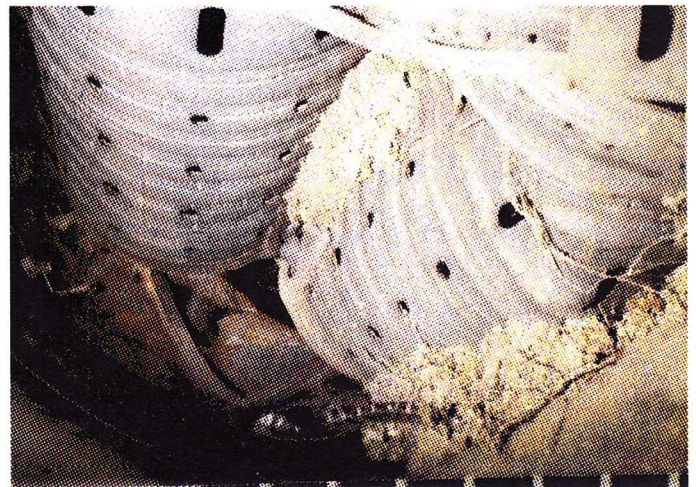
A section of CCOC was cut to view into the burner. Four burner cans were exposed for viewing through the cut out section. There were no visible indications of burner section distress and there was no metal debris splatter on the front of the fuel nozzles, fuel nozzle supports, or burner can domes.

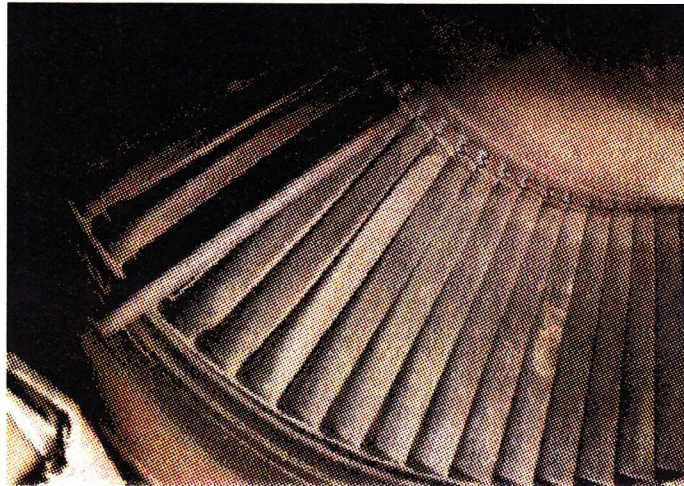
The last low-pressure turbine (T-3) and the turbine exhaust case struts showed no evidence of upstream distress prior to engine/pylon liberation.

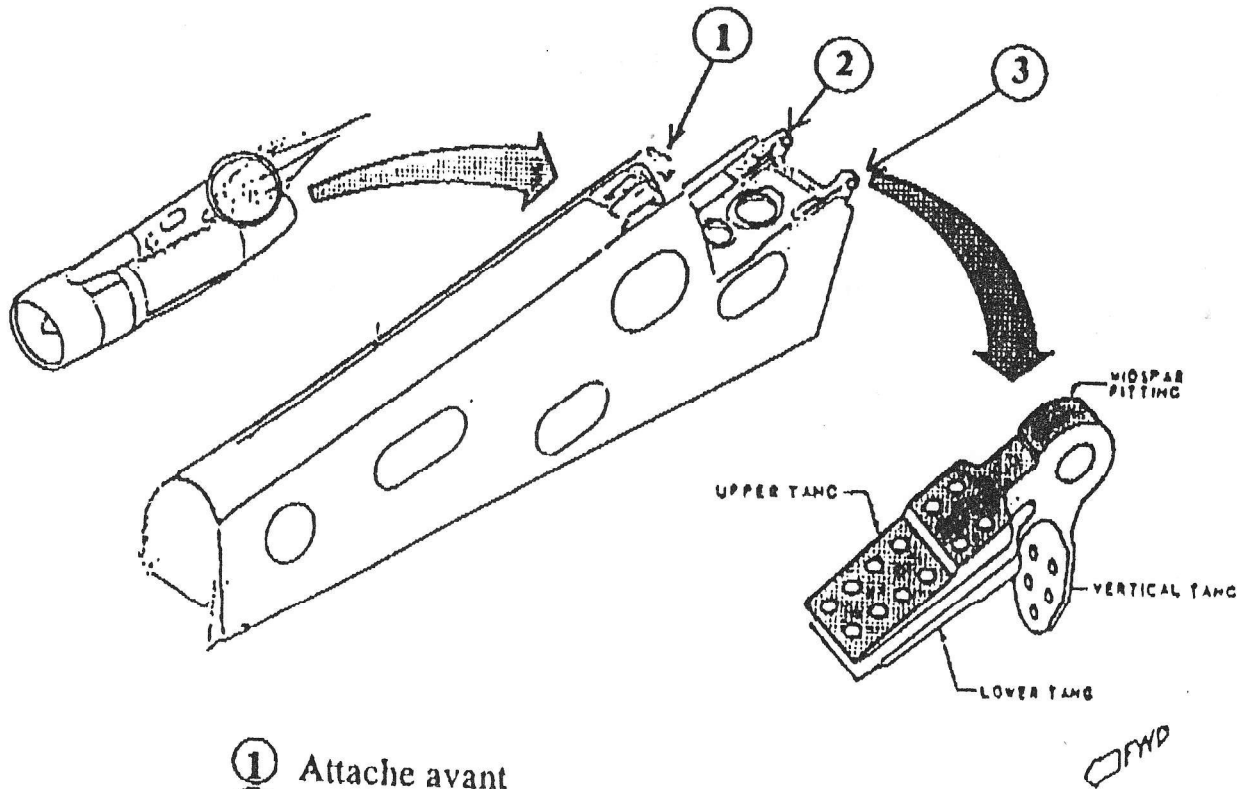
Picture 1: indicates engine attachments, relative position of parts and nomenclature.

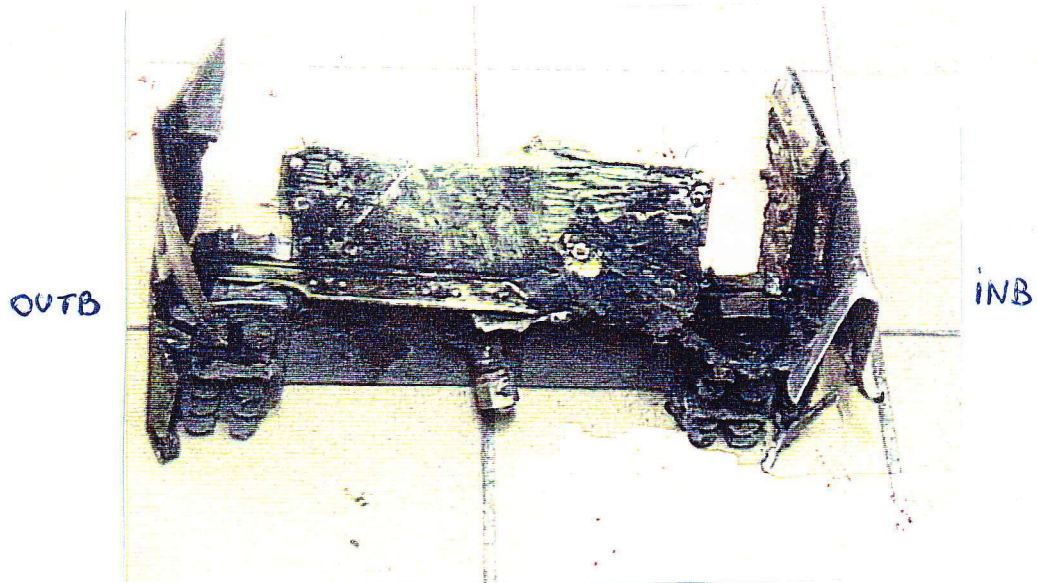
Picture 2: View on as-received structure containing upper and lower tangs fractured from inboard and outboard midspar fittings. This section was cut from the engine that had separated.

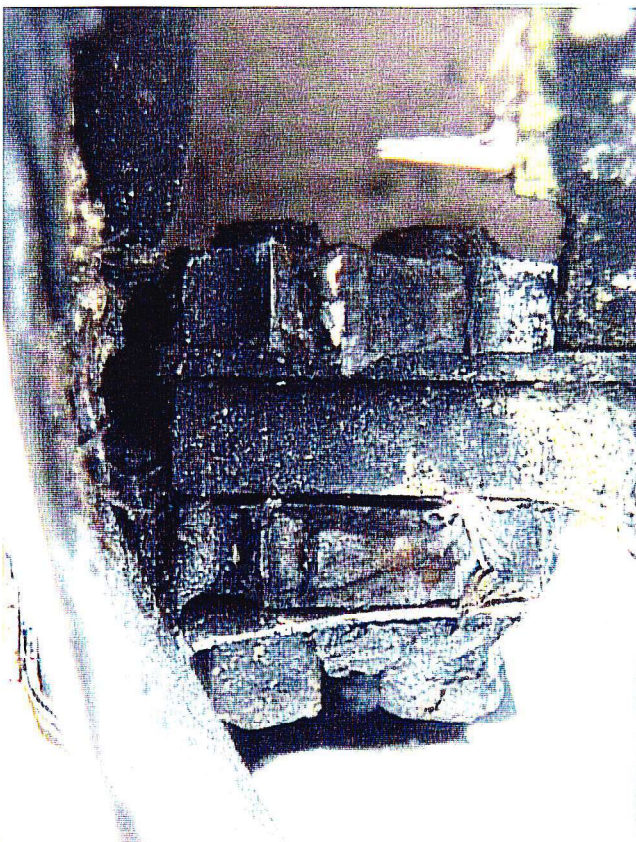
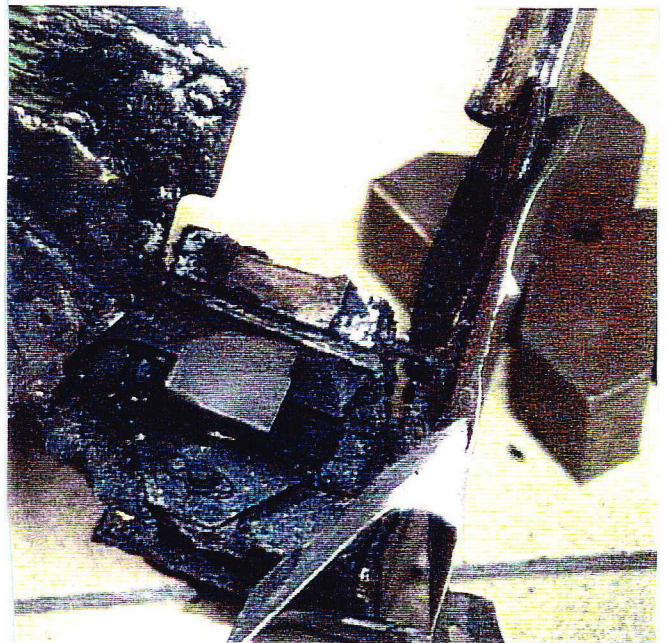
All parts cut from the separated engine were analysed and found to have failed in static overload, except for the inboard midspar fitting. Pictures 3 and 4 detail the fracture surfaces from both midspar fittings as visible on picture 2. The outboard fitting is an overload failure while the inboard fitting reveals **stress-corrosion cracking** at the upper tang and an almost 100 % fatigue crack at the lower tang. See pictures 5 to 8 for more detail. Note also the mechanical damage on the upper tang indicating beating of both parts against each other after cracking (beating caused by engine vibration).

Pictures 3 & 4: Detail of fracture surfaces of midspar fittings on the part from picture 2.

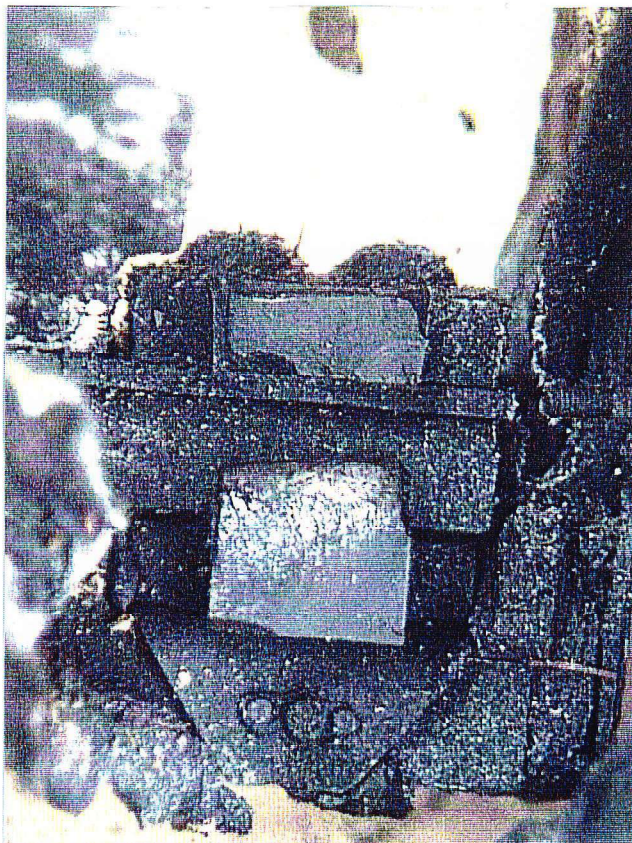
Picture 5: More detail of picture 4. Magn. 0.83x.

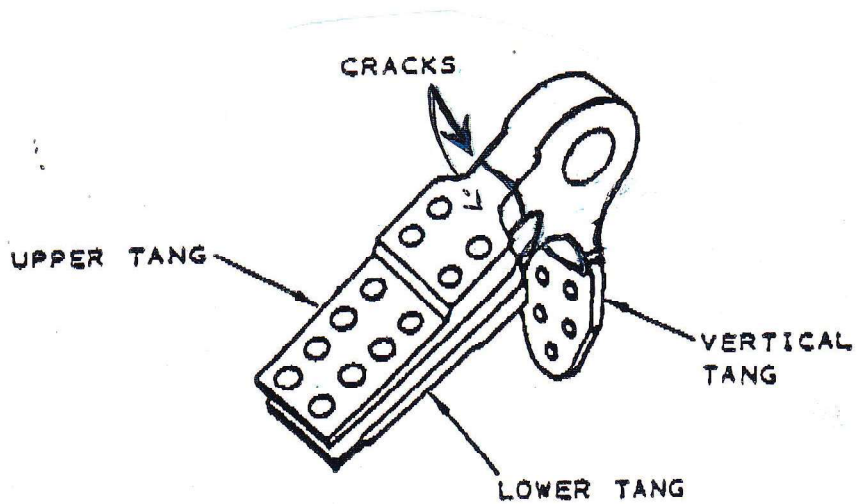
Picture 6: Sketch indicating fracture location on midspar fitting.

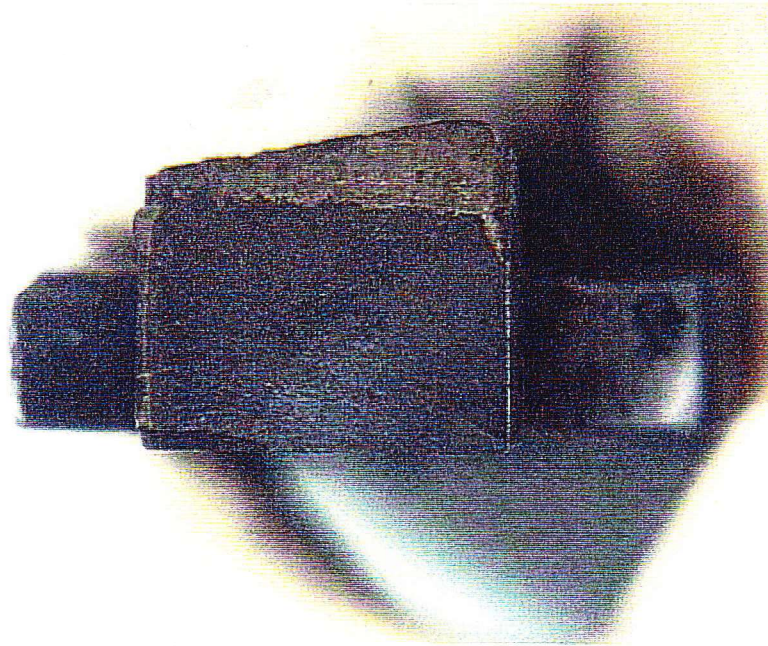
THE OLD, NON-IMPROVED MIDSPAR FITTINGS FAILED BY STRESS CORROSION CRACKING (UPPER TANG) AND FATIGUE CRACKING (LOWER TANG).

Picture 7: View on fracture surface of upper tang typical of stress-corrosion cracking starting from the corner. Note the beaten area on top. Magn. 1.5x.

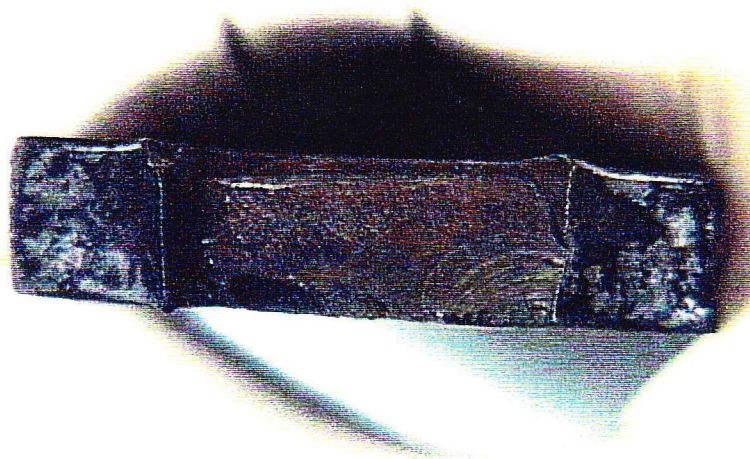
Picture 8: View on fracture surface of lower tang typical of fatigue cracking starting from the corner. Fatigue progresses almost to 100 % of fracture surface. Magn. 1.5x.

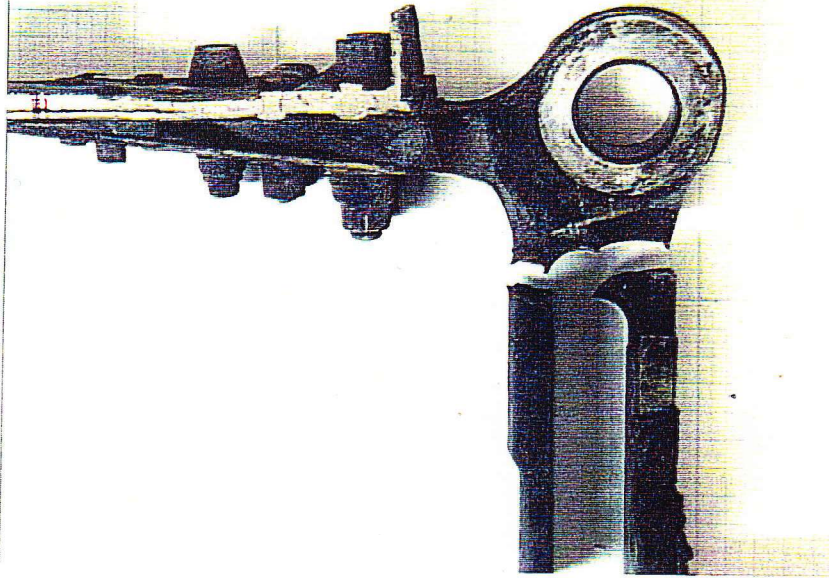
Picture 9 reveals the mating part of the fitting removed from aircraft relative to the fractured upper and lower tang. Pictures 10 and 11 reveal the fracture surfaces of the outboard respectively inboard midspar fittings removed from aircraft. Note the brown corrosion which is post-incident. Note the absence of corrosion on the stress-corrosion fracture surface. This can be explained by the fact that this surface has accumulated dirt and greasy substance during operation, preventing corrosion. This proves it concerns a crack which has been present for a reasonable time. The stress-corrosion cracking of the upper tang has induced higher stresses on the lower tang which developed a fatigue crack.

Picture 9: Mating part of the fitting removed from aircraft relative to the disassembled fractured upper and lower tangs.

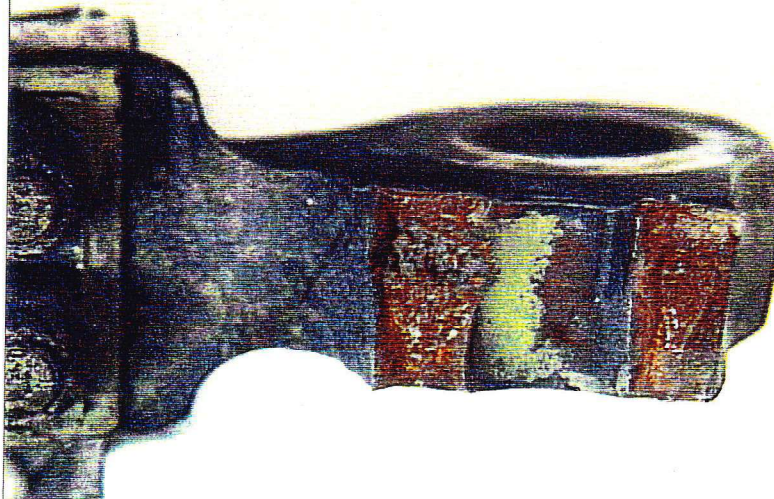
Picture 10: Fracture surface of outboard midspar fitting as removed from aircraft.

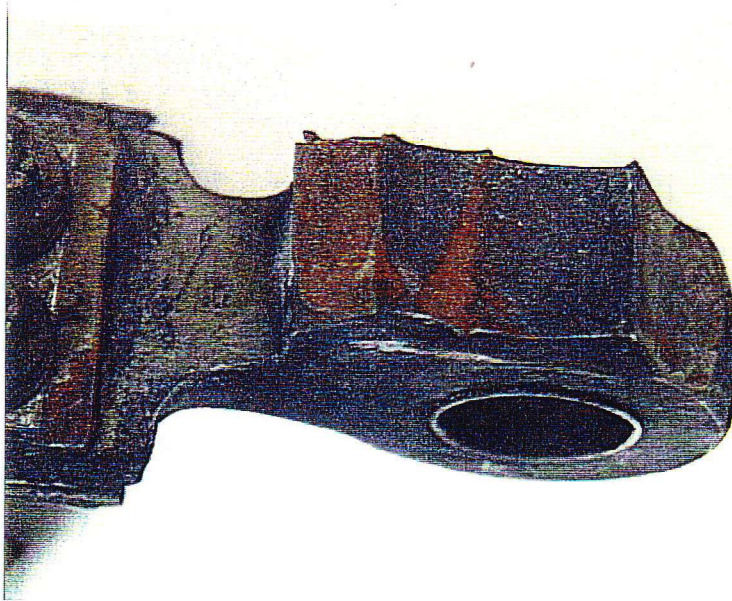
Picture 11: Fracture surface of inboard midspar fitting as removed from aircraft.

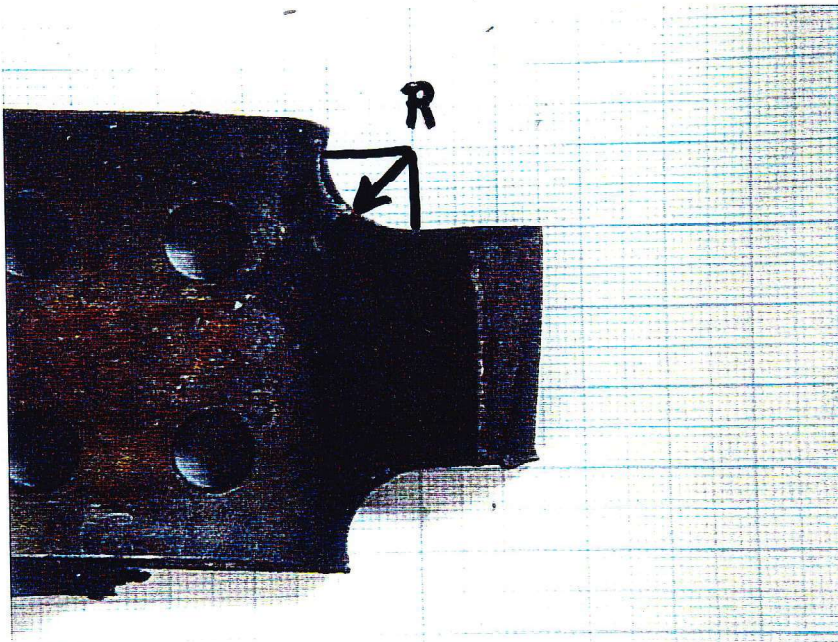
The only visible differences are a larger transition radius at the top (1.00" instead of 0.38") and a smaller flat area on the large lug (2.1" instead of 3.0"). See also drawing on last page of this report.

Review of the received fittings reveals a .38" transition radius (see picture 12) and a 3.0" flat area, **proving** that the midspar fittings have never been replaced by new, improved fittings.

Picture 12: View on transition radius of as-received fittings. Radius is 9.7 mm (0.38") and not 25.4 mm (1.00").

Fracture of the midspar fittings resulting in separation of the strut and engine from an airplane in flight has been experienced before on B707 (see ref (1)). To address this problem the ref (2) AD has been issued. Replacement of the midspar fittings with new, improved fittings, iaw ref (1), constitutes terminating action for the inspections required by the AD.
