AVIATION OCCURRENCE REPORT

**BRADLEY AIR SERVICES LTD.
BRITISH AEROSPACE HS 748-2B C-GFFA
CHENEY, ONTARIO
15 SEPTEMBER 1988**

REPORT NUMBER 88H0011

18 June 1991

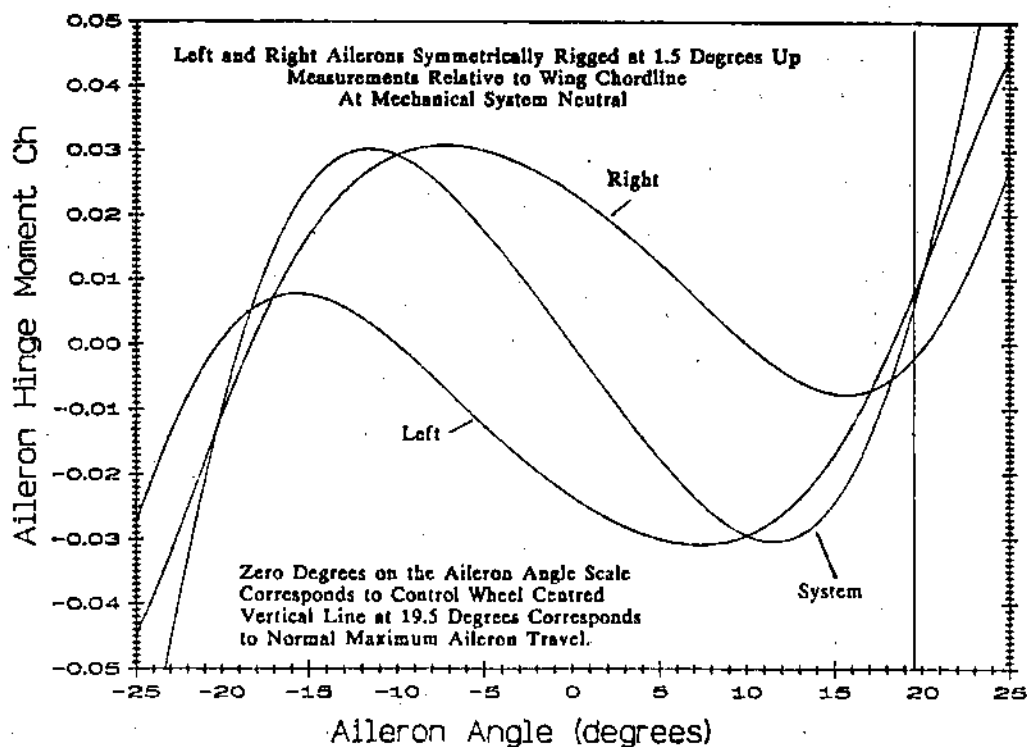
Figure 1.2 Aileron Hinge-Moment Characteristics
(Rigged Up 1.5 Degrees from Chord Line)

The net effect of these provisions is a non-linear hinge-moment characteristic as depicted in Figure 1.2; this hinge-moment curve is derived from ATP flight data, corrected theoretically for the different tab gearing. At zero deflection, an isolated aileron has a down-floating tendency, but, as a pair, the ailerons counterbalance each other. The aileron system has stable hinge-moment characteristics up to about half travel. However, at larger angles, the aerodynamic balances protrude sufficiently into the air stream to cause the hinge-moment characteristics to adopt an unstable gradient. This behaviour occurs first on the up-going aileron. Protection from aerodynamic overbalance or "lock" is provided by the then increasing hinge moment on the down-going aileron. Thereafter, some lightening of wheel forces occurs. Correct rigging is required for the designed protection from aileron aerodynamic overbalance.

At large deflection angles (greater than 20 degrees above the chord line), the up-going aileron would be driven upwards by aerodynamic forces were it not restrained by its cable connection to the down-going aileron. At this point, the force that the pilot must overcome in moving the ailerons is the total of system friction and the resistance of the down-going aileron less the force provided by the up-going aileron's tendency to go up.

The net force balance is a function of the neutral position of the ailerons. If they are both rigged up from the wing chord line, aileron control wheel forces will lighten. With normal rigging of the aileron system, that is, with both ailerons rigged trailing edge 1.5 degrees up from the wing chord line, the aileron wheel force falls steeply for aileron deflections of more than 12 degrees from neutral. A centring spring system (Modification 4080), which comes into play at about 14 degrees mean aileron angle, progressively adds wheel return force, reaching approximately 17 pounds at the normal maximum control-wheel angle of 88 degrees, to reduce the lightening of the wheel forces at large mean aileron angles.

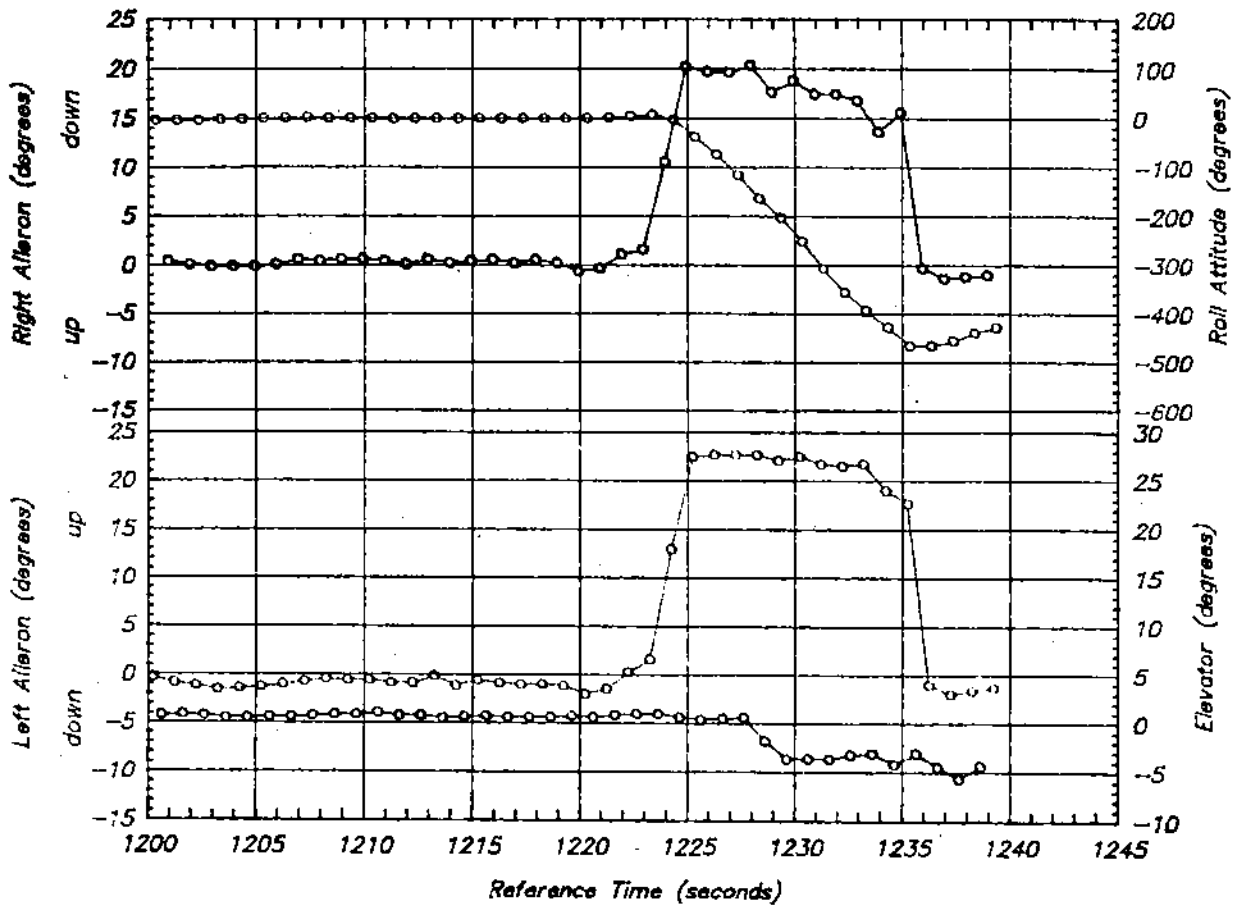
Figure 1.3 FDR Recorded Aileron Deflections and Roll

The aircraft rolled to the left (the direction appropriate for the deflection) at a maximum roll rate of about 46 degrees per second (278 degrees of roll in six seconds, from 1226 RT to 1232 RT). During this period, the ailerons remained at or near the fully deflected position. The left aileron deflection varied slightly, reducing by a maximum of about 1.0 degrees at 1233 RT; a gradual reduction was then noted, yielding a deflection value of about 18 degrees at 1235 RT. The right aileron deflection reduced momentarily to about 19 degrees at 1230 RT and then commenced a steady slow reduction to about 14 degrees at 1234 RT. The recorded right aileron deflection returned to about 15 degrees at 1235 RT.

Seven seconds elapsed from passing through wings-level (after 360 degrees of roll) to ground impact (1232 to 1239 RT). Both ailerons abruptly returned to the previously noted in-flight neutral position at 1236 RT. The ailerons then went to slightly past the previously noted in-flight neutral position. This resulted in the roll stopping with the roll attitude of the aircraft at about 100 degrees of left bank and the commencement of rolling motion in the opposite direction.

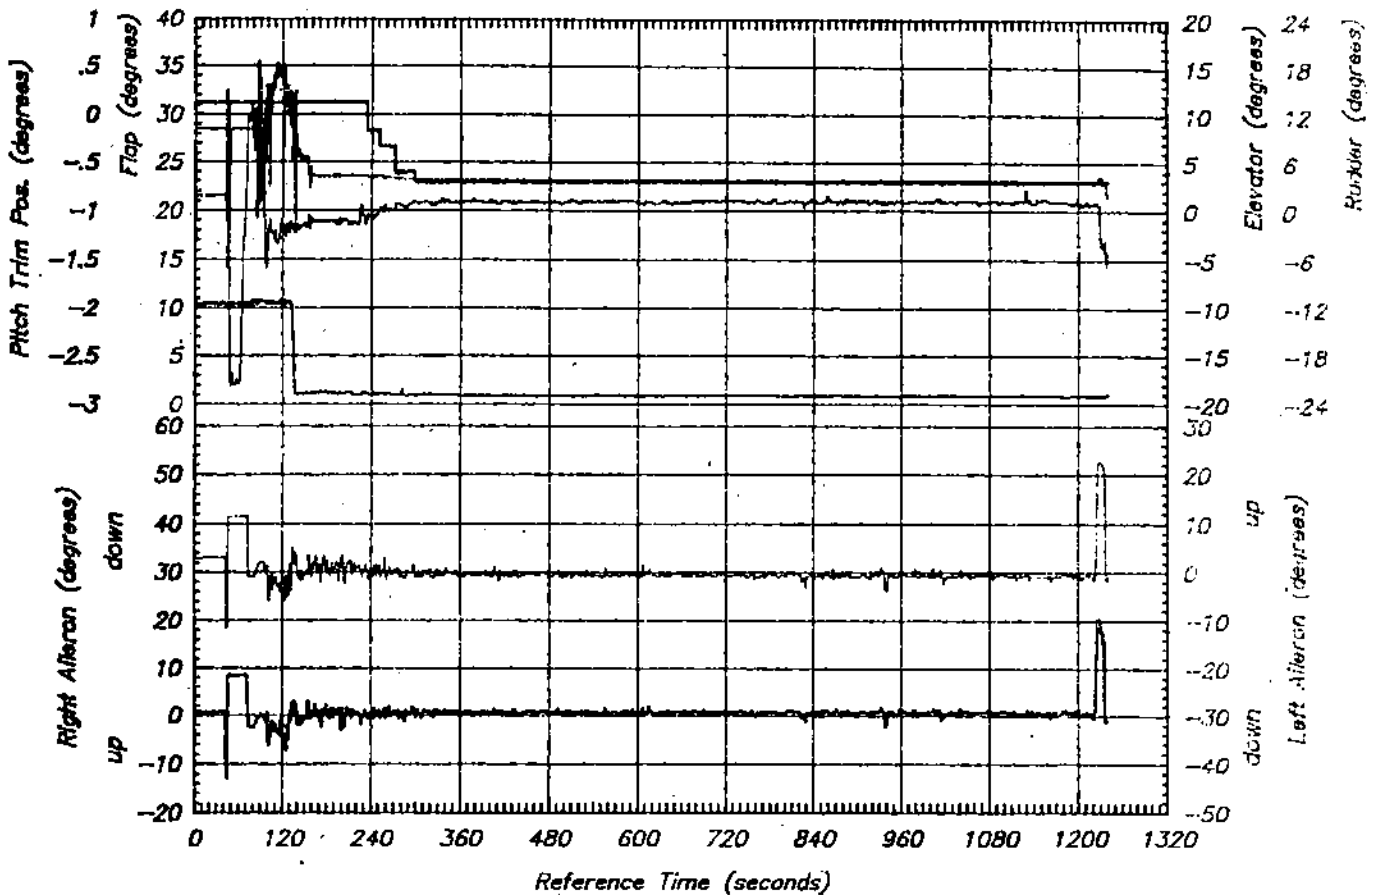
Figure 1.4 FDR Recorded Control Positions and Airspeed

As previously indicated in section 1.11.1.2, it was noted that there was about 3.5 degrees of downward movement (float down) in the left aileron neutral position from the on-ground, no airload condition (gust-locked) to the flight loaded condition at 200 KIAS. No observable change was recorded in the neutral position of the right aileron when it was subjected to airloads (Figure 1.4). This float down phenomena was observed in all 25 hours of data on the accident FDR tape.

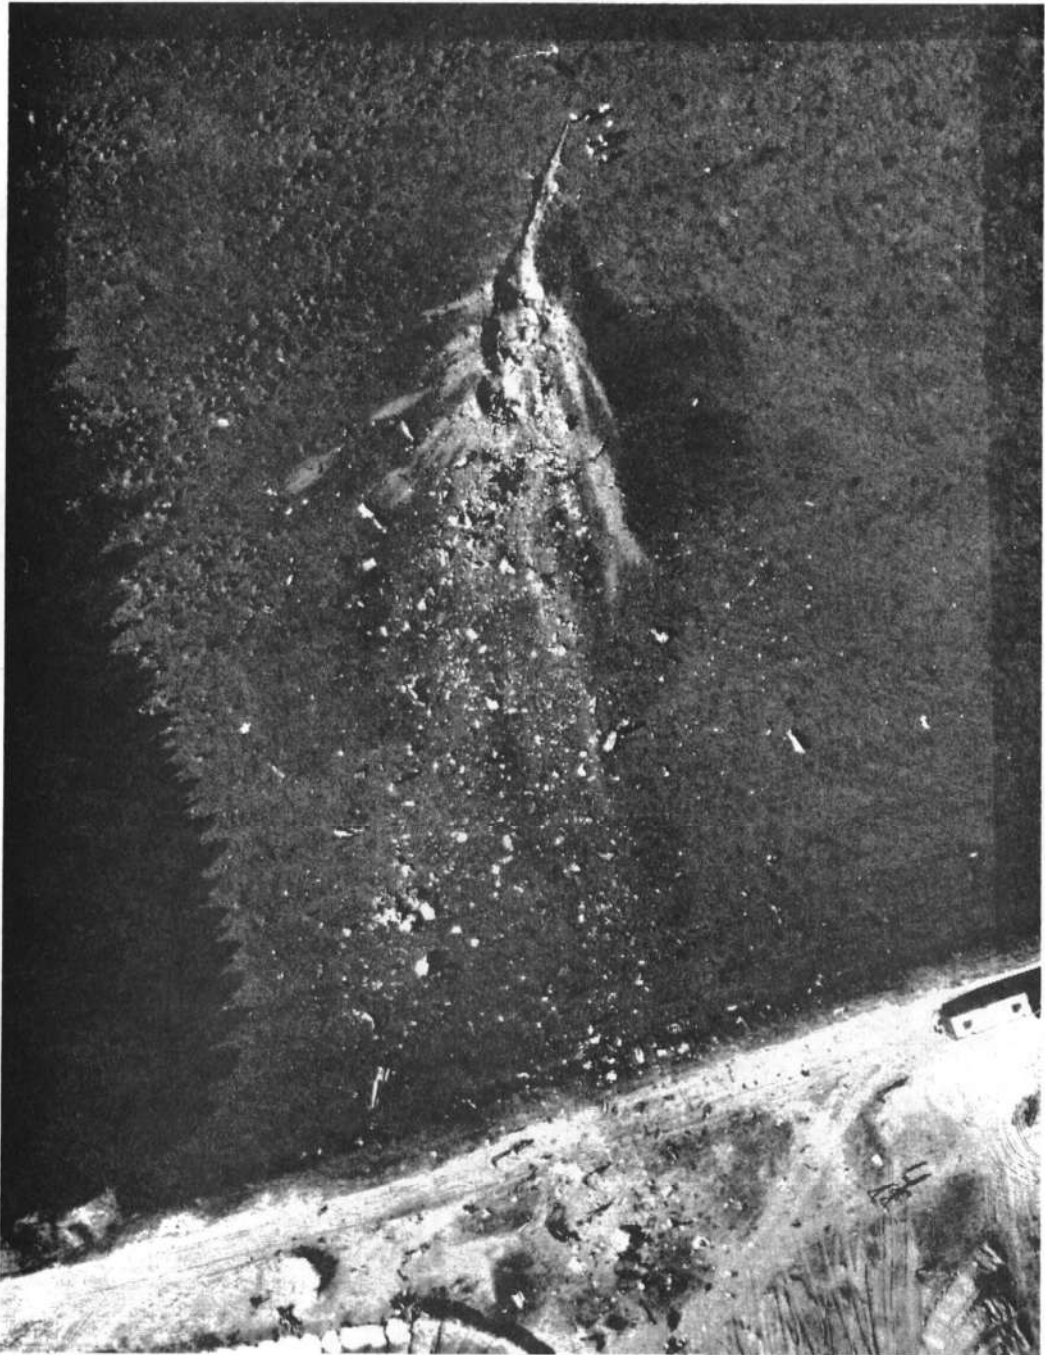
Figure 1.5 Aircraft Impact

Pieces of the red lens cover from the left wing tip navigation light were found where the aircraft first struck the ground. From this point, a ground scar was made by the left wing for approximately 50 feet leading to three consecutive craters, the deepest of which was four feet. The three craters were caused by the impact of the left engine, the fuselage, and the right engine respectively. From the initial ground impact the wreckage was scattered over a 50-degree arc (maximum width of 300 feet) with the farthest piece, an aileron balance weight, thrown 785 feet.

Superficial soot and ash patterns observed indicated that a brief post-crash fire occurred following impact. There was no evidence of a pre-impact fire.

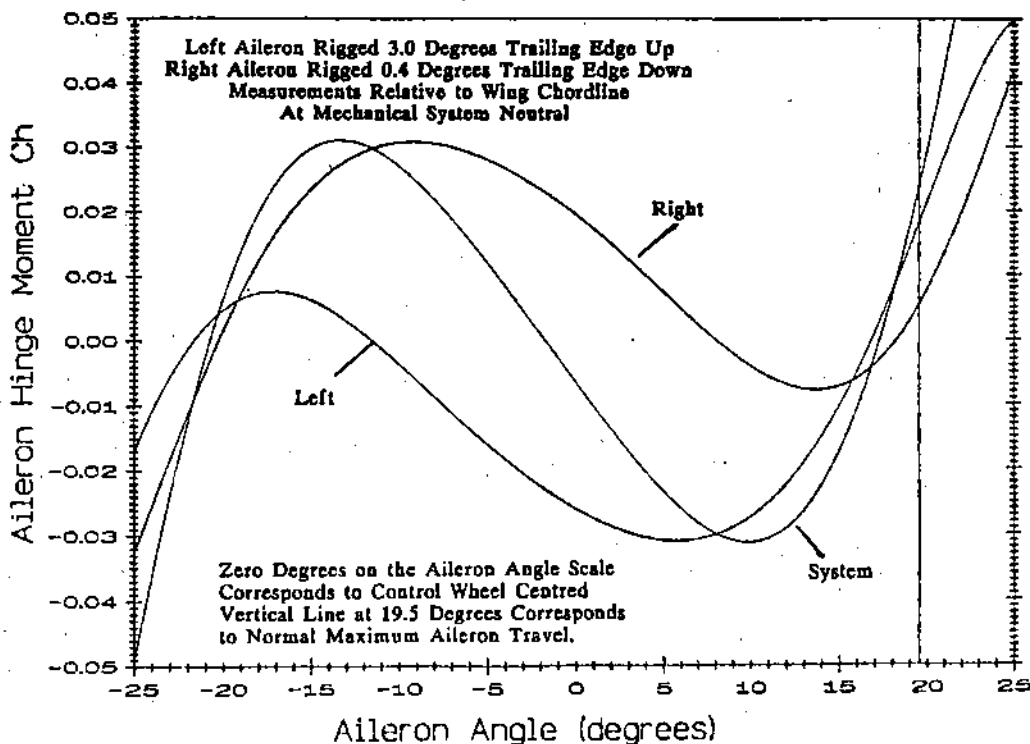
Figure 1.6 Aileron Hinge-Moment Characteristics
 (Left Aileron 3.0 Degrees up Right Aileron 0.4 Degrees down)

left aileron extra travel as measured by the FDR), an overbalance force of about 37 pounds would hold the ailerons deflected at 200 KIAS (after considering about 17 pounds of positive assistance provided by Modification 4080 centring springs in the system). Based on the hinge-moment data provided by BAe, TSB investigators calculated that, at 225 KIAS, and at the same 20.25 degrees of aileron system deflection indicated by the FDR, the overbalance force would be 52 pounds; at 250 KIAS, the force would be 68 pounds.

The preceding calculations have uncertainties because hinge-moment curves provided by the manufacturer are theoretical and are not based on measured or test data. In addition, because of the slope of the hinge-moment curves at large deflection angles, the change of the overbalance force with the change of aileron angle is rapid. At 200 KIAS, in the range of maximum aileron deflection angles, each 1.0 degree change of aileron angle equates to approximately 20 pounds of overbalance force for the given conditions of 3.0 up-rigged left aileron and 0.4 degree down-rigged right aileron. Any increase in the rigging asymmetry increases the overbalance force and the rate of change of the force with aileron deflection.
