Aviation Investigation Final Report

Location:	Hot Springs, Virginia	Accident Number:	ERA24FA136
Date & Time:	March 10, 2024, 14:52 Local	Registration:	N1125A
Aircraft:	ISRAEL AIRCRAFT INDUSTRIES 1125 WESTWIND ASTRA	Aircraft Damage:	Destroyed
Defining Event:	Controlled flight into terr/obj (CFIT)	Injuries:	5 Fatal
Flight Conducted Under:	Part 91: General aviation - Personal

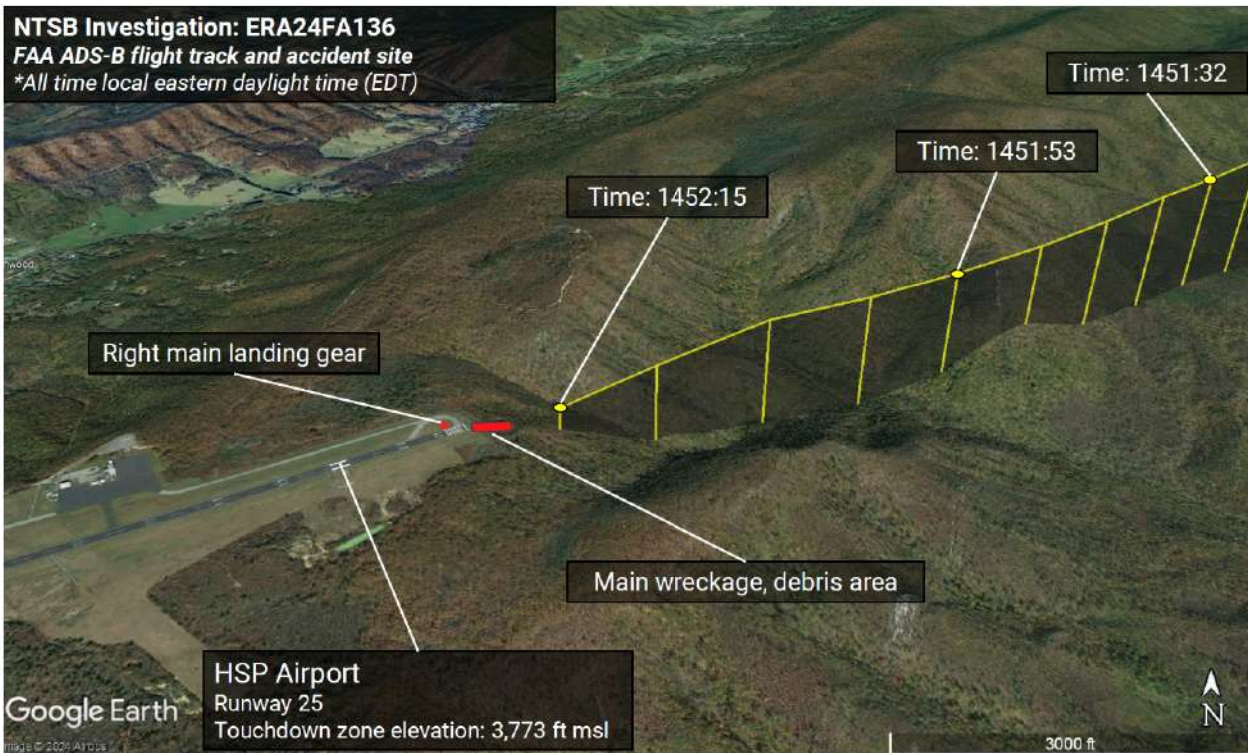
The final recorded ADS-B position was about 200 ft from the airplane's initial impact point with terrain. Figure 1 provides an overview of the airport environment, accident site, and the final 45 seconds of flight track data. Figure 2 provides an overview of the final 1 minute and 18 seconds of flight track data.

Figure 1: Overview of the airport environment, accident site, and the final 45 seconds of flight track data.

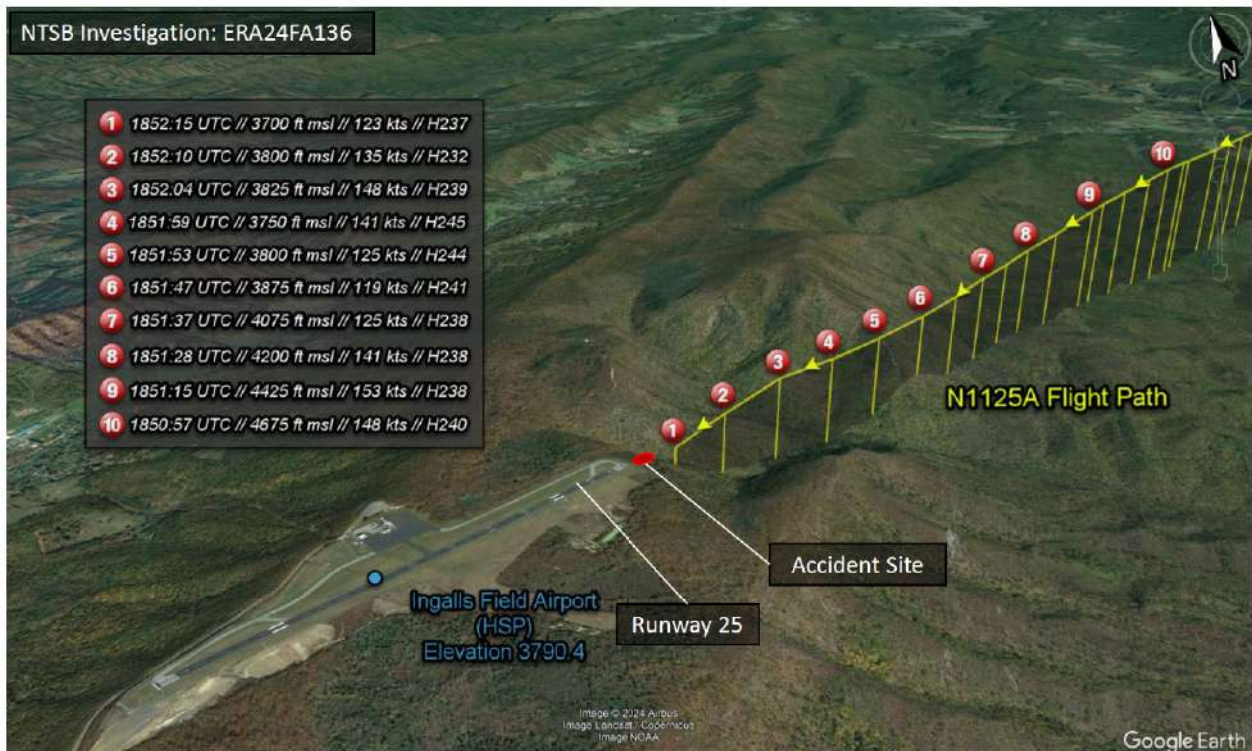
Figure 2: Overview of the final 1 minute and 18 seconds of flight track data.

The NTSB Office of Research and Engineering plotted the airplane's flight track using ADS-B data and airplane performance information. These plots showed that the airplane crossed the AHLER intersection at 5,800 ft, which was 200 ft below the "at or above" altitude noted on the ILS RWY25 instrument approach procedure (IAP) and 300 ft below the crossing altitude assigned by ATC. The airplane crossed the final approach fix at 4,800 ft, which was 300 ft below the "at or above" altitude noted on the IAP. The airplane continued at 4,800 ft until reaching a point where the glideslope indicator would have depicted about a half dot "fly up" indication. The airplane then began its final descent about 3.3 nautical miles nm from the runway threshold.

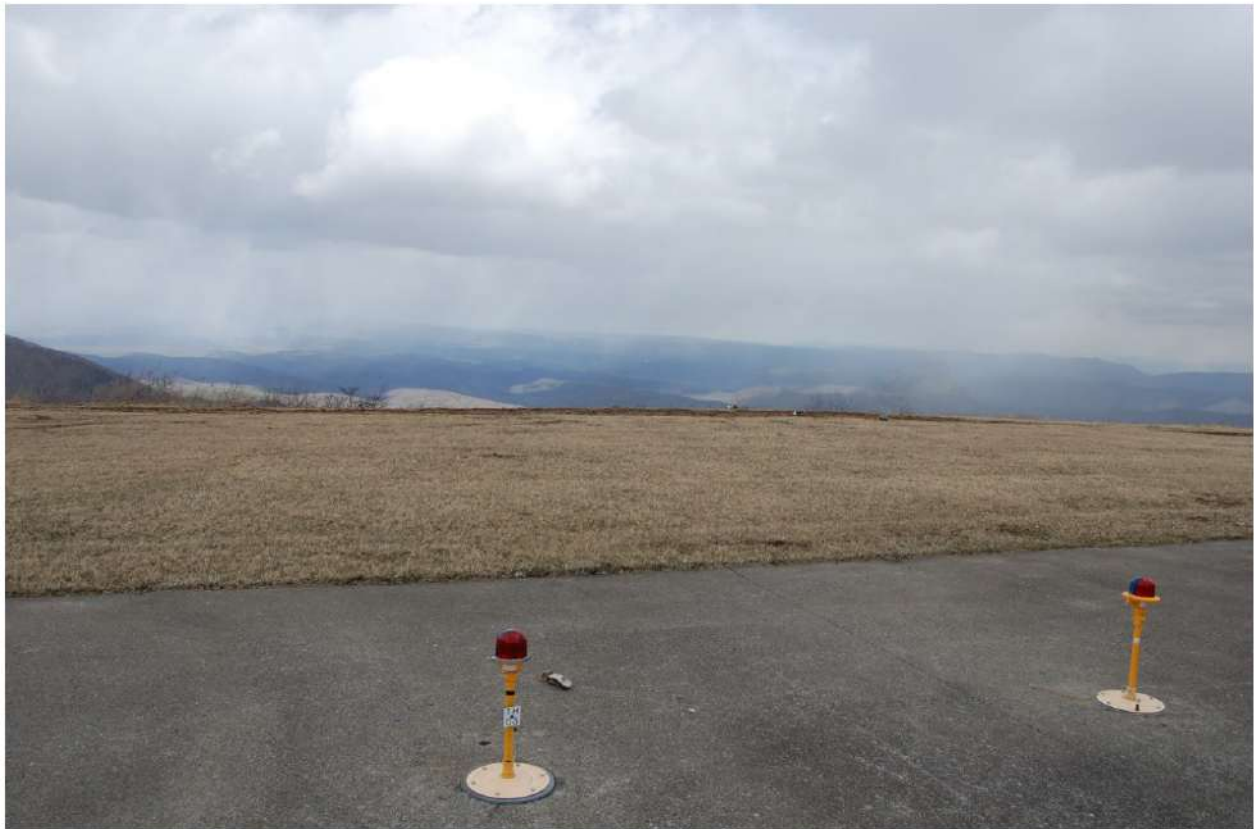
A photograph of the conditions at the touchdown point of runway 25, looking towards the northeast and the accident site, was taken by a first responder about 30 minutes after the accident (figure 3). The image depicted general broken to overcast cloud layers with showers and virga below the clouds over the area, with several of the precipitation shafts reaching the ground and restricting visibility.

Figure 3: Photograph taken by first responder looking northeast from the touchdown point of runway 25 towards the approach path to the runway.

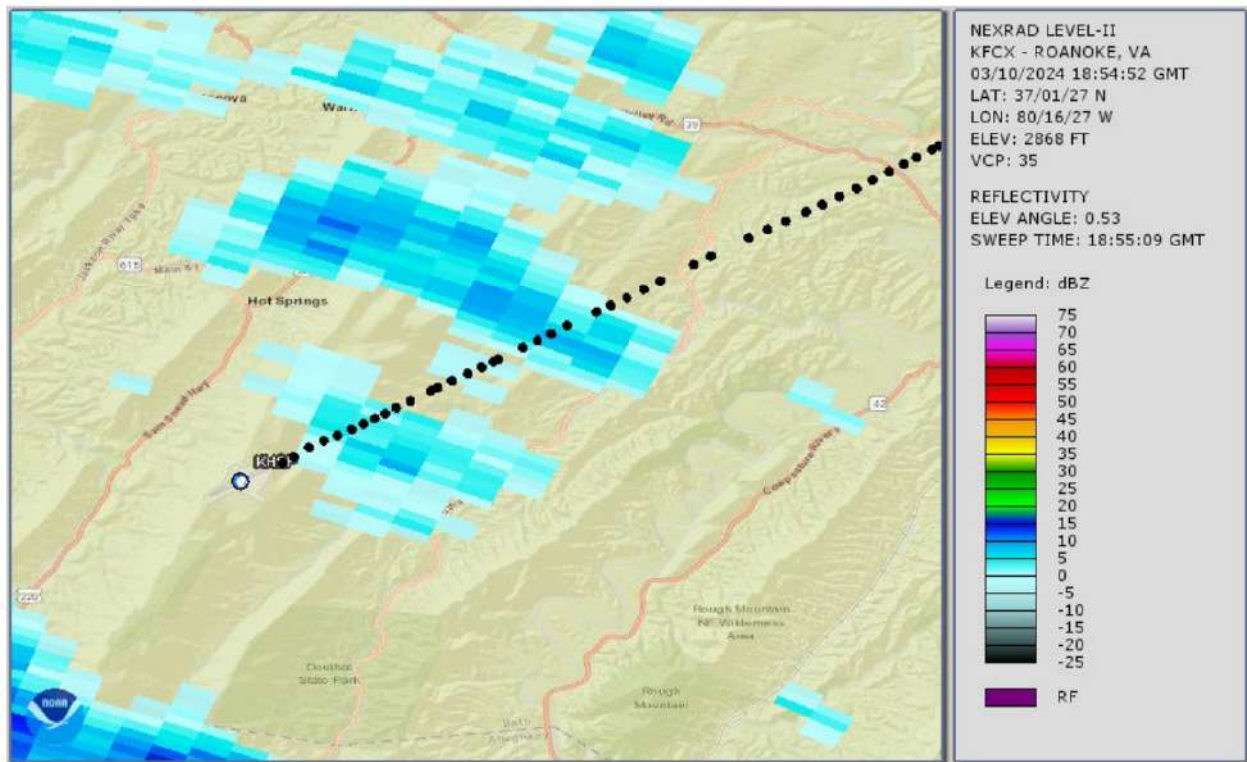
Figure 4 shows a weather surveillance radar base reflectivity image generated at 1454 with the flight track overlaid in black. Several bands of very light intensity echoes extend along the flight path and immediately northeast of the airport. The accident airplane's flight track depicted it flying through two of the bands on approach, with the accident site immediately on the southwestern edge of one of the bands.

Figure 4: Base reflectivity weather radar image for 1454 with the accident airplane's flight track of overlaid.
