# Aviation Investigation Final Report

| <b>Location:</b> | Pierson, Florida | <b>Accident Number:</b> | ERA25FA119 |
| <b>Date &amp; Time:</b> | February 14, 2025, 18:40 Local | <b>Registration:</b> | N40EA |
| <b>Aircraft:</b> | Cessna 208 | <b>Aircraft Damage:</b> | Substantial |

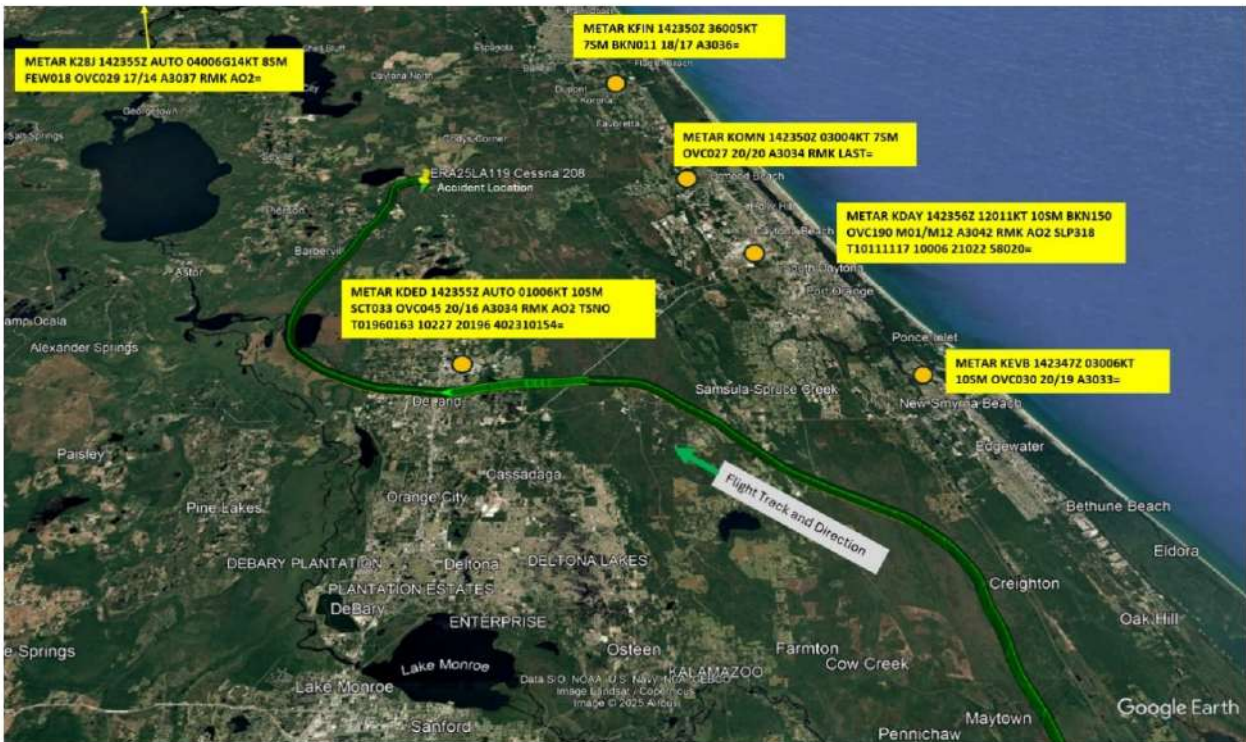
The reported weather along the route of flight and near the accident site consisted of twilight conditions (dusk), with scattered and overcast clouds between 2,700 to 3,300 ft msl and 7 to 10 miles visibility. At the destination airport, there were few clouds reported at 1,800 ft agl. The airplane's flight track and select surface weather observations are shown in figure 1 below.

Figure 1. Flight track data with associated airports and their respective surface weather observations annotated.

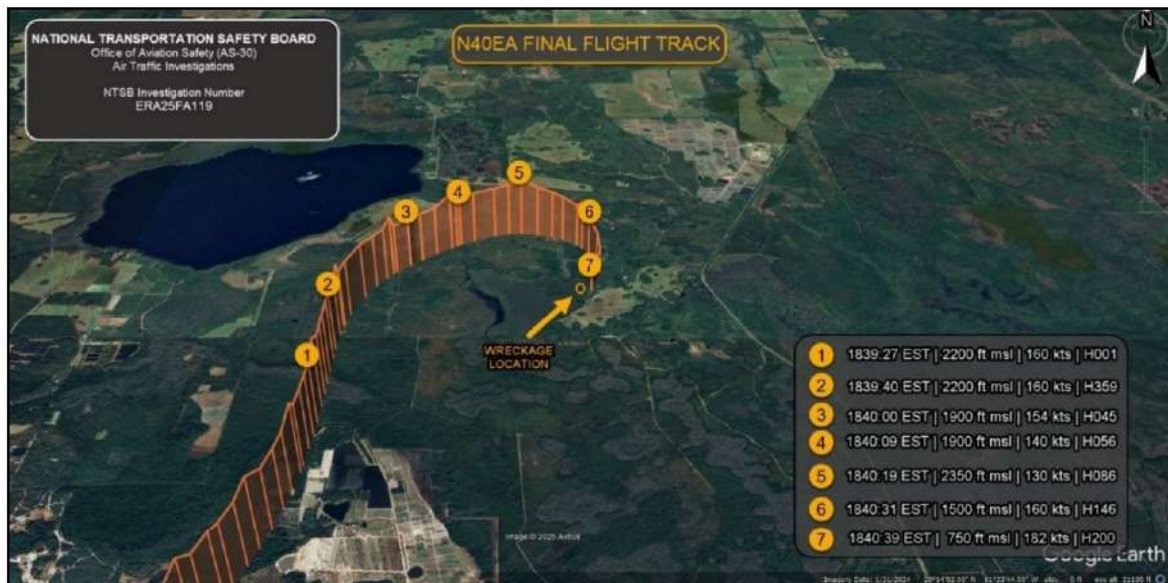
About 5 nm after turning to the 024° track, the airplane began a steady descent, and its vertical speed oscillated between positive and negative values before entering a descending 180° turn to the right (see figure 2). The descent rate increased steadily to greater than 12,000 fpm until the data ended. The final ADS-B target was on a track of 209° at 400 ft msl (about 370 ft agl), at a groundspeed of 182 kts. The area where the final turn occurred was rural with few ground lights or other visual references.

Figure 2. Flight track with altitudes and groundspeeds for final portion of the flight.

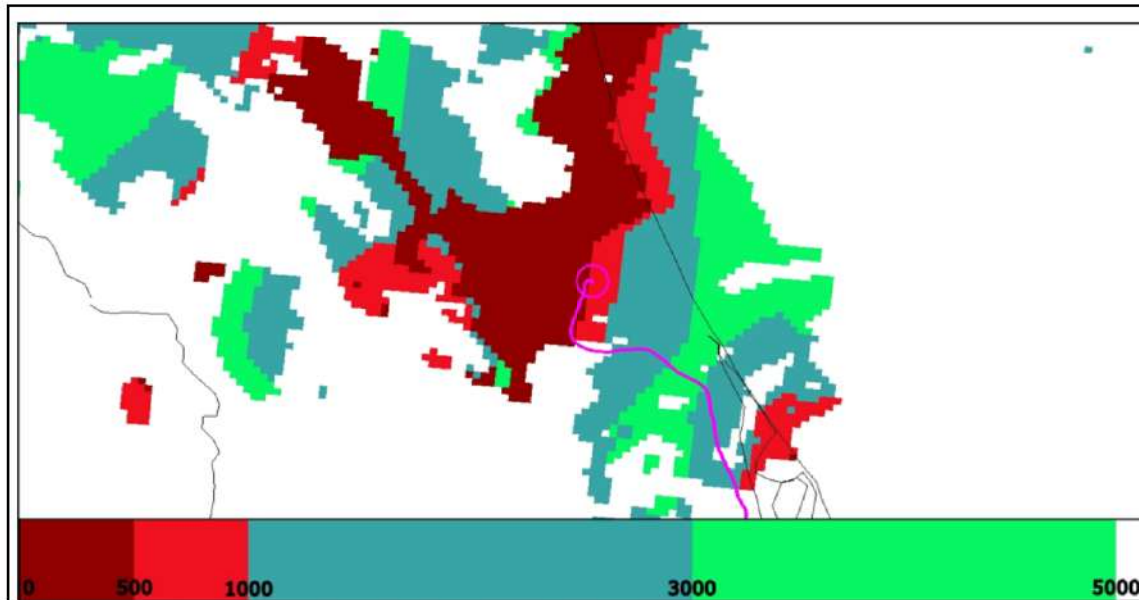
A review of a graphical presentation of the Un-Restricted Mesoscale Analysis (URMA) ceiling product valid for 1900 indicated cloud ceilings of about 550 ft agl in the vicinity of the accident site (see figure 3). A cloud top height forecast product valid at 1900 forecast cloud tops between 6,000 and 9,000 ft msl in the vicinity of the accident site.

Figure 3. URMA ceiling analysis (in feet) valid for 1900. The accident aircraft's flight track is marked by the purple line, and the accident location is within the purple circle.
