Aviation Investigation Final Report

Location:	McKinney, Texas	Accident Number:	CEN24FA240
Date & Time:	June 27, 2024, 10:28 Local	Registration:	N414BS
Aircraft:	Cessna 414A	Aircraft Damage:	Destroyed
Defining Event:	Fuel starvation	Injuries:	2 Fatal, 1 Serious
Flight Conducted Under:	Part 91: General aviation - Personal

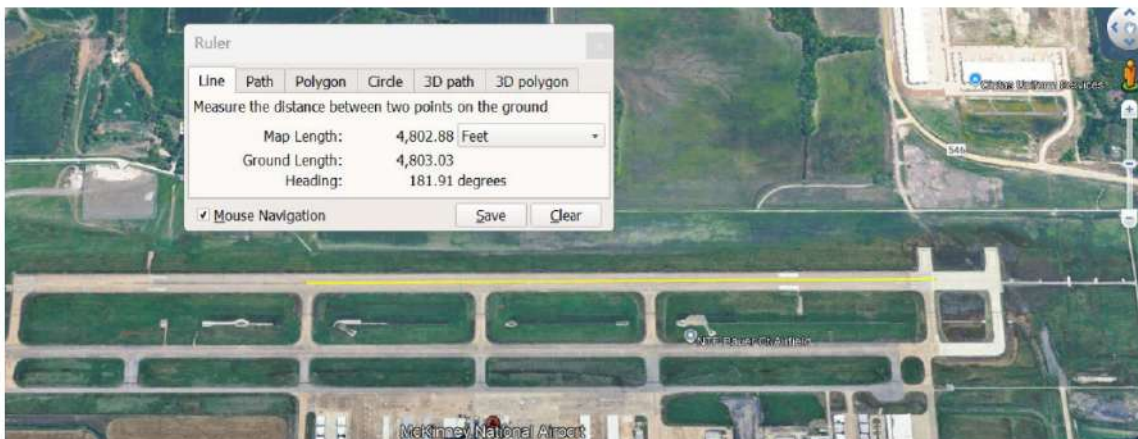
The airplane took off from runway 18 at the McKinney National Airport (TKI), Dallas, Texas. Airport surveillance video showed that the airplane lifted off the runway before the second runway/taxiway intersection, B2, which was about 2,100 ft down the runway. The distance from the B2 taxiway intersection to the end of the runway was about 4,800 ft, excluding the hard surface beyond the runway departure end, as shown in Figure 1.

Figure 1. Runway remaining distance from B2.
