Aviation Investigation Final Report

Location:	Aguadilla, Puerto Rico	Accident Number:	ERA24FA301
Date & Time:	July 11, 2024, 09:23 Local	Registration:	N4167G
Aircraft:	Cessna 402B	Aircraft Damage:	Destroyed
Defining Event:	Loss of engine power (partial)	Injuries:	1 Fatal, 1 Minor
Flight Conducted Under:	Part 91: General aviation - Personal

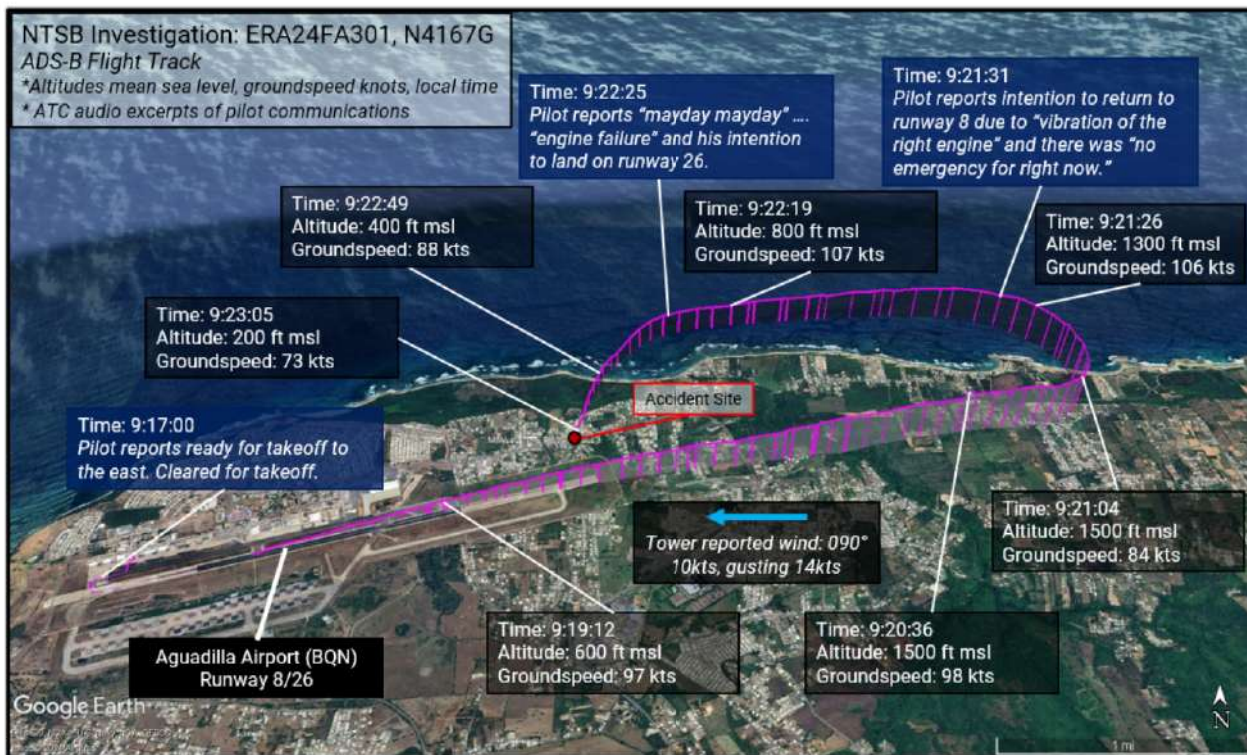
FAA ADS-B data showed that the airplane departed runway 8 and climbed to about 1,500 ft mean sea level (msl) about 2 miles east of the approach end of runway 8. The airplane then made a turn to the left and began a descent. When the airplane reached about one mile northeast of the airport, the track turned directly toward the approach end of runway 26. In the final 30 seconds of track data, the altitude and groundspeed continued to decrease rapidly.

The final track data point showed the airplane about .3 miles northeast of the runway 26 threshold at 200 ft msl and 73 knots groundspeed, on a heading of 209°.

Review of FAA air traffic control (ATC) ground and tower communications found that about 0914 the pilot requested a visual flight rules (VFR) departure to the east and about 3 minutes later was cleared for takeoff from runway 8. At 0921:31, the pilot called the tower and stated, “yeah going back to runway 8 I just wanna check the uh vibration on the right engine uh uh no emergency for right now for 1 6 7 gulf” (see figure). The controller immediately cleared the pilot to enter the left downwind for runway 8 and provided him with the current weather and airport information. At 0922:25, the pilot stated “aguadilla ground mayday mayday I engine failure I will use the other side of the runway for 1 6 7 gulf.” The controller immediately cleared the pilot to land on runway 26 and provided him the current wind information of 090° at 10 kts, gusting to 14 kts. The pilot read back cleared to land and there were no further communications.

Figure: Overview of the airplane's flight path and excerpts of the pilot's communication with the ATC tower
