Aviation Investigation Report AIR-26-02

Midair Collision over the Potomac River PSA Airlines Flight 5342, Mitsubishi Heavy Industries (MHI) RJ Aviation CL-600-2C10 (CRJ700), and US Army Priority Air Transport Flight 25, Sikorsky UH-60L

Washington, DC
January 29, 2025

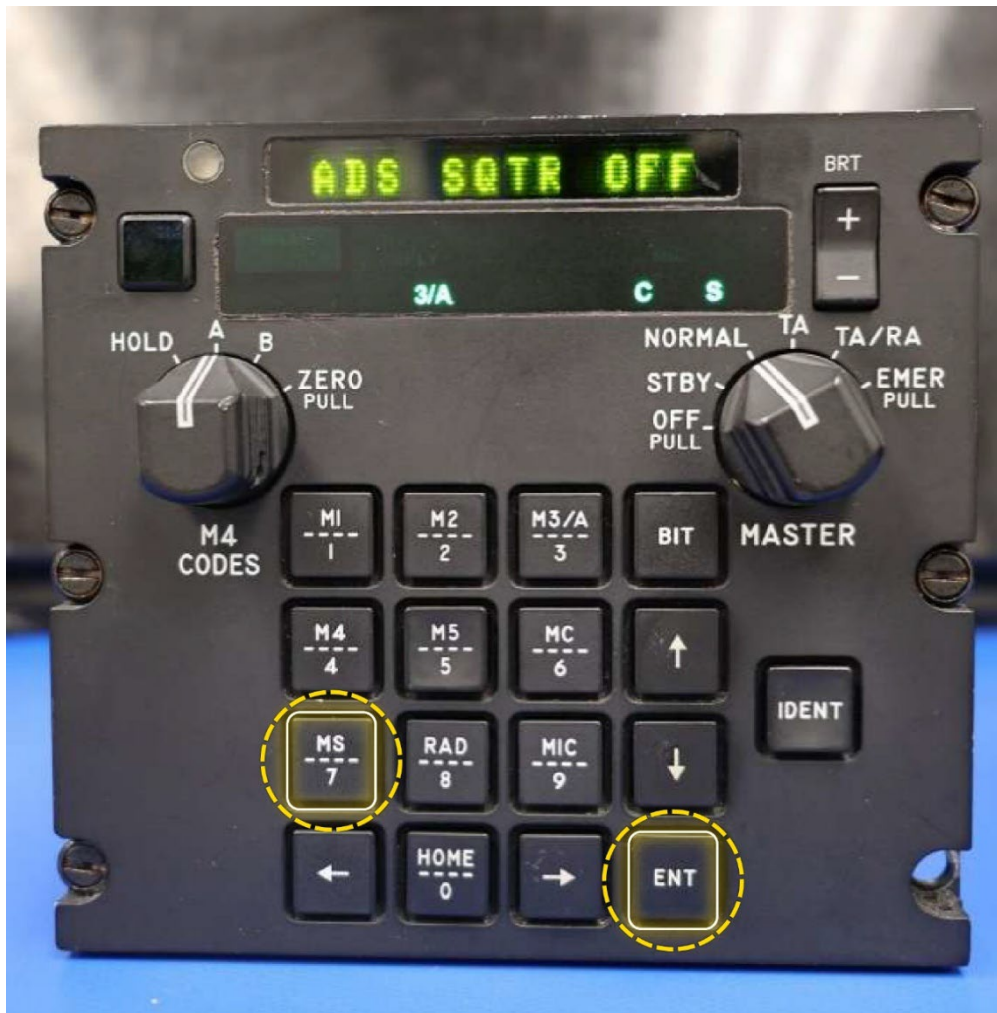
Figure 5. A UH-60L transponder with the ADS-B squitter turned off. (Source: BAE Systems)

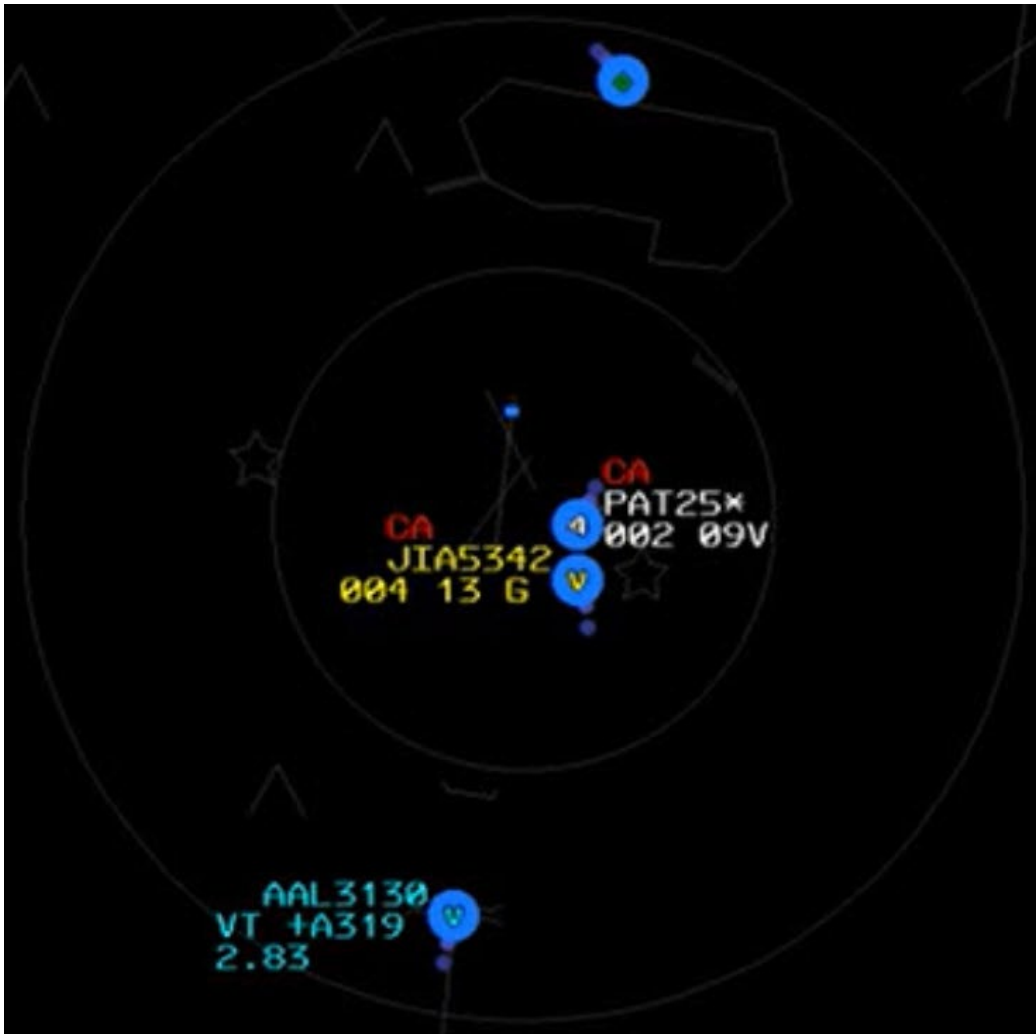
Figure 24. Photo of a CTRD screen showing the active conflict alert between PAT25 and flight 5342 (shown as JIA5342). The conflict alert activated at 2047:33 (about 26 seconds before the collision).

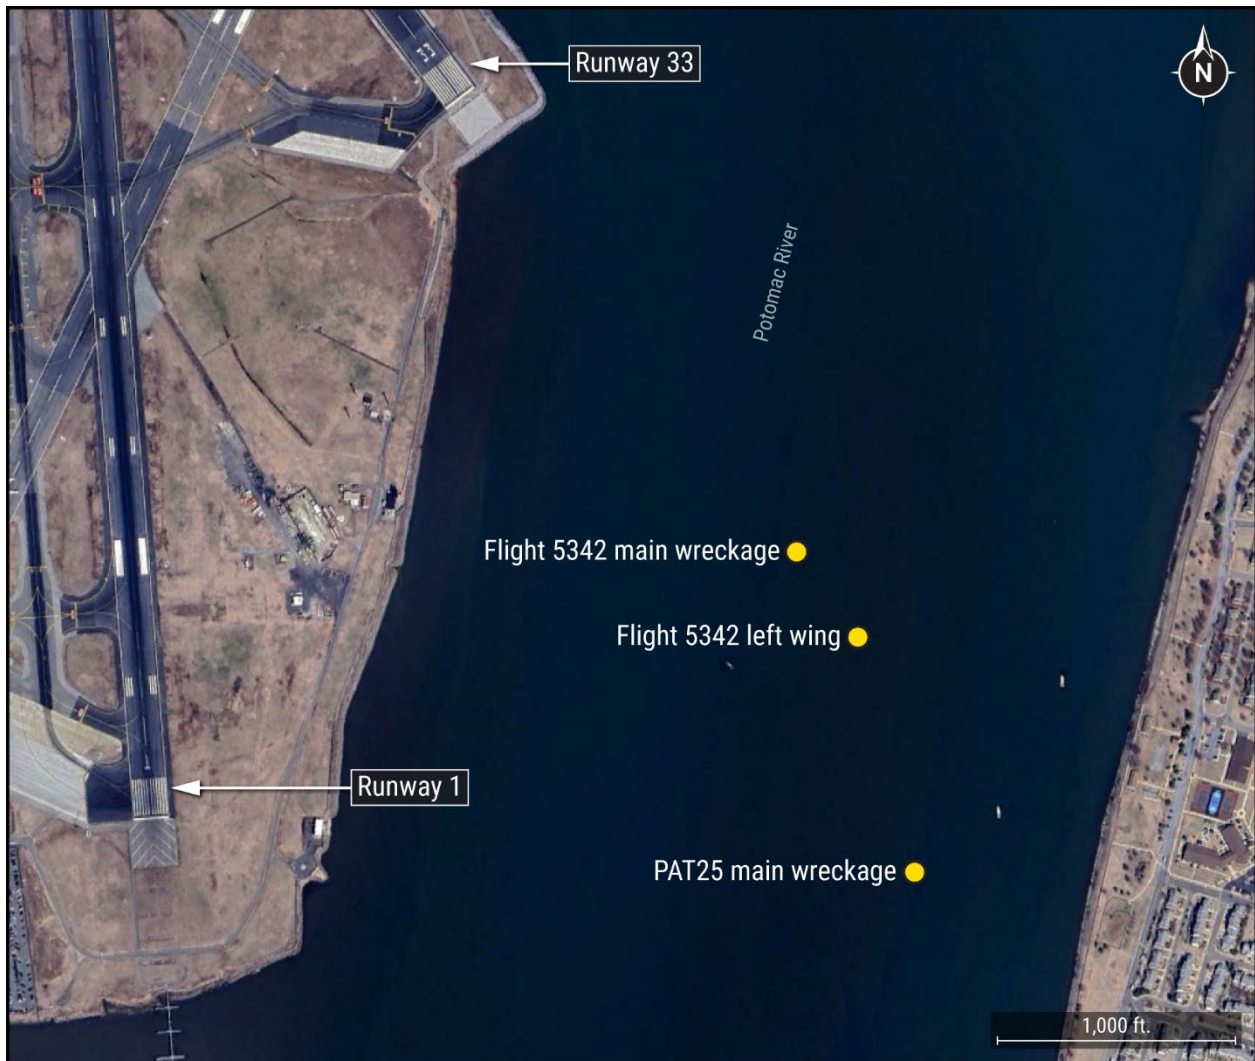
Figure 26. Diagram of main wreckage locations in the Potomac River.

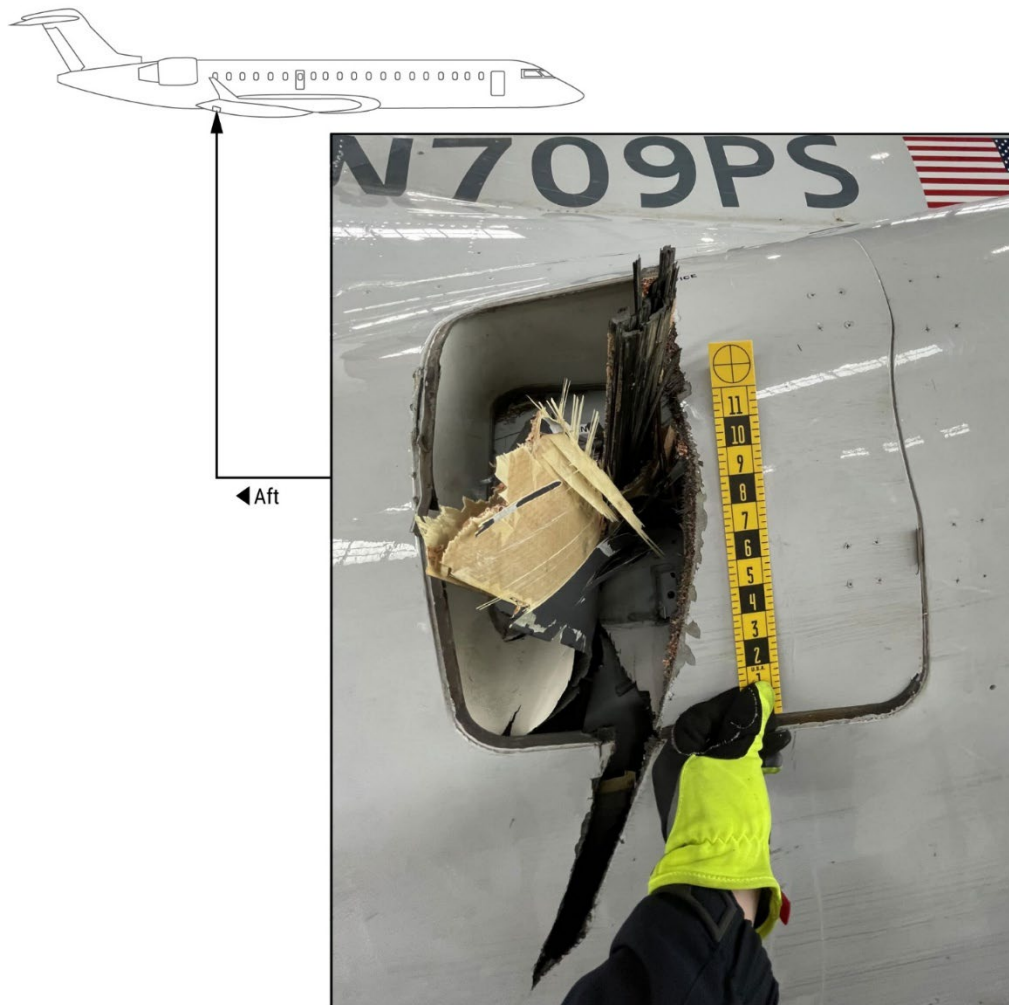
Figure 27. Aft fuselage of airplane embedded with a helicopter tail rotor blade.

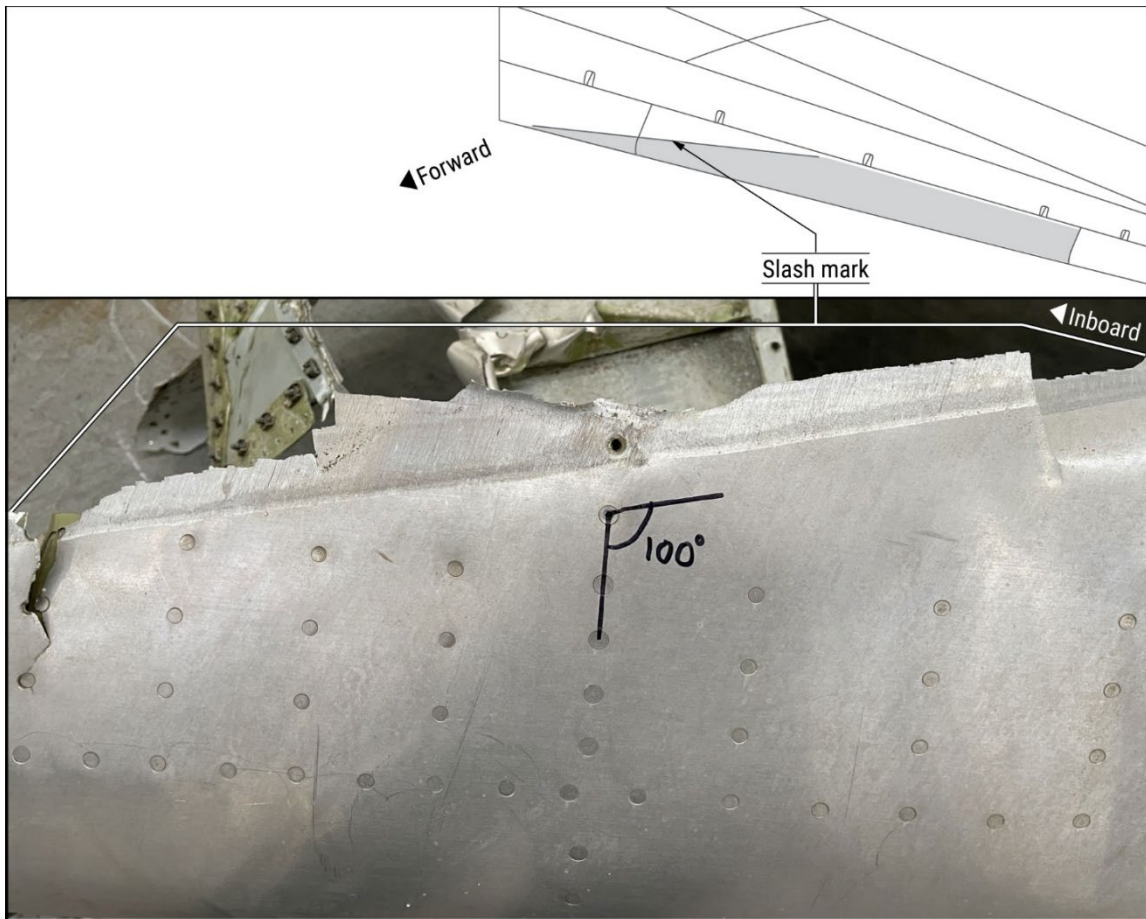
Figure 28. View of slash mark displayed on the airplane's left wing center leading edge slat.

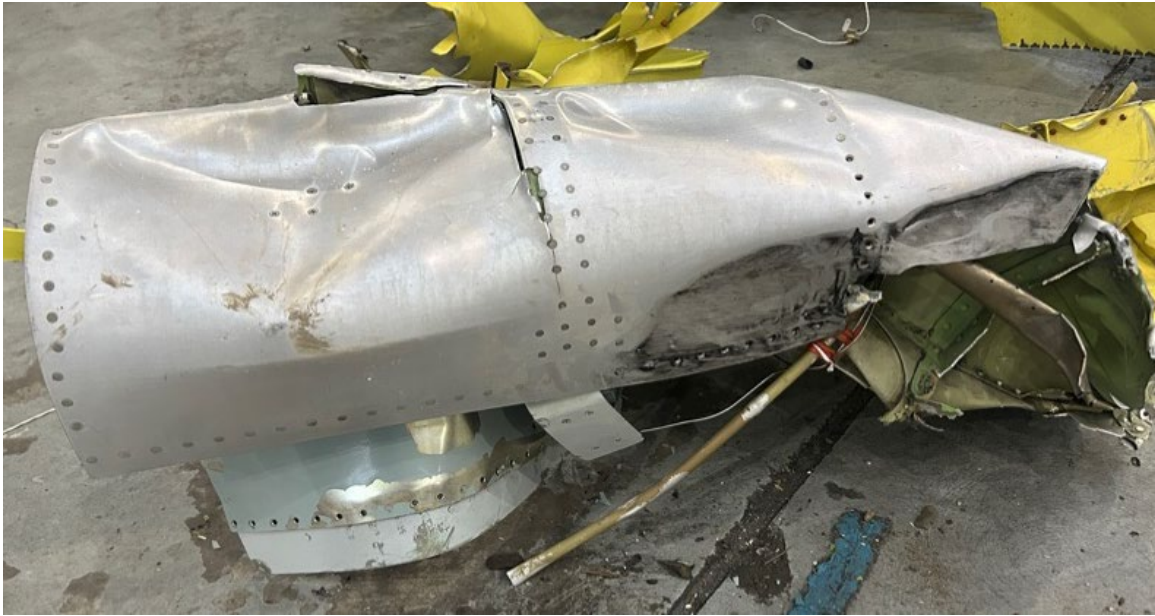
Figure 29. Wide view of impact mark on the airplane's left wing inboard leading edge slat.

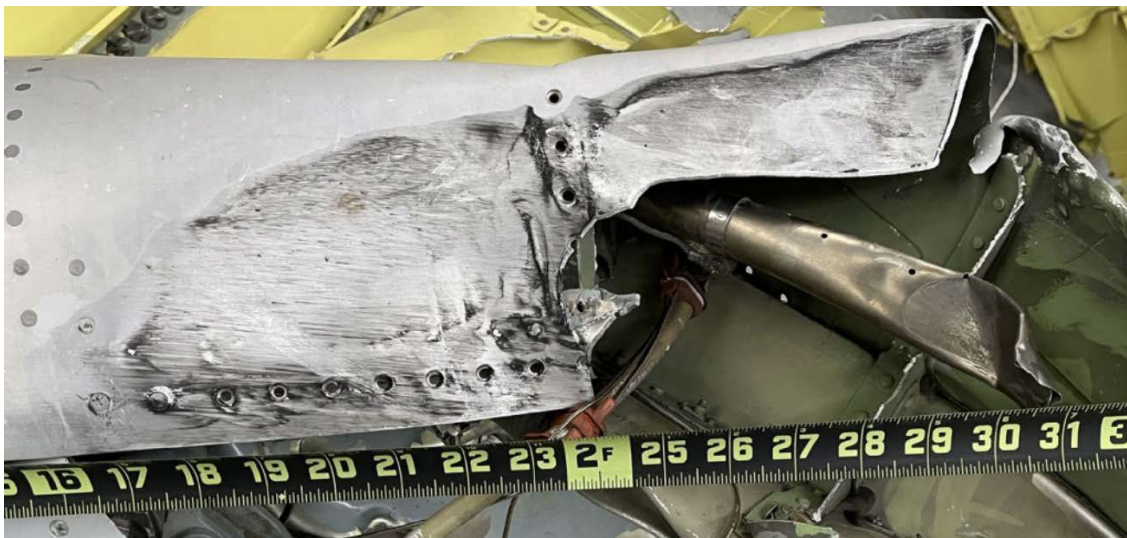
Figure 30. Close-up view of impact mark on the airplane's left wing inboard leading edge slat.

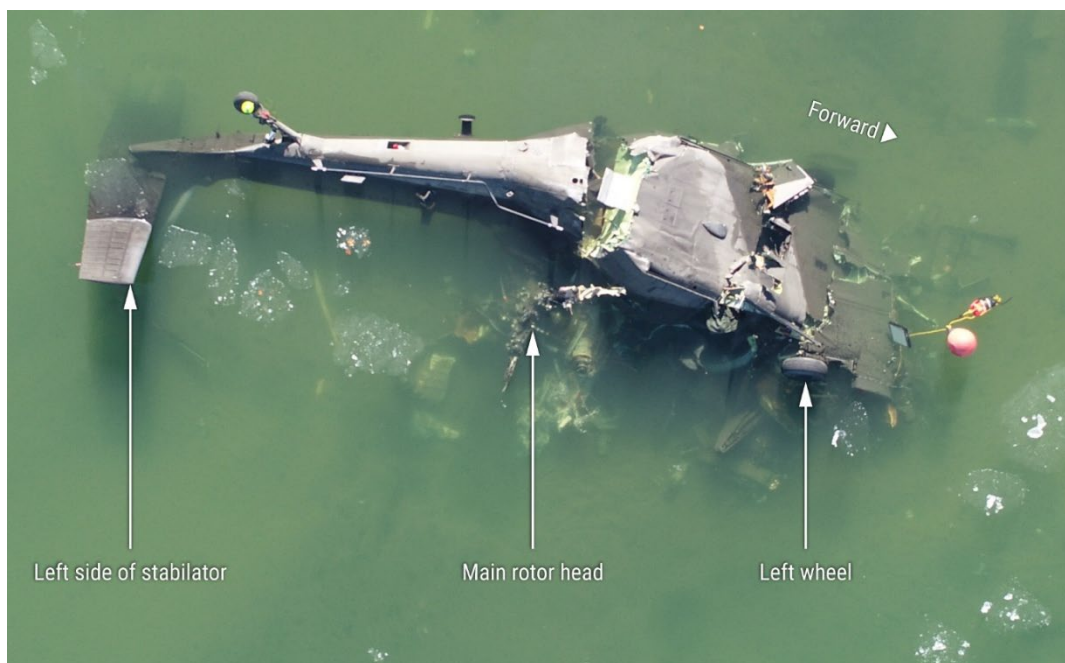
Figure 31. Helicopter main wreckage as it came to rest in the Potomac River.

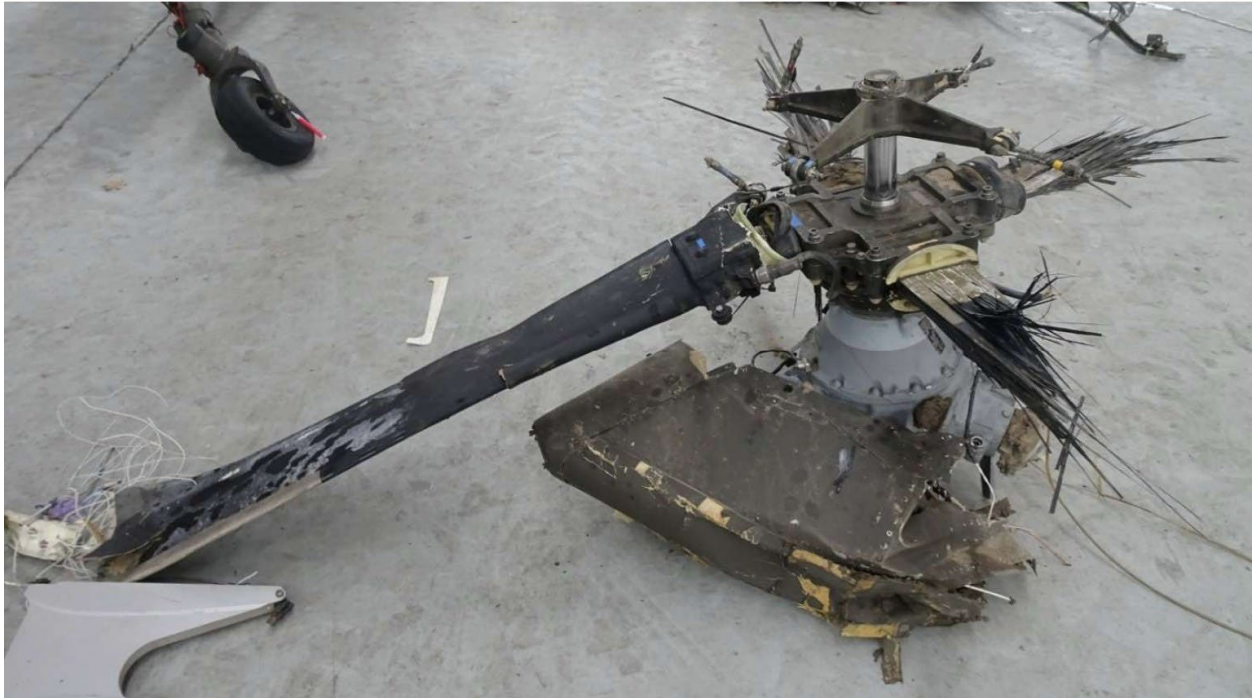
Figure 32. The helicopter's tail rotor as recovered, attached to the tail rotor gearbox.

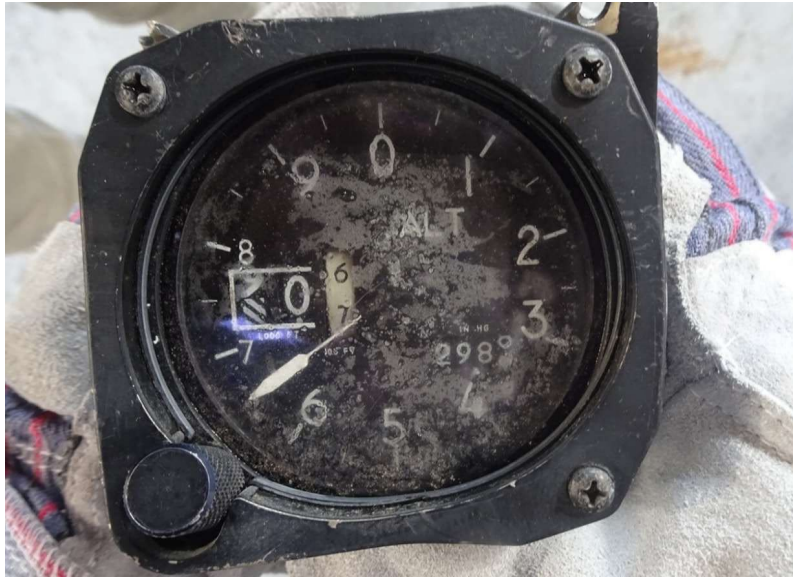
Figure 33. The left (pilot's seat) barometric altimeter.

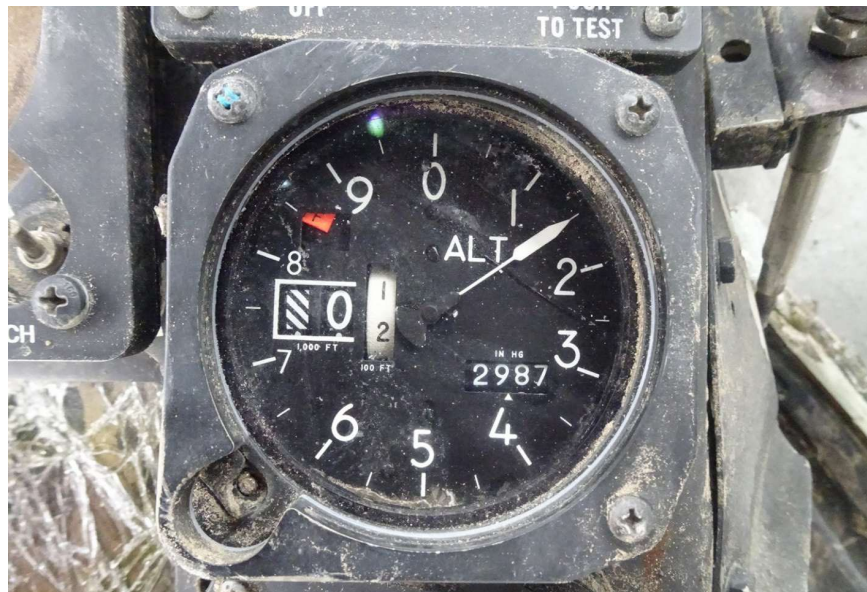
Figure 34. The right (IP's seat) barometric altimeter.
