Aviation Investigation Final Report

Location:	Naples, Florida	Accident Number:	ERA24FA110
Date & Time:	February 9, 2024, 15:11 Local	Registration:	N823KD
Aircraft:	BOMBARDIER INC CL-600-2B16	Aircraft Damage:	Destroyed
Defining Event:	Powerplant sys/comp malf/fail	Injuries:	2 Fatal, 4 Minor
Flight Conducted Under:	Part 135: Air taxi & commuter - Non-scheduled

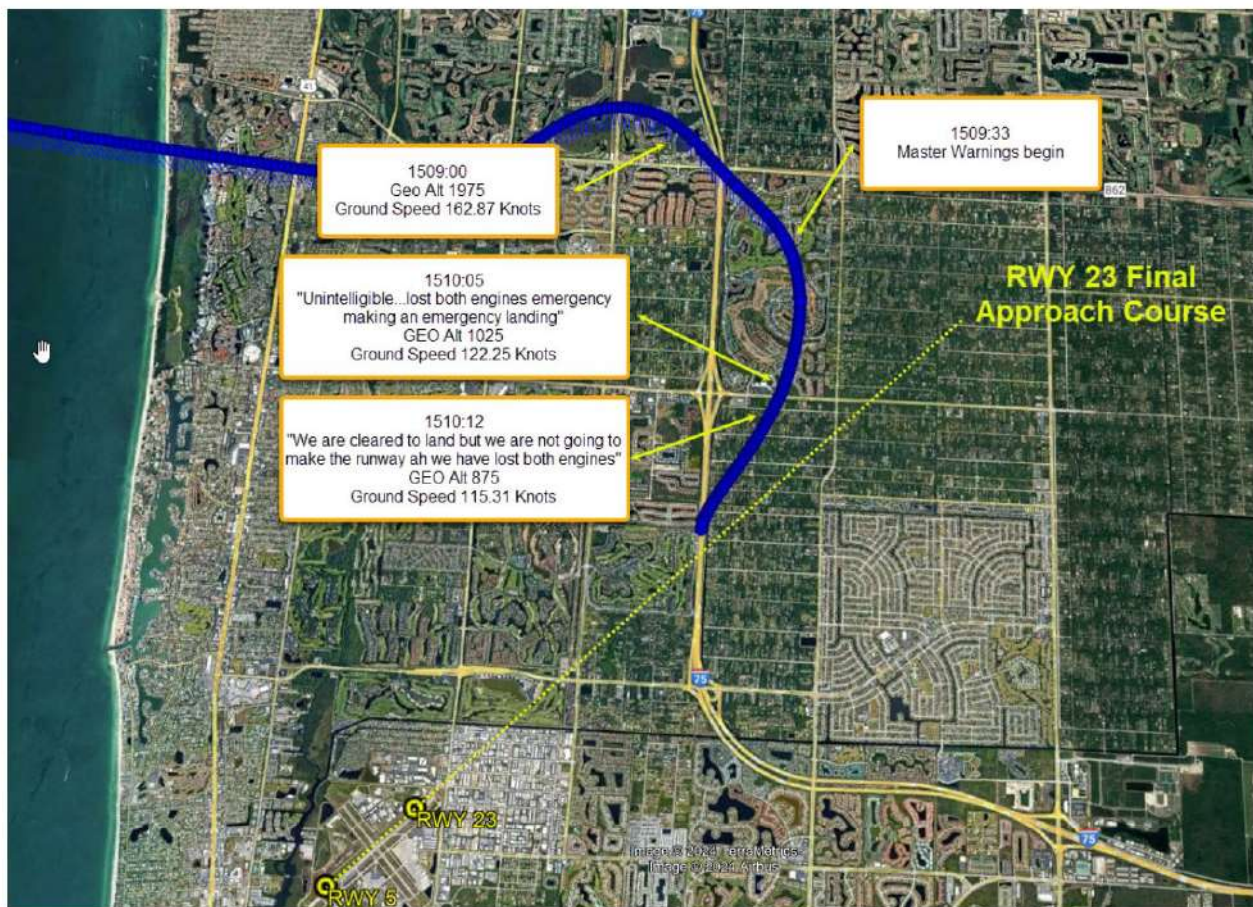
Twenty-three seconds later, at 1510:03, about 1,000 ft pressure altitude and 122 kts, on a shallow intercept angle for the final approach course, the crew announced, "...lost both engines... emergency... making an emergency landing" (see figure 1). The tower controller acknowledged the transmission and cleared the airplane to land. At 1510:12, about 900 ft and 115 kts, the crew replied, "eh we're clear to land but we're not gonna make the runway uh we've lost both engines."

Figure 1. ADS-B ground track (blue dots) with annotations of specific events during the approach, including time and the airplane's geometric altitude and ground speed (source: FAA).

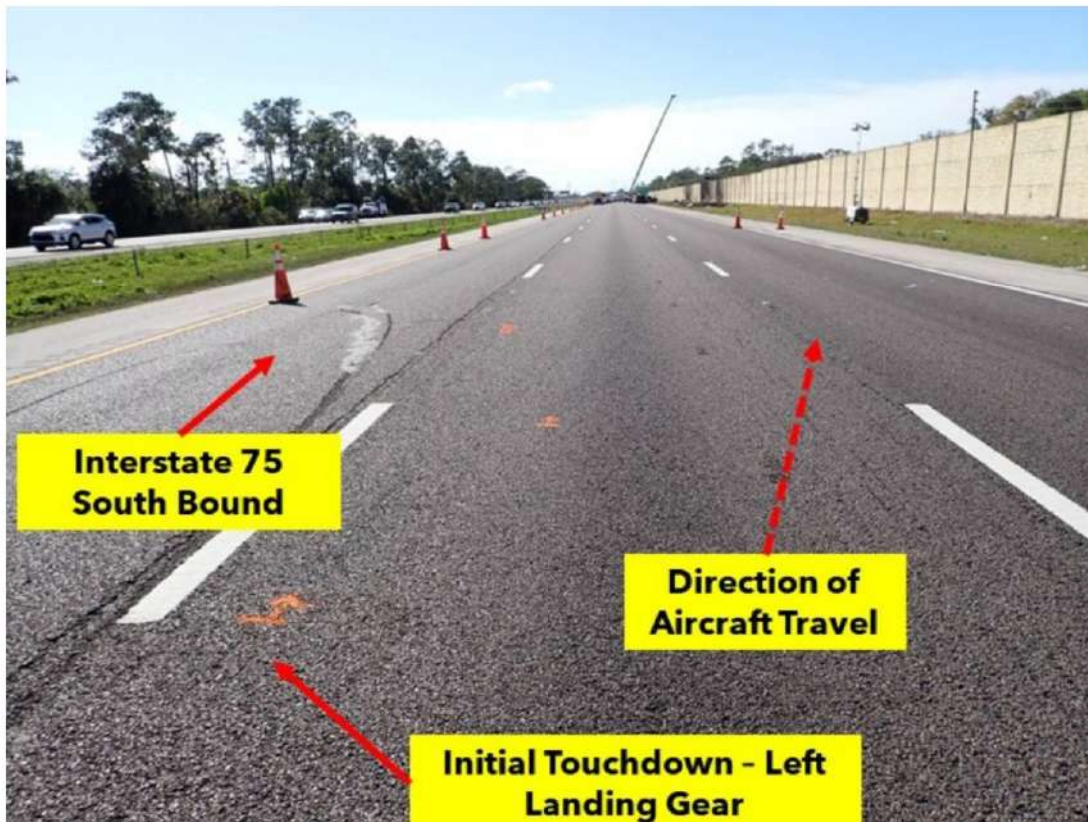
Examination of the accident site revealed tire marks on the southbound lanes of Interstate 75 consistent with the left main landing gear (see figure 2). The airplane came to rest about 1,000 ft past the initial touchdown point, upright in the grass area between the breakdown lane and the sound barrier wall and facing north, opposite the direction of travel.

Figure 2. Initial touchdown point on Interstate 75.

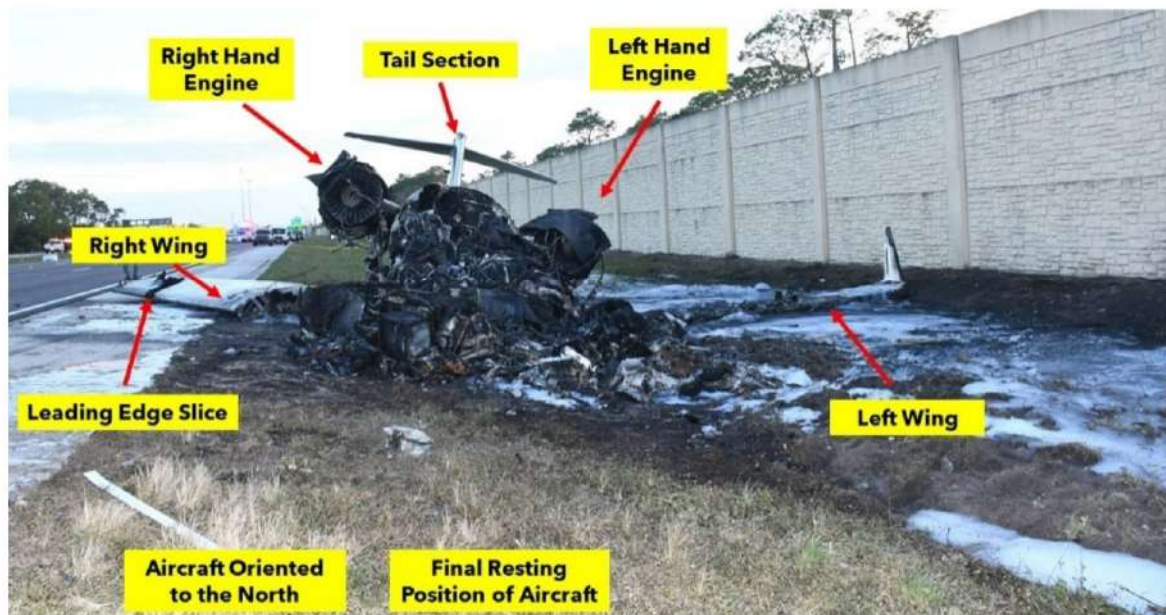
The forward portion of the fuselage was consumed by postimpact fire (see figure 3). All major components of the airplane were accounted for at the scene, and the ground surrounding the wreckage was fuel-soaked, having an odor consistent with Jet A fuel. The cockpit center console was found separated from the main wreckage. Both engine thrust levers were found near the IDLE stop position. The flap selector handle was found in a position consistent with 45° flap extension.

Figure 3. Main wreckage as found.
