Fuel starvation and collision with terrain involving Britten-Norman Islander BN2A-20, YJ-AT2

6 km east-south-east of Port Vila International Airport, Vanuatu on 15 July 2024

Aviation Occurrence Investigation

AA-2024-008 (CAAV investigation number: 136272/AIG/A2.5)

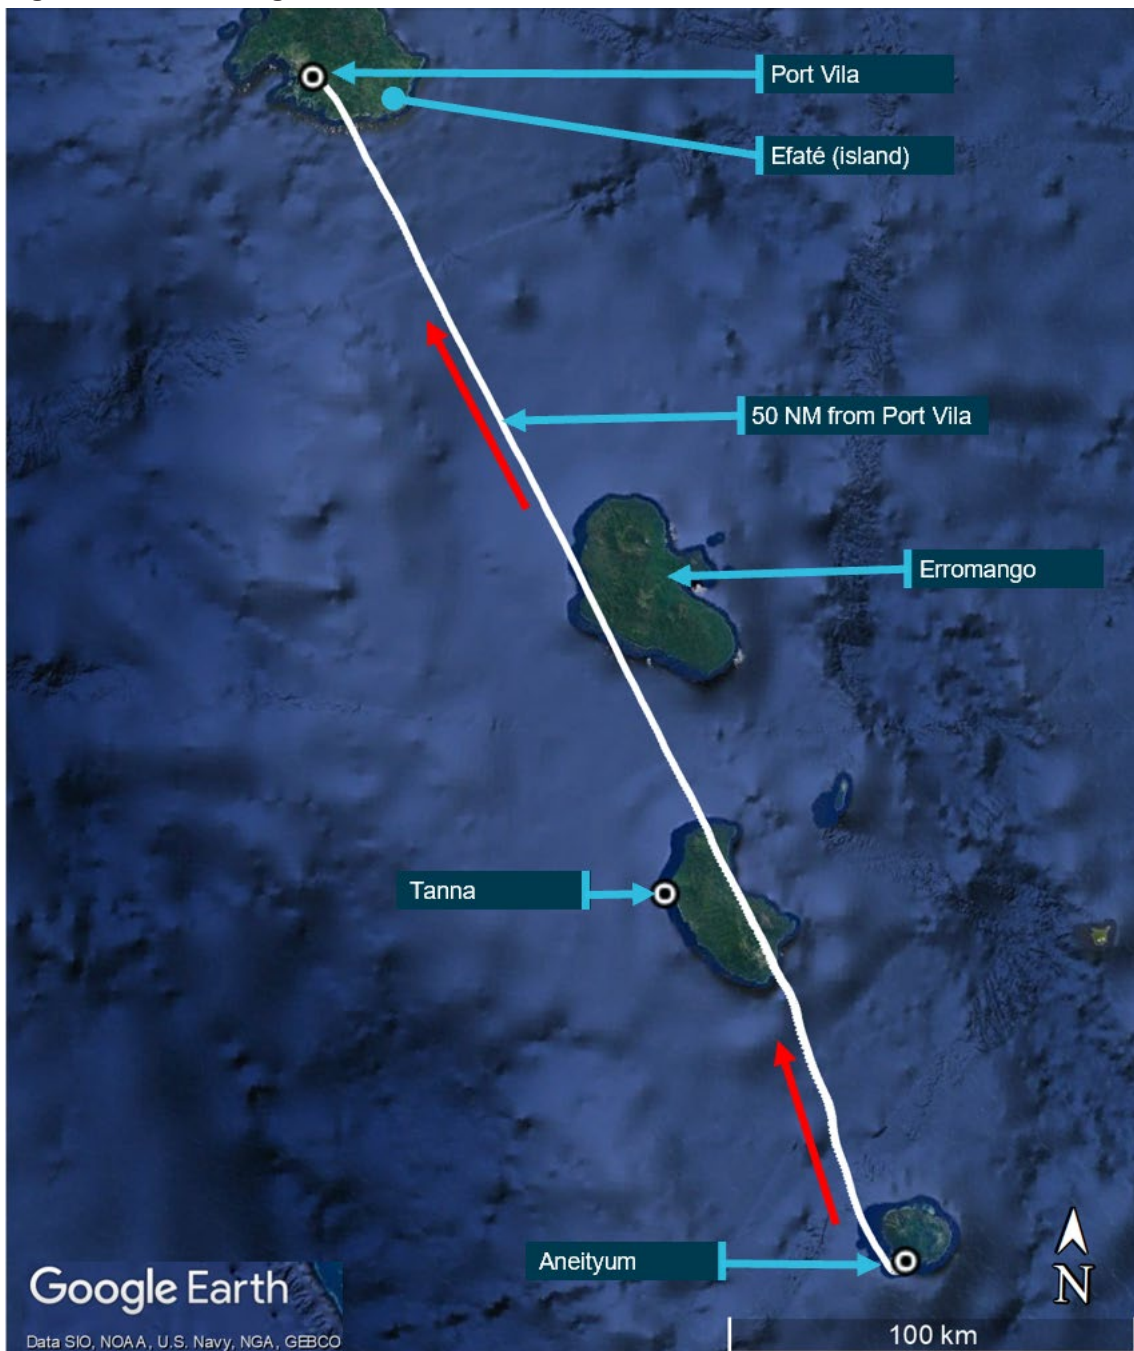
Figure 2: Accident flight GPS track

The pilot commenced descending about 46 km from Port Vila. At about 1546, the pilot contacted Vila Tower air traffic control (ATC) and advised they:

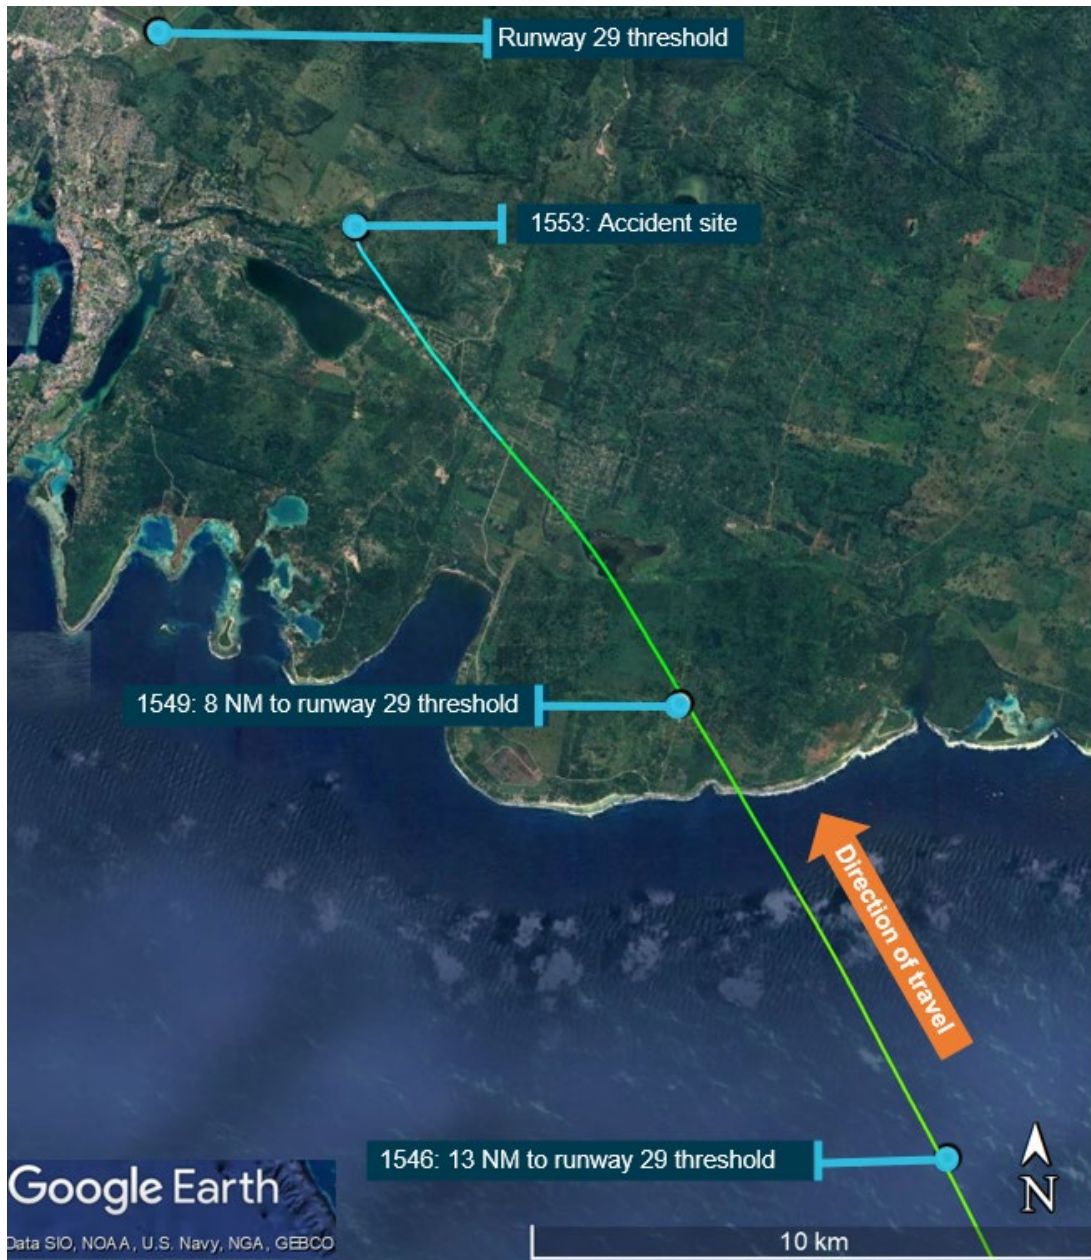
Figure 3: Aircraft's recorded ADS-B track from 1545 to 1553

During that radio transmission, engine surging was audible in the last 2 seconds of the transmission. In response, the controller alerted the Aviation Rescue and Fire Fighting Services (ARFFS) to standby. The pilot reported that, as the aircraft descended towards Port Vila, the right engine surged, ran roughly and then stopped producing power.

At about 1549, the pilot advised ATC that they were 8 NM from the field at an altitude of 4,000 ft, and the controller responded with a clearance to land on runway 29. Audio analysis indicated that no engines were operating at that time, although the pilot reported that, shortly after that transmission, the left engine surged and then stopped.

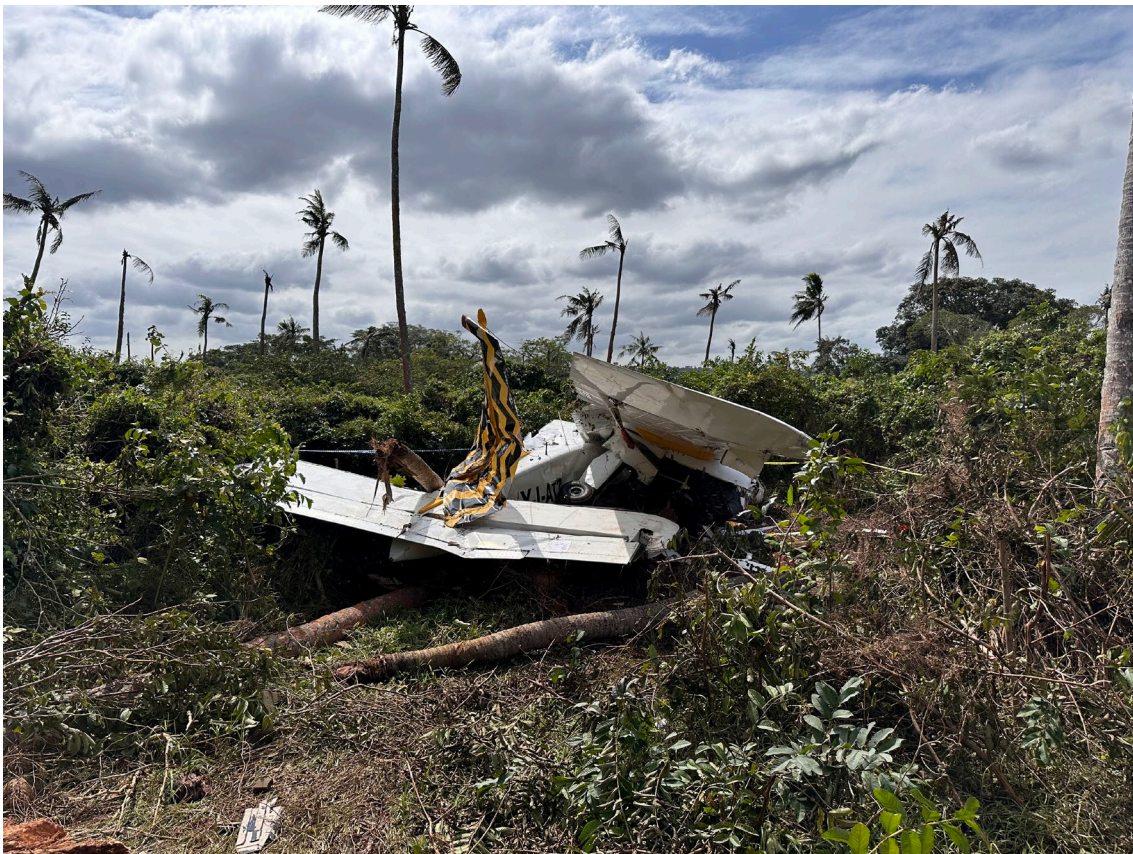
Figure 4: Accident site

One passenger was fatally injured during the accident sequence, with 2 passengers sustaining serious injuries. The pilot and one passenger sustained minor injuries and the aircraft was destroyed.

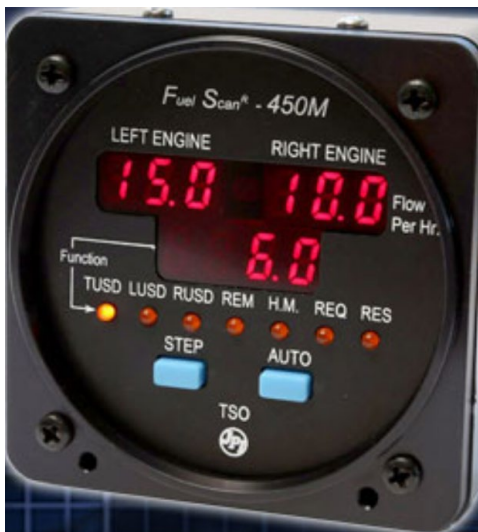
Figure 5: Fuel Scan instrument

The pilot reported monitoring the fuel flow displayed on the instrument, but not inputting any fuel figures, and therefore not using the functionality of constant fuel state indication or low fuel/time warnings.

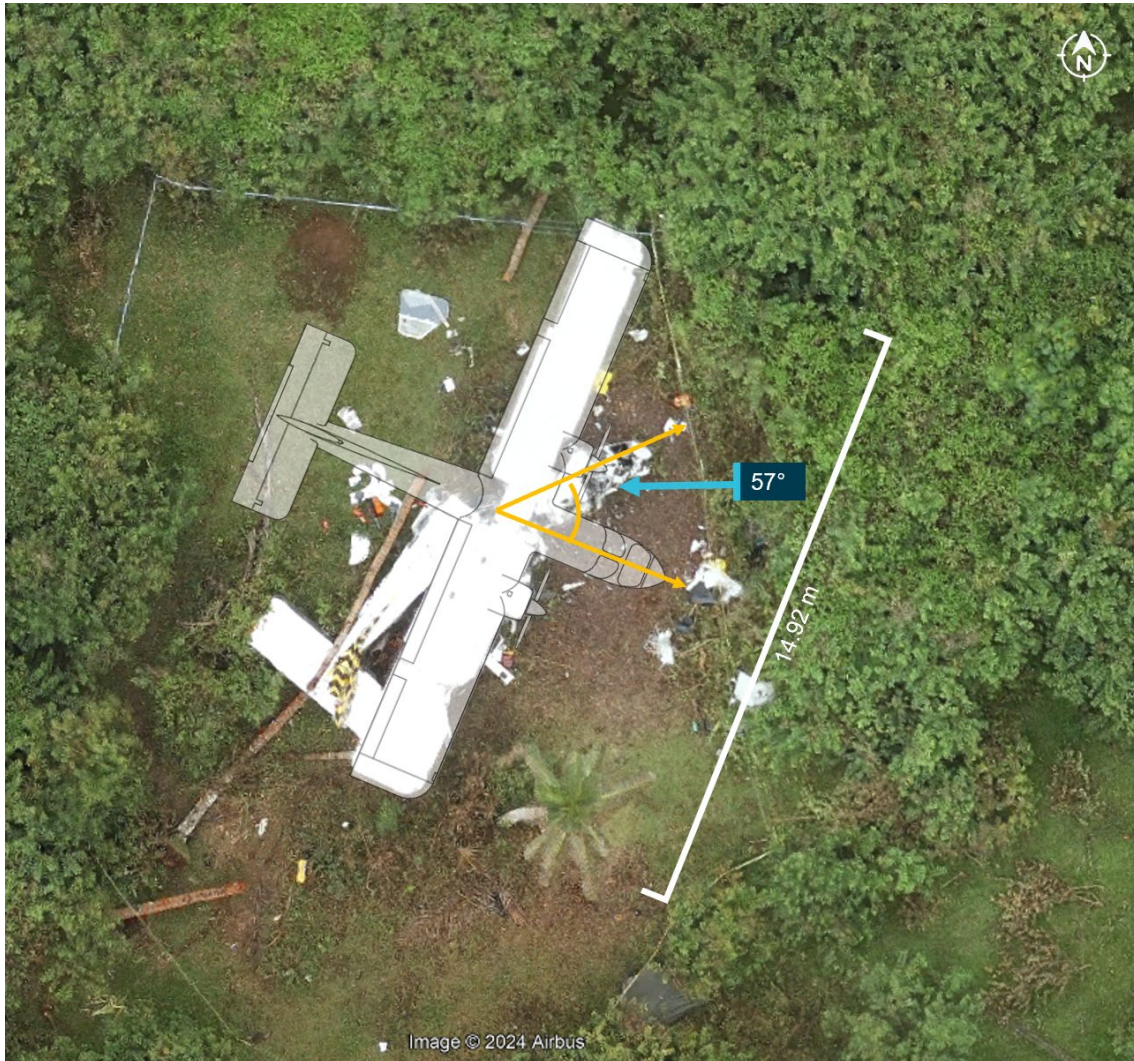
Figure 8: Accident site showing position of YJ-AT2 and rotation of fuselage about wings

The accident site was in a coconut and guava plantation about 5 km south-east of the runway 29 threshold. The aircraft's nose was facing north-east, and the wings had rotated clockwise 57° about their fuselage attachment point (Figure 8). Other than a few small fragments, the entire aircraft was contained within a 7.5 m radius.

The aircraft struck 2 coconut trees, the first at about 6.8 m and the second about 6 m above ground level. The first trunk struck the nose and right side of the fuselage, and the second tree trunk impacted the right wing just inboard of the wingtip. The aircraft contacted the ground nose-first and left wing-down, about 21 m beyond the first tree strike and about 12 m beyond the second.

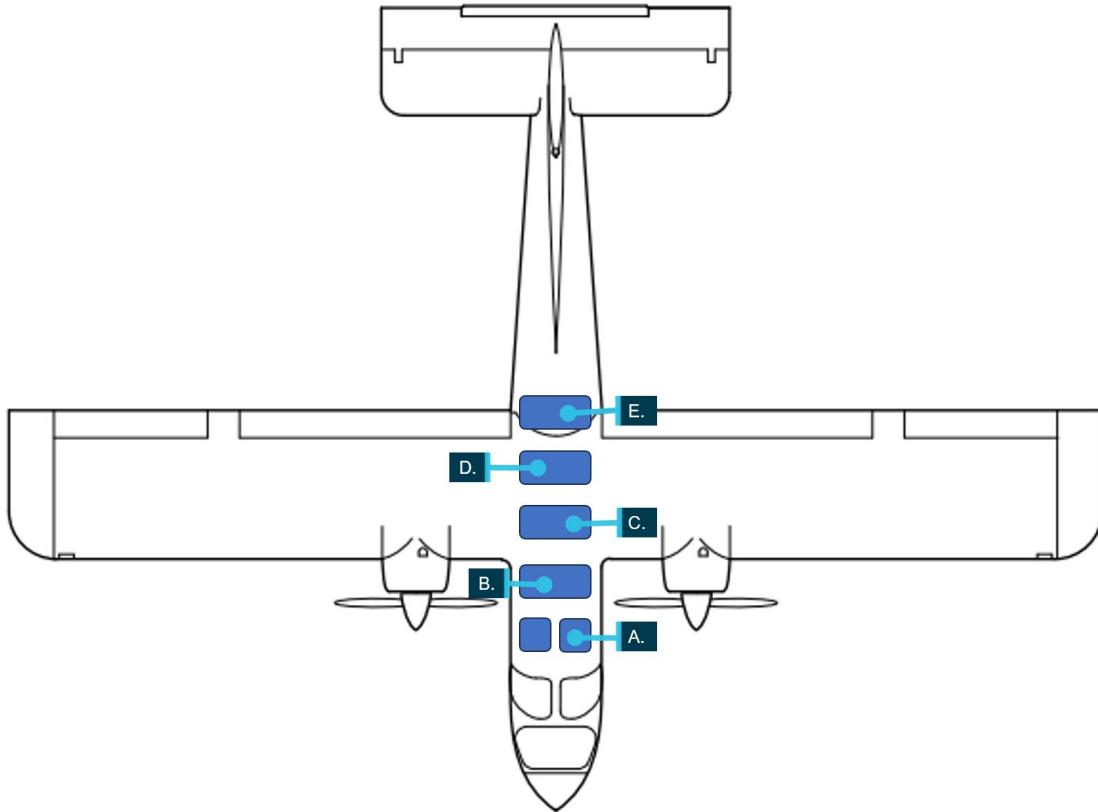
Figure 11: Seating positions

The pilot wore a 4-point restraint and the 4 passengers each wore a lap belt, with seating positions depicted in Figure 11 and injury information detailed in Table 11. Injury information was obtained from interviews, witnesses and CAAV, however, no medical records were provided to the investigation to detail or confirm the injuries. The injury mechanisms included deceleration, flail and impact with the aircraft.
