AIRCRAFT ACCIDENT REPORT AND EXECUTIVE SUMMARY

Reference:	CA18/2/3/8559	
Aircraft Registration	ZS-OSD	Date of Accident	05 October 2008		Time of Accident	1338Z
Type of Aircraft	Brittan-Norman Islander		Type of Operation	Private		
Pilot-in-command Licence Type		Commercial	Age	21	Licence Valid	Yes
Pilot-in-command Flying Experience		Total Flying Hours	275.7		Hours on Type	9.6
Last point of departure		Kruger Mpumalanga International Airport (FAKN)				
Next point of intended landing		New Tempe aerodrome (FATP)				
Location of the accident site with reference to easily defined geographical points (GPS readings if possible)						
Tree plantation near Barberton, Mpumalanga Province.GPS position S25°40.739 E30° 44.907						
Meteorological Information		Adverse weather conditions prevailed in the area				
Number of people on board	1+8	No. of people injured	0	No. of people killed	9	
Synopsis						
<p>The pilot, accompanied by eight passengers, departed from Kruger Mpumalanga International Airport (FAKN) on a visual flight rules (VFR) flight to New Tempe aerodrome (FATP).</p> <p>Approximately 20 minutes after departure from FAKN, a witness observed the aircraft flying at a height of approximat

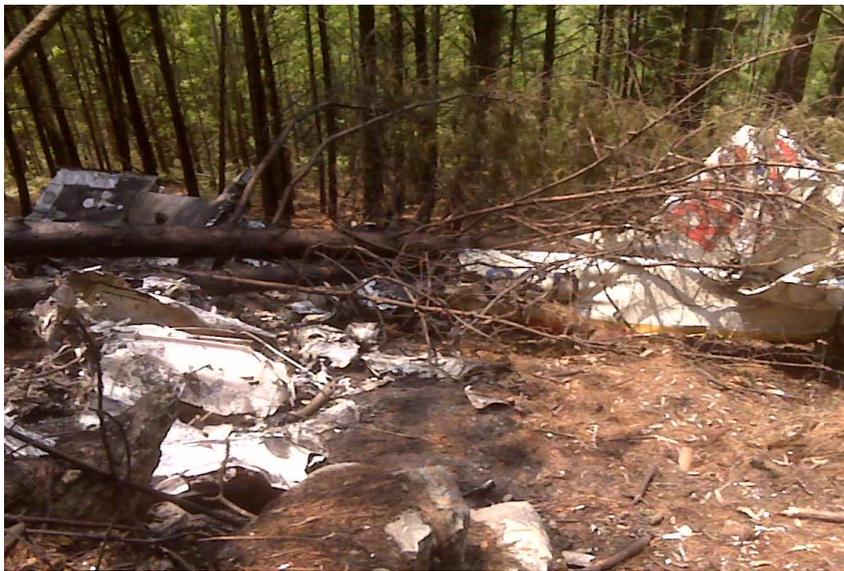
1.3.1 The wings had separated from the fuselage on impact with the trees in the pine tree plantation. A post-impact fire had erupted. The main wreckage, with the exception of the tail section, was destroyed by the ensuing fire. The engines were also damaged by the post-impact fire, but remained intact.

Photo 1: Showing the main wreckage.

3.1.8 The aircraft was destroyed by impact forces and a post-impact fire.

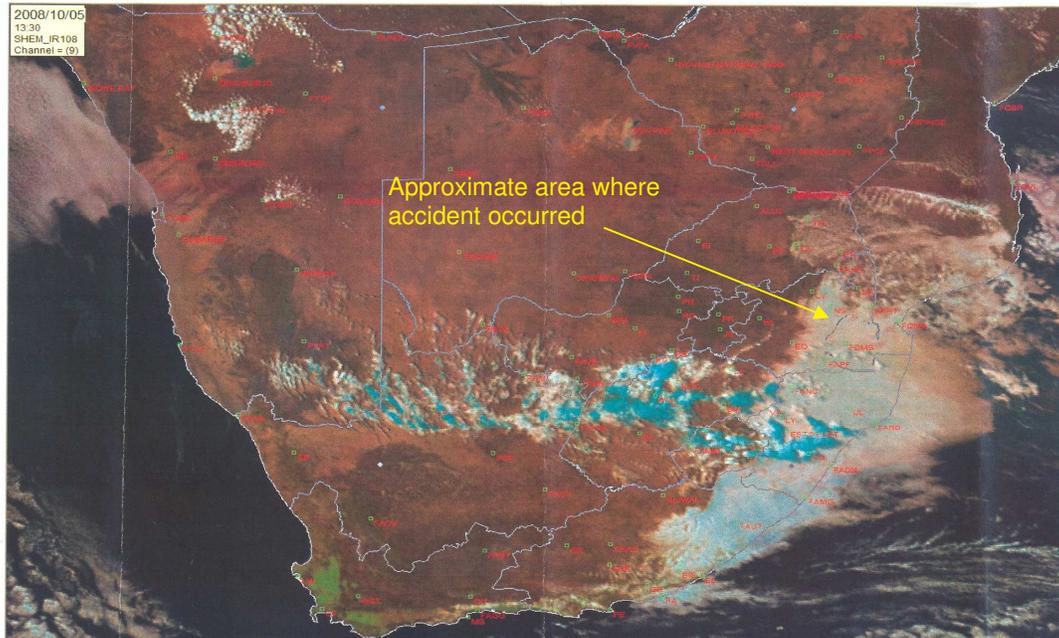
1.7.2 The above weather report states that weather conditions in the vicinity of the accident, were caused by a ridging high pressure system that was feeding moist air in over the eastern part of the country, causing low cloud to occur all along the eastern escarpment with light rain or drizzle in places.

Figure 1: Shows the weather in the area at the time of the accident

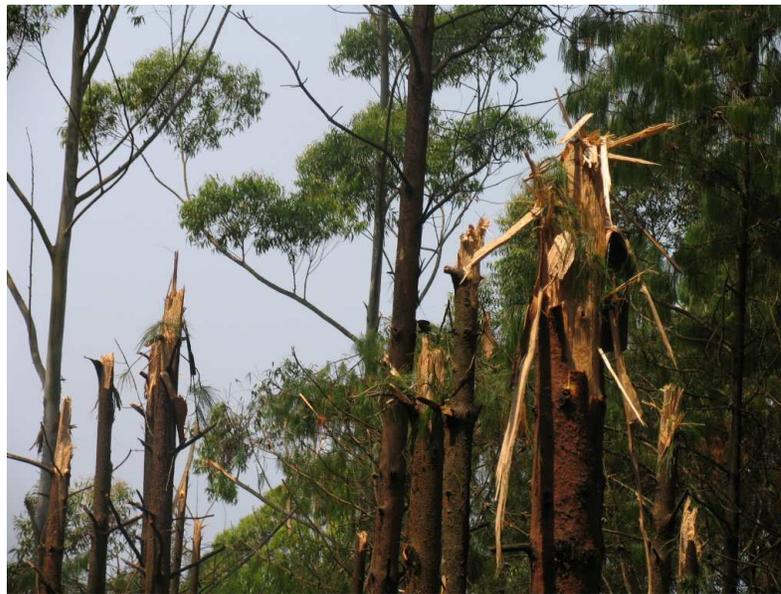
The vegetation located adjacent to the impact area displayed branches that were freshly broken. The trees that were impacted by the aircraft displayed signs that they were impacted in straight and level flight. A number of branches of the trees showed signs that they were cut by the propellers of the aircraft turning at high power.

Photo 2: Showing trees impacted in straight and level flight.

3.1.9 Propeller blade damage, together with the number of branches exhibiting signs of being cut by an object turning at high speed, were consistent with the engines producing power at impact.
