**AVIATION INVESTIGATION REPORT  
A10Q0117**

**LOSS OF CONTROL AND COLLISION WITH TERRAIN**

**NORDAIR QUÉBEC 2000 INC.  
DE HAVILLAND DHC-2 MK 1 C-FGYK  
LA GRANDE-RIVIÈRE, QUEBEC  
24 JULY 2010**

Report Number A10Q0117

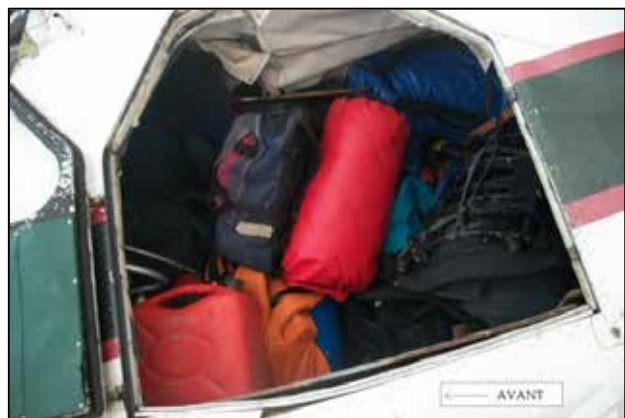
The cabin floor was not severely damaged. However, the aluminum legs of the triple seat were broken and the seat was completely separated from its attachment fittings, propelling the passengers forward. The seatbelts were anchored directly to the seats. Although baggage tie-down fittings were installed in the aircraft, the baggage was not secured to the floor, and it shifted forward (Photo 1).

**Photo 1.** Baggage shifted toward the front of the aircraft

The construction and installation of the triple seat was, with few exceptions, consistent with the manufacturer's original drawings and allowed it to withstand some impact forces. However, the forward shift of the unsecured baggage was a major contributing factor in the injuries sustained by the 3 rear-seat passengers, who were propelled towards the cockpit when their seat pivoted forward.
