AAIS Case Reference: 13/2010

AIR ACCIDENT INVESTIGATION REPORT

**Uncontained Cargo Fire Leading to Loss of Control
Inflight and Uncontrolled Descent Into Terrain**

Boeing 747-44AF
N571UP
Dubai
United Arab Emirates
03 September 2010

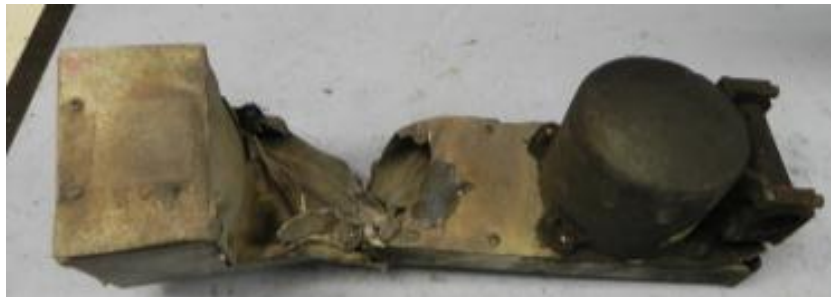
Picture 3 Damaged Flight Data Recorder in the Recovered condition

The recorder had extensive heat and impact damage

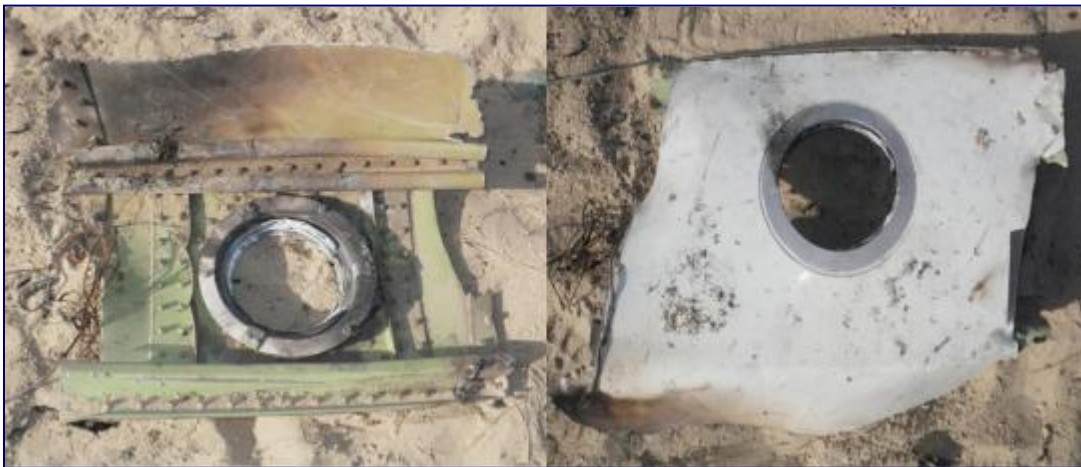
Photo 4 Fuselage Viewport

The piece of the fuselage observation window, or viewport, had sooting around the viewport opening and the viewport seal was charred and reduced to a white powder. An area of the green primer had evidence of thermal degradation of the primer paint. The level of damage sustained by the viewport window and seal in contrast to the level of damage to the surrounding material and primer paint is consistent with the thermal exposure having occurred while the viewport was covered by the bezel leaving only the window portion exposed to the interior of the main deck cargo compartment. This viewport was located on the right side of the aircraft at approximate station number 840, which is also cargo position 6R

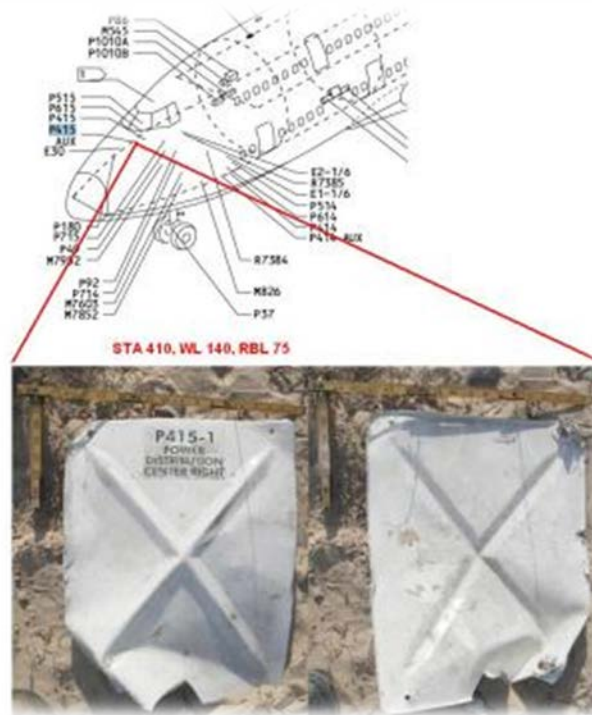
Photo 6 Cover from power distribution center

The cover from the power distribution center right was found to have a light sooting on the exterior and interior surfaces. There was no thermal degradation associated with this component which would have been located at approximately body station 420 on the lower lobe.

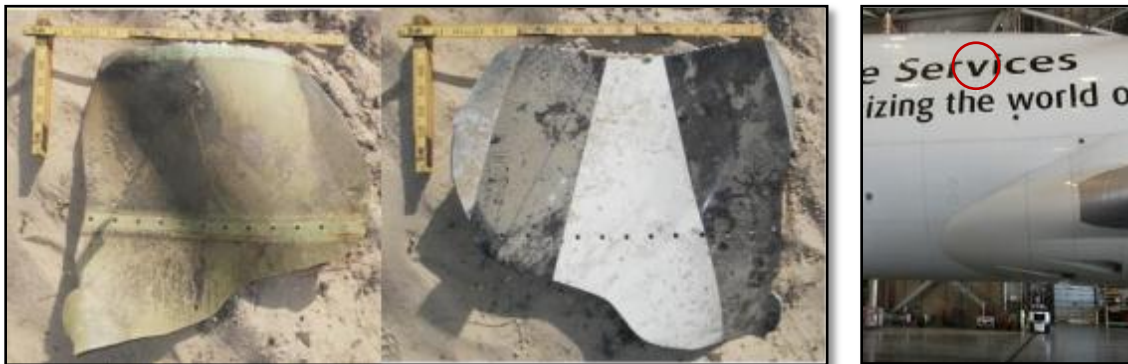
Photo 7 Recovered Fuselage skin section [LH]. Exemplar aircraft exterior [RH]

The fuselage skin piece was a heavy gauge (~.125") skin piece from fuselage. On the interior surface there is sooted corrosion inhibiting compound (CIC) around a protected surface which became exposed after the aircraft breakup. On the exterior surface of this part is a portion of lettering identified as belonging to the letter "V" from the text "Worldwide Services" displayed along the upper lobe on the left side of the aircraft.

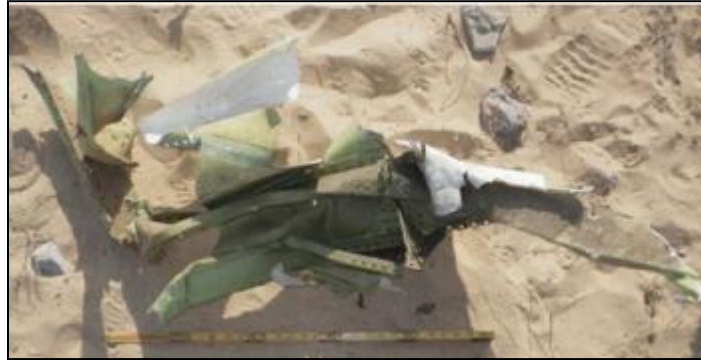
Photo 8 Fuselage skin and structure piece

The fuselage skin and structure piece originated from the right hand side of the aircraft's fuselage skin between station 460 and 488 and somewhere between stringer 17 and 24. This item was found to have soot trapped within impact induced folds.

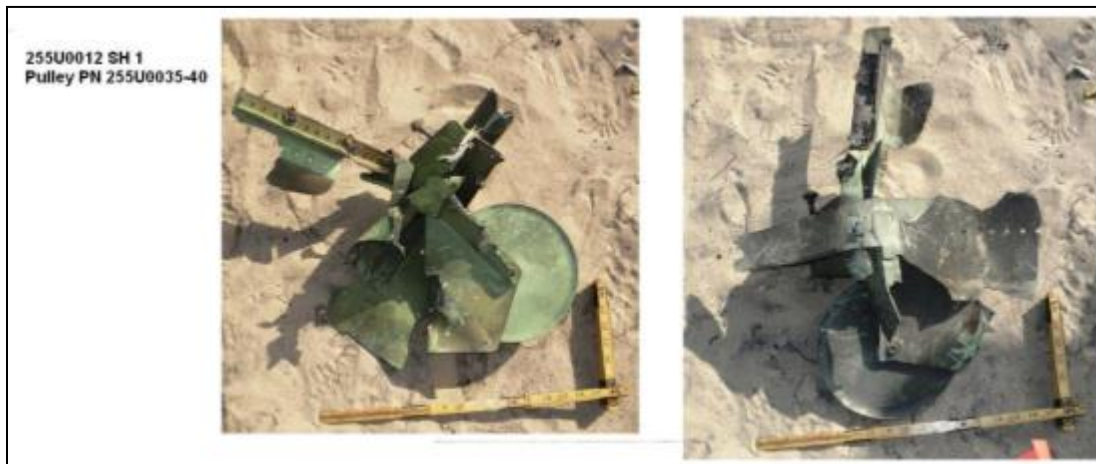
Photo 9 Structure piece with pulley (showing both sides)

The portion of structure with pulley was found to have heavy sooting on one side while being relatively devoid of soot on the other. This item would have been at a location described by, LBL 40, WL 302, station 287 25sv0012.

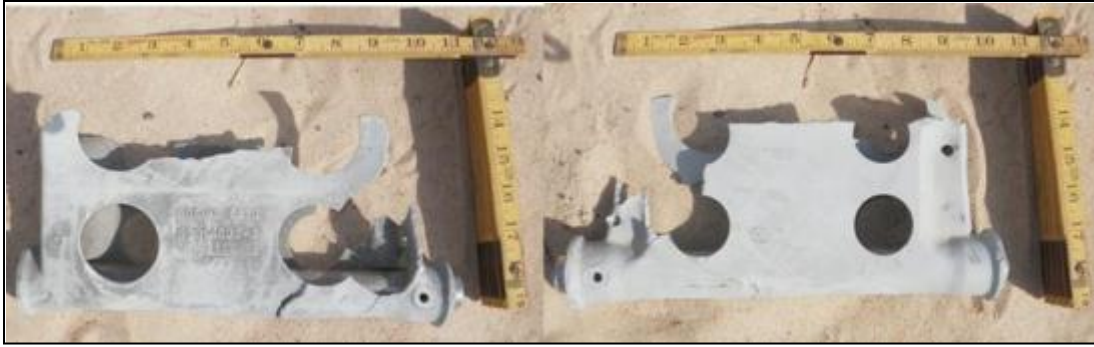
Photo 12 Hinge casting component

The hinge casting (PN:65b14006-3) piece was found with soot on one side and clean on the other. This item belonged to the escape slide mechanism on the right side of the upper lobe just aft of the flight deck

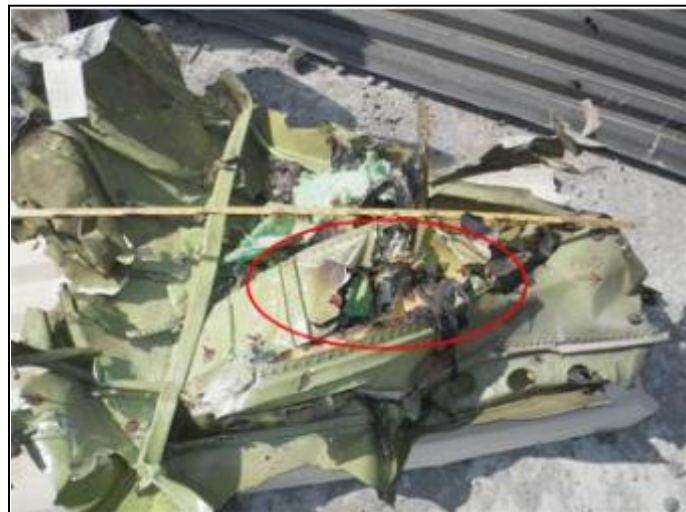
Photo 13 Portion of nose door (lower right hand side)

This portion of the nose door was from the lower part of nose door on the right hand side near station 180. This item exhibited localized charring of the primer and some burnt insulation in the area shown circled in

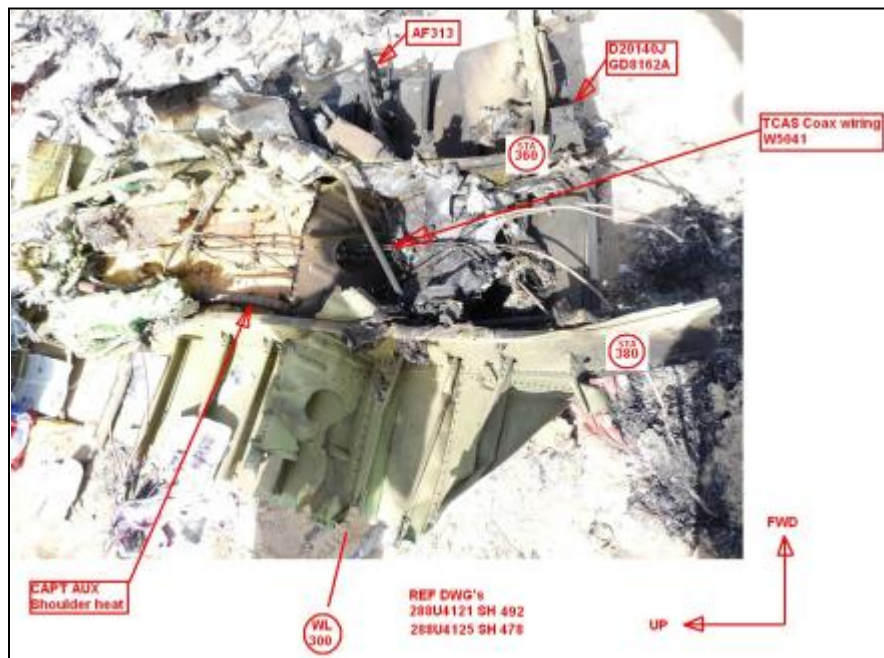
Photo 15 Recovered assembly of structure and fuselage skin

This recovered assembly of structure and fuselage skin originated from the left hand side, upper section 41, Station 360 – 420. There was heavy fire damage in the form of charred insulation and primer paint between stations 360 and 380 stopping at the level of the upper deck floor. The fire-damaged area contained TCAS coax cables and an air vent hose.

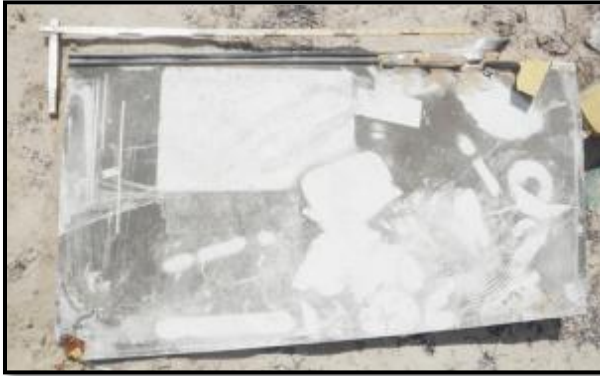
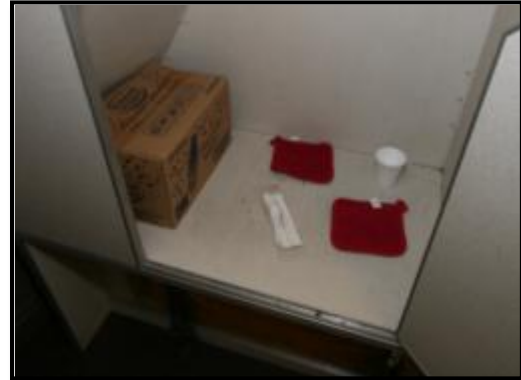
The shelf originated from the cabinet behind flight deck bulkhead. The shelf has heavy soot stains around outlines of items that had been sitting on the shelf during flight.

Photo 18 Shelf from galley cabinet [LH]/ Galley shelf behind flight deck bulkhead in exemplar aircraft [RH]

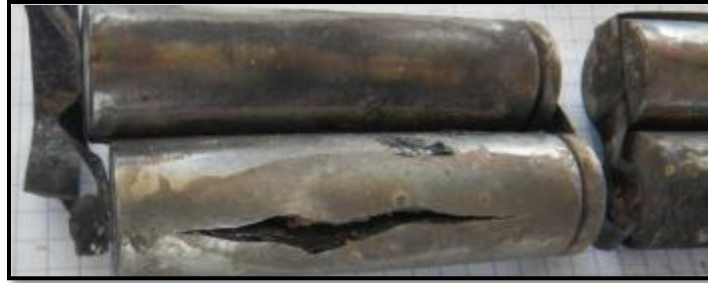
Fire damaged remains of battery pack with a fractured cell

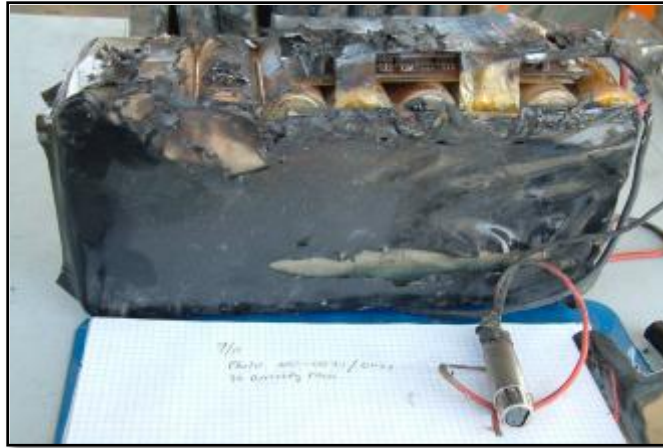
36-cell lithium-ion battery pack with thermal damage.

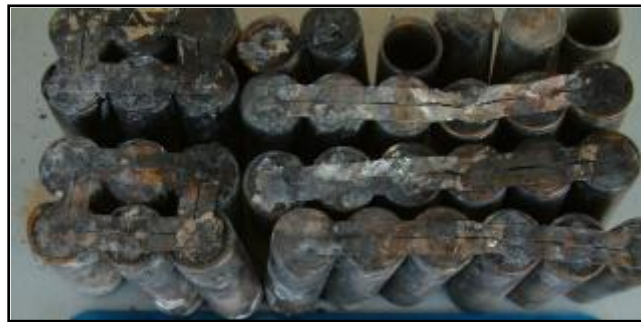
36-cell lithium-ion battery pack with multiple vented cells

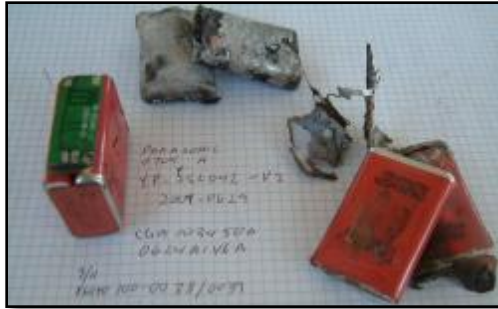
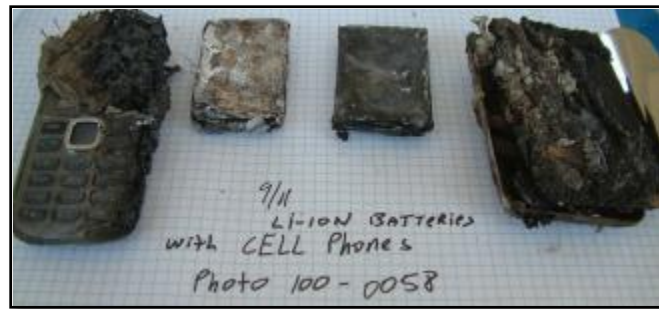
Intact and fire damaged Panasonic batteries (2-pack Li-ION set)[LH]/Mobile phones and batteries [RH]

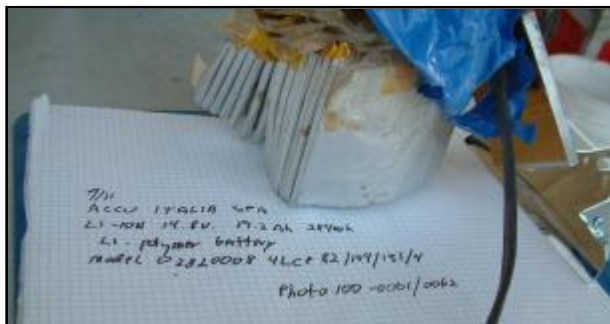
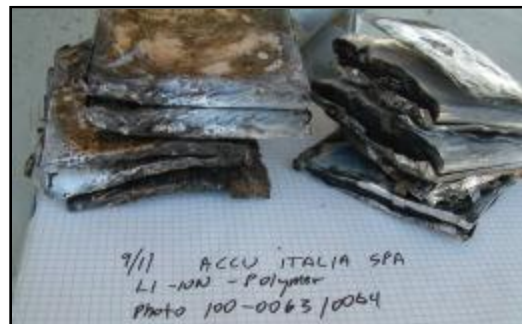
Lithium-ion polymer type battery pack [LH]/ Lithium-ion polymer type battery pack with thermal damage [RH]

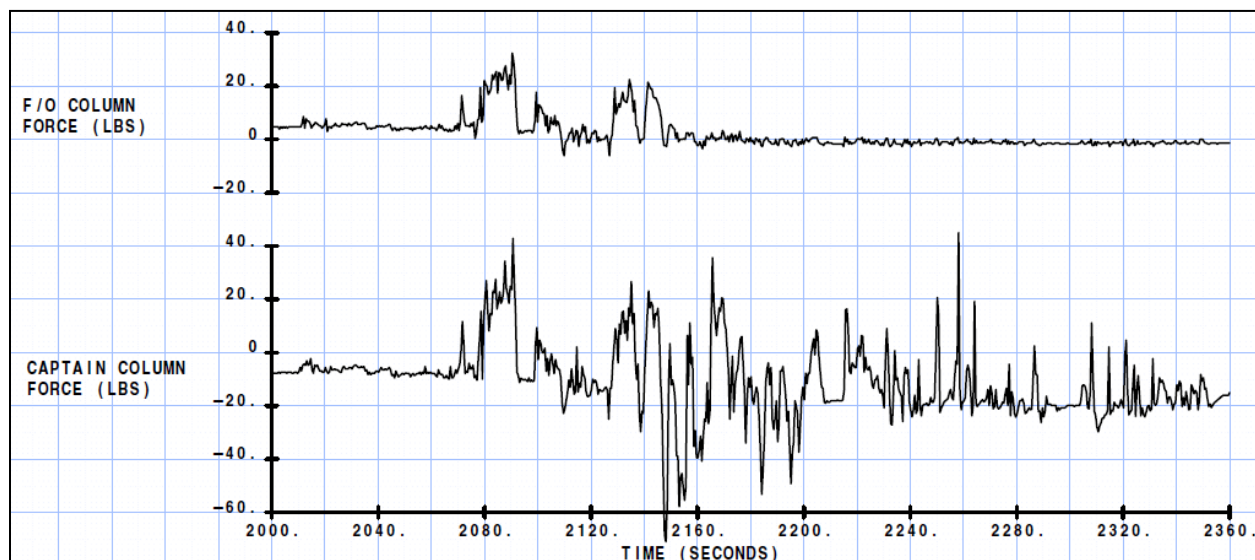
Figure 51 Captain and First Officer column forces following the fire warnings

The captain's column force parameter does not go to zero but it does require less force for the same change in column deflection. This is likely due to the fact that the captain's forward quadrant contains a tension regulator that was designed to remove slack from the elevator control cable. In effect the tension for the captain was less than normal but greater than zero while the tension for the F.O was effectively zero.

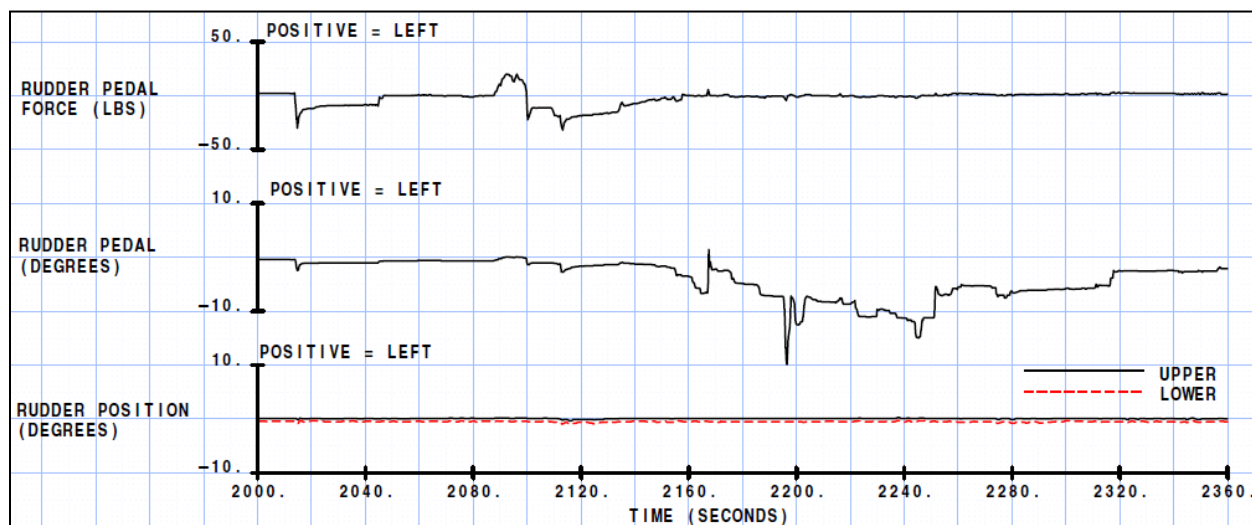
Figure 52 Rudder and rudder pedal data

During the first segment the pedal force moves the pedal. For the rest of the time segment much larger changes in pedal are seen with no pedal force. In addition the 10 degree rudder pedal inputs are not deflecting the rudder. Both of these effects can be caused by a loss in tension of the rudder control cable.

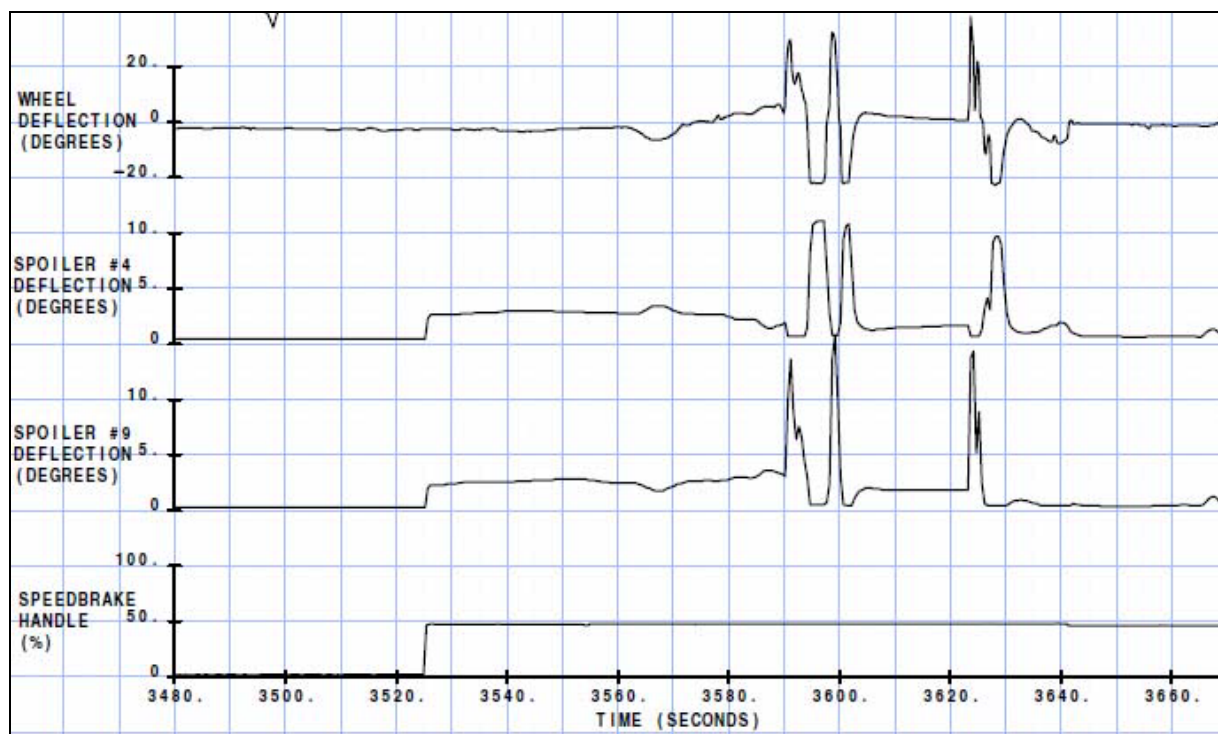
Figure 53 - Spoiler deflection from speed brake handle and wheel deflection

The Figure below demonstrates the inconsistency between speed brake handle and spoiler deflection – At 15:38:09 to end of flight the spoiler response to speed brake handle when moved to flight detent position was only 3 to 4 surface degrees for flight spoilers #4 and #9 Normal response to speed brake flight detent for these spoiler surfaces would be greater than 25 degrees at the flight conditions. The spoiler panels responded normally to wheel inputs during this time period which demonstrates that these spoiler surfaces had capability to move further. Spoiler deflections are consistent with the flight path of the aircraft.

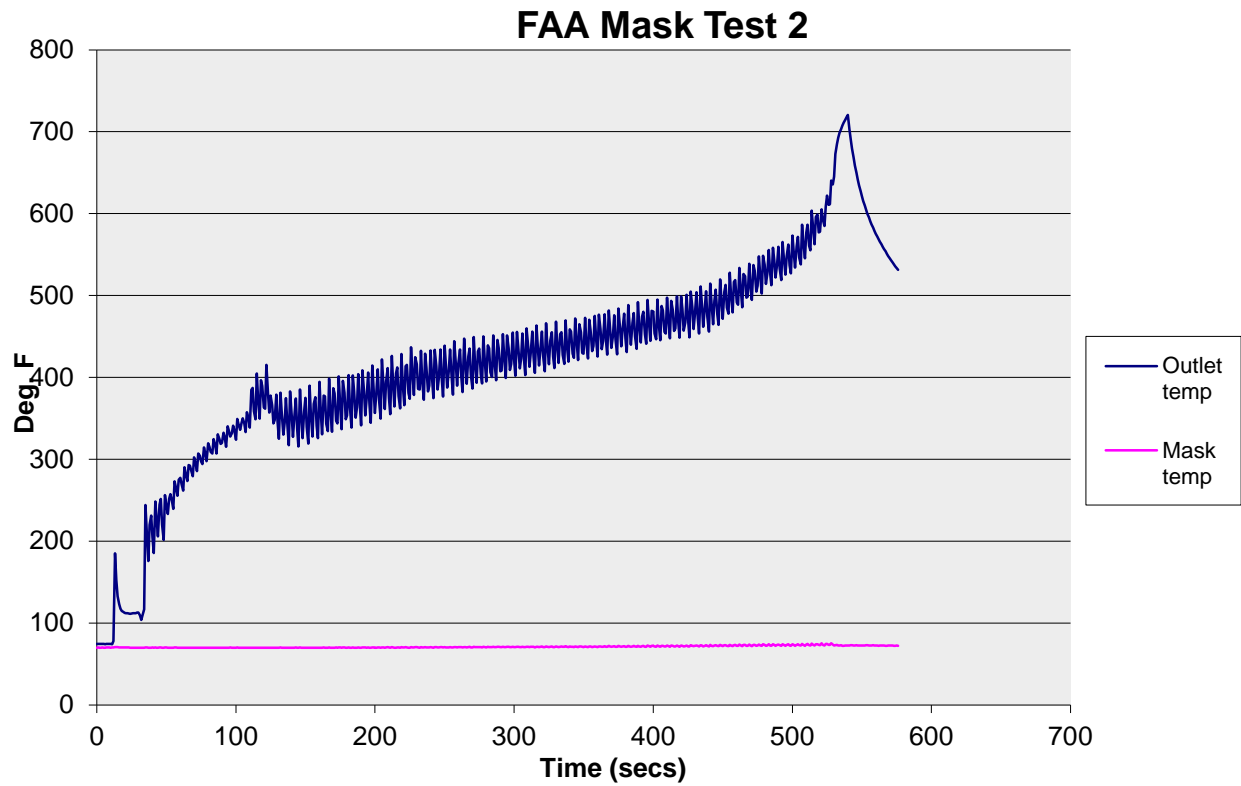
Mask Test #2 Flex Hose 60B50059 hose failure

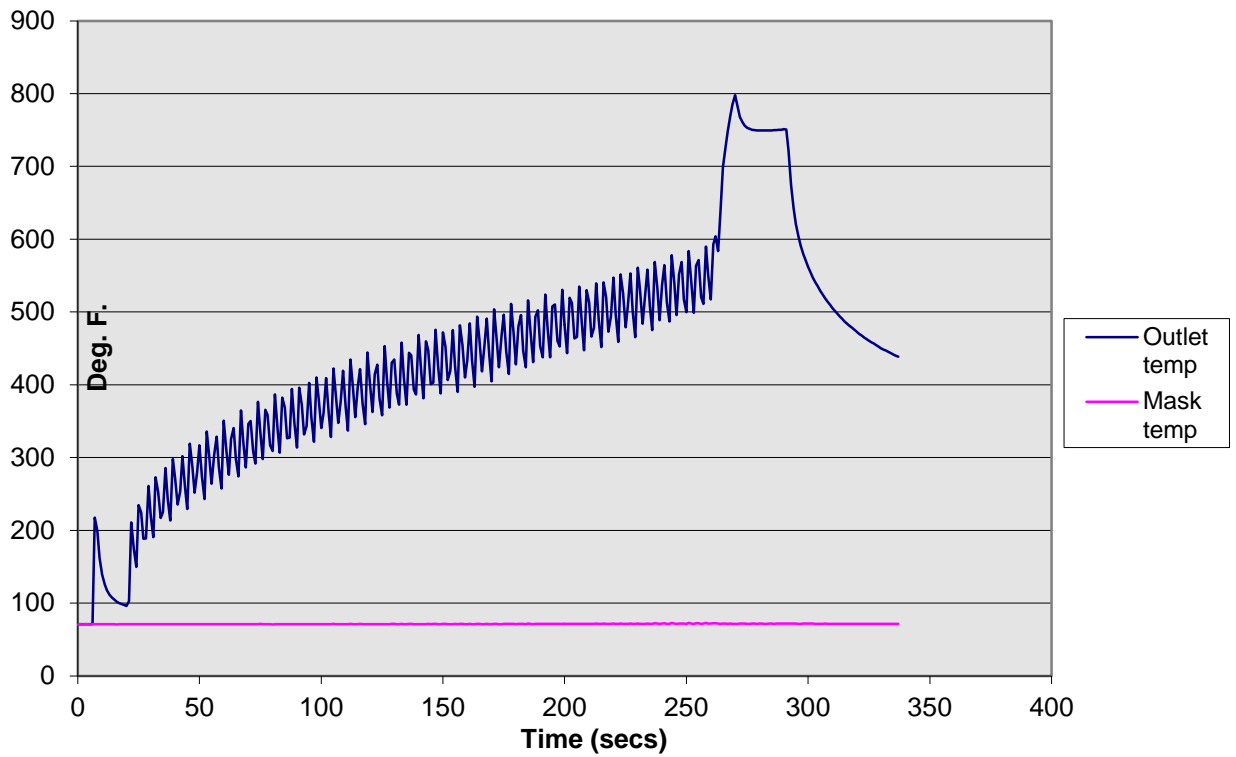
Mask Test #3 Flex Hose 60B50059 hose failure
