KNKT 09.12.28.04

**Aircraft Serious Incident Investigation Report**

**PT. Merpati Nusantara Airline  
Fokker F 28–MK100 ; PK – MJD  
El Tari Airport, Kupang, East Nusa Tenggara  
Republic of Indonesia**

**02 December 2009**

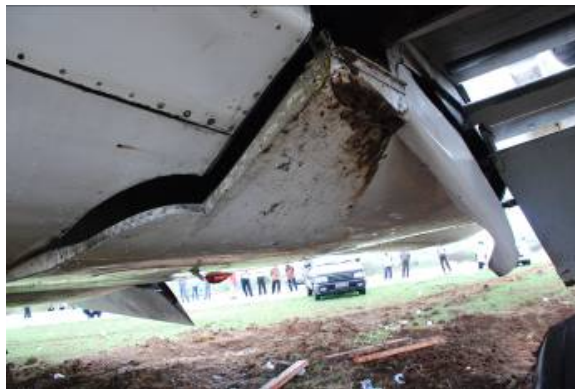
The left landing gear door was damaged.

**Figure 2: Left main landing gear door**

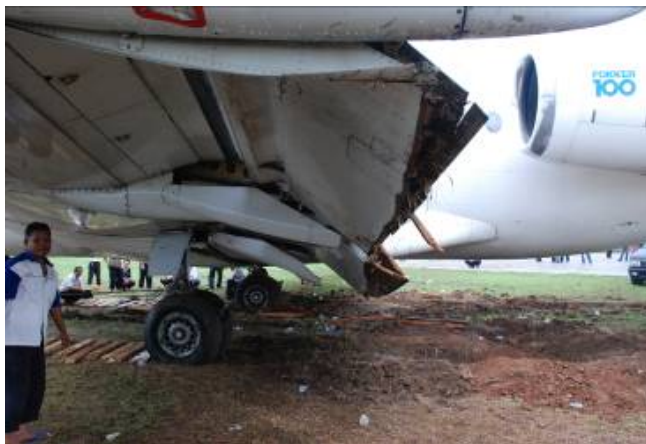
The left flaps inner and outer were damaged.

**Figure 3: Inner and outer flaps were damage**

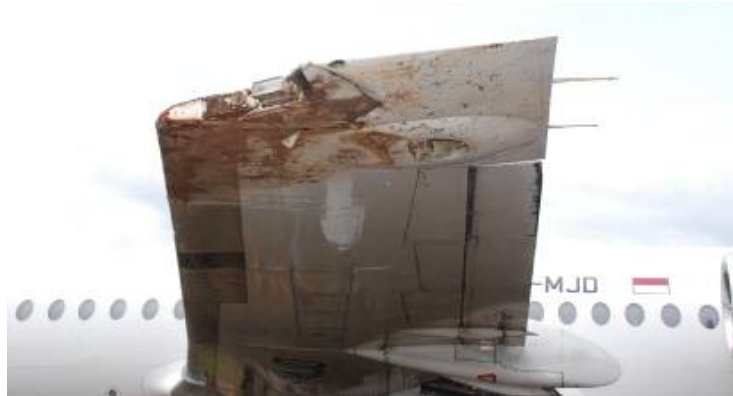
The left wing tip and the landing lamp was damage

**Figure 4: The left wing tip and landing lamp was damage**

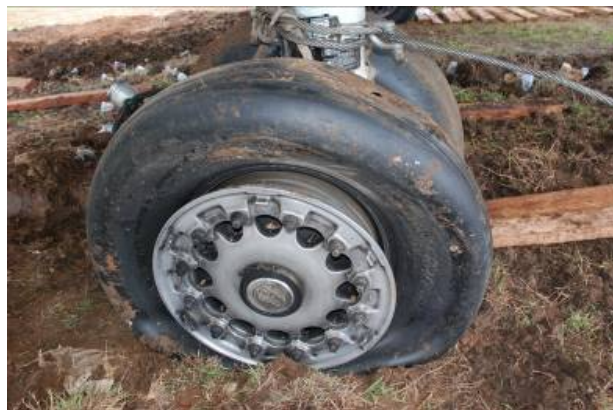
The number-4 tire (right tire) was blown out.

**Figure 5: The number-4 tire was blown out**

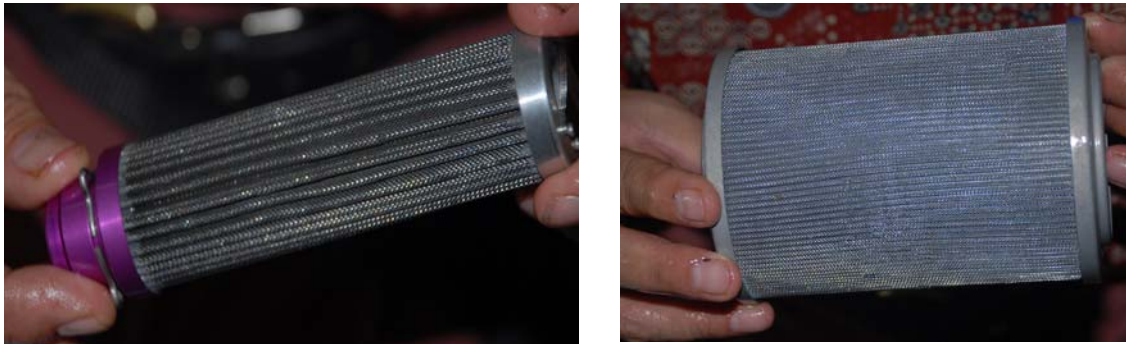
A detail visual inspection on the pressure line filter and return filter showed that there was no dirt or foreign material, both filters were normal and clean (Figure 6).

**Figure 6: Left side high pressure filter and Right side return filter, there were no abnormality**

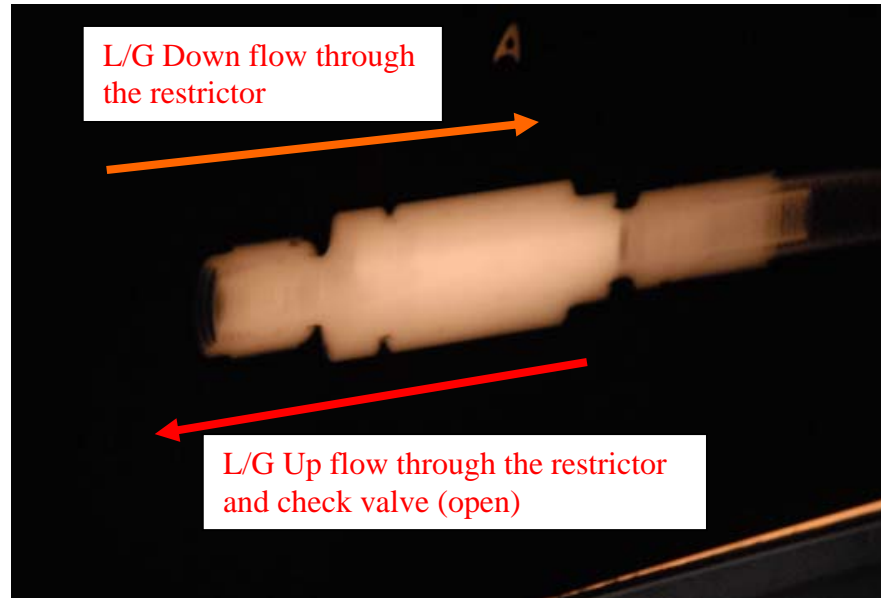
Inspection was started by X-ray to determine the position and condition of internal part of each component. The result of X-ray showed that there was no abnormality on those components (Figure 7).

**Figure 7: X-ray photograph of return line before opened**

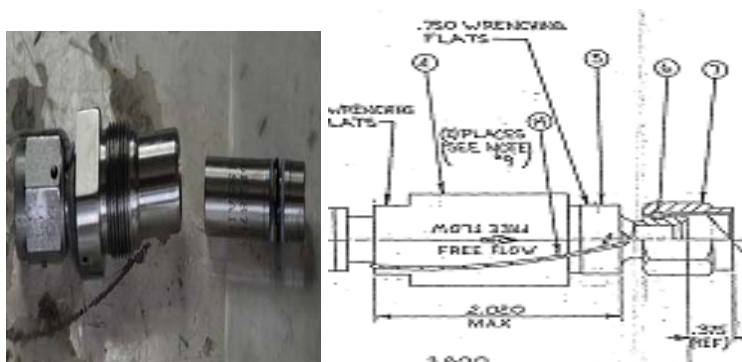
Figure 10: Left restrictor check valve removed from its housing

The restrictor check valve was disconnected from its flexible hose (see Figure 10) and found that the screen filter on the up line was damage (see Figure 12) and the opposite screen which still intact and clean (see Figure 13).

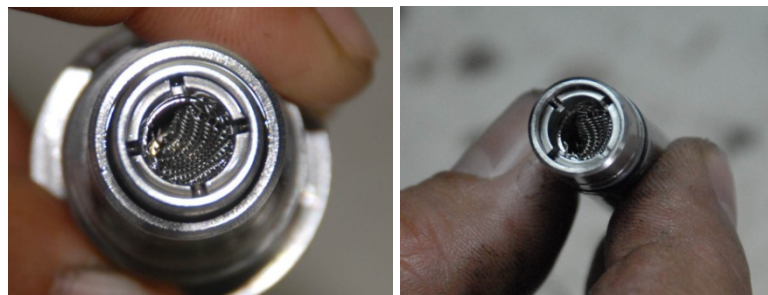
Figure 12: Left restrictor check valve screen damage, up flow direction

The damage of the screen filter on the up line (Figure 12) indicated that the O-ring debris were blocked it. Subsequently during the landing gear up position, the applied pressure of 3000 psi pushed the debris and caused the screen filter damage. Those debris were continued to enter to the chamber between the orifice and the stopper next to the following screen filter, through the opening of the check valve. This stopper was preventing the damage of the intact screen from the blockage (Figure 14).

- The screen filter damaged of the restrictor check valve caused by the blocked of the O-ring debris, subsequently those debris were entered to the chamber between the orifice and the stopper next to the following screen filter, through the opening of the check valve during the landing gear up. The debris was trapped in this chamber.

The National Transportation Safety Committee recommends that the Merpati Nusantara Airline should ensure that the hydraulic system is free from debris.

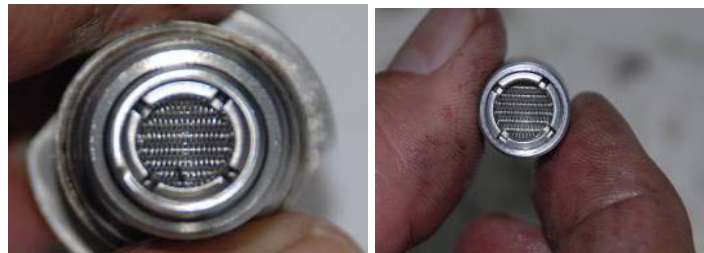
Figure 13: Left restrictor check valve, the opposite screen still intact, down flow direction

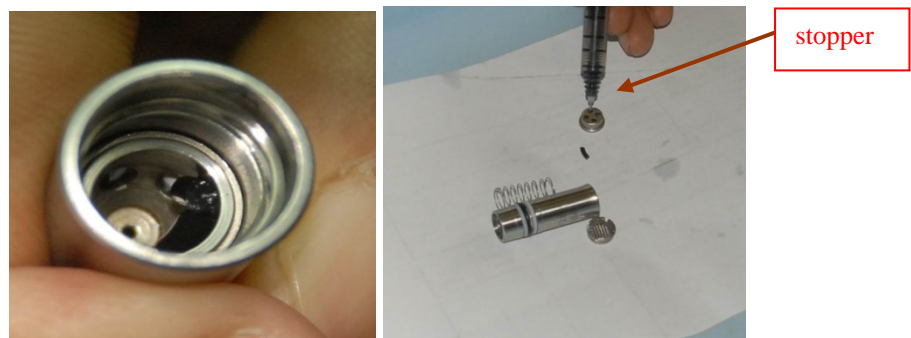
The O-ring debris was found in the chamber between the orifice and the stopper next to the intact screen filter.

Figure 14: The O-ring debris found on the left restrictor check valve chamber

After opening the restrictor check valve as mentioned at factual above found O-ring debris six pieces inside the restrictor (between orifice and the screen filter). The debris were trapped in this chamber. When the landing gear selected to down position, it would cause the hydraulic flow with 500 psi through the orifice. This hydraulic flow would cause one of the O-ring debris blocked the orifice, then resulted the hydraulic from the actuator stop flowing. This condition prevented the actuator to move to down position.

The debris trapped in the chamber between the orifice and the stopper of the restrictor check valve, it caused the orifice closed. This condition was resulted the hydraulic flow from the actuator blocked and caused the left main landing gear jammed at up position.

The National Transportation Safety Committee recommends that the aircraft manufacture should review design of the landing gear hydraulic system should be reconsidered to be redesigned.

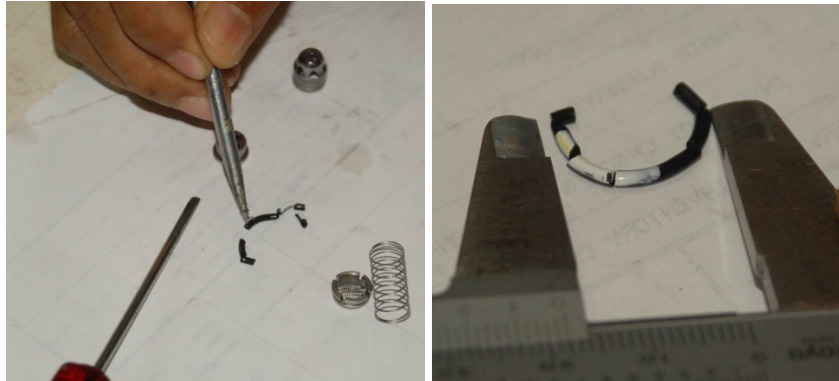
The diameter of the restrictor or orifice is much smaller than the O-ring diameter of debris (the cross section diameter 1.74 mm).

**Figure 15: The O-ring cross section diameter about 1.74 mm and O-ring diameter about 20 mm**

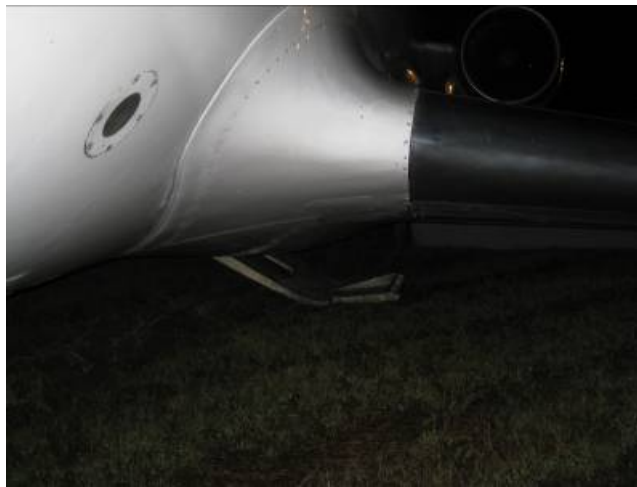
On approach, at altitude approximately 2,000 feet, at a distance approximately 10 Nm to the runway, the pilot selected landing gear to down position. After the selection, the left main landing gear indicator light showed red, while the others were green. This indication means that the left main landing gear was not in down and locked position, unsafe for landing.

**Figure 16: The Left main landing gear still up-locked position.**
