ATSB TRANSPORT SAFETY BULLETIN
Aviation Level 5 Investigations AB-2010-061
Final

Level 5 Factual Investigations: July 2010 to September 2010

**Level 5 factual investigations:
1 July 2010 to 30 September 2010**

AO-2009-024: VH-NXM, Runway lighting failure

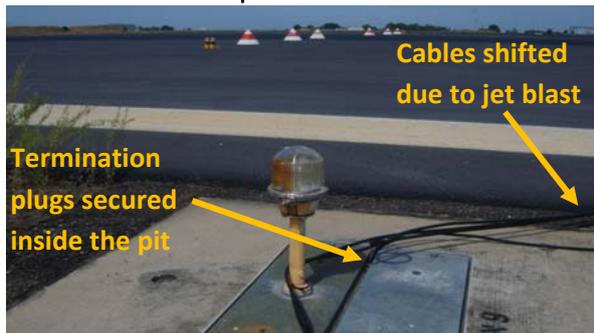
To modify the lighting system on runway 11/29, temporary cables were placed behind the displaced threshold from a lighting pit on the northern side to a lighting pit on the southern side of the runway. The lighting pit on the northern side was a newer style and the termination plugs connecting the cables were placed inside the pit and the cover screwed down to secure it (Figure 1).

Figure 1: Runway 11 displaced threshold and northern pit

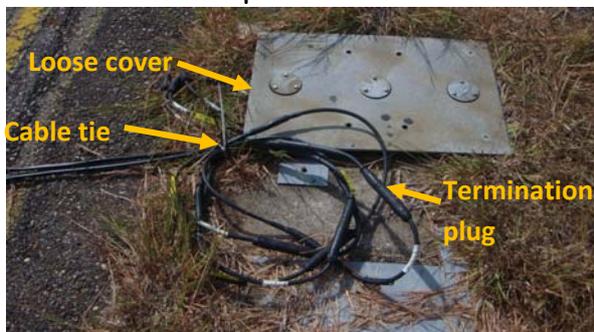
On the southern side of the runway, the pit was an older style and had a cover that could not be secured. During the lighting modification, the termination plugs were placed inside the pit and the cover loosely fitted over the top. The lighting technicians reported that because the cover for the pit could not be secured, jet blast had pulled the cables out of the pit and separated the plugs, resulting in the lighting failure.

Figure 2: Runway 11 displaced threshold and southern pit

After the incident, the cables were looped and cable tied so that they could not be separated from undue tension (Figure 2).

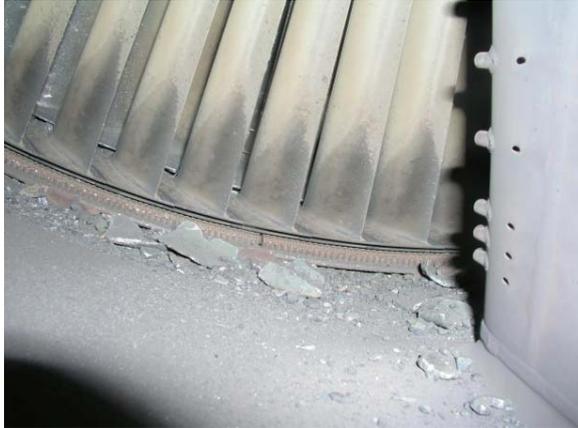
A post landing inspection by maintenance personnel found metal debris and evidence of a fire in the tailpipe of the right engine.

Figure 1: Debris in engine tailpipe

During the inspection, the HPC stages 6 to 11 vane airfoil surfaces were found to be broken and/or missing. Impact damage to some stage 5 vane trailing edges was also noted. A build up of molten blade and/or vane material had been deposited on all vane and rotor path surfaces from the stage 5 vane trailing edges downstream, which was consistent with an internal titanium fire.

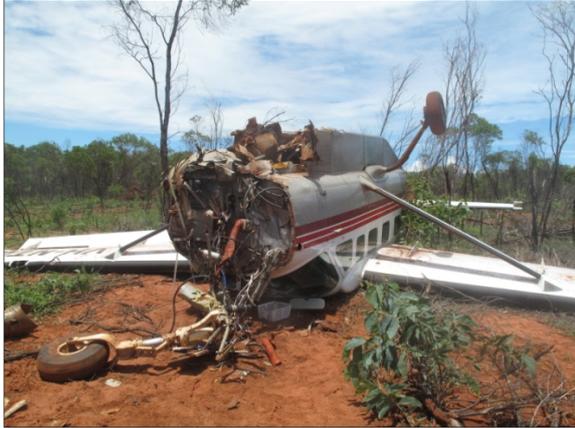
Figure 1: Accident site

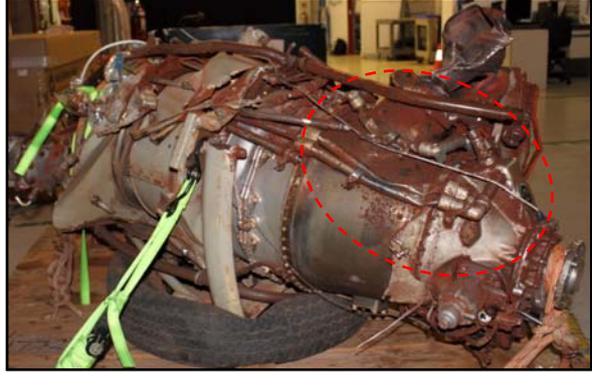
External examination of the engine showed that red dust from the accident site had attached itself to the areas of the engine that had been contaminated with engine oil. It was apparent that there was a high concentration of oil on the outer surface of the reduction gear box between the 4 and 7 o'clock positions, the mid and rear sections of the engine were relatively oil free in comparison. Figure 2 shows the engine assembly as received at the engine overhaul facility, attached to a pallet with the bottom of the engine facing upwards; the highlighted area indicates a high concentration of oil contamination.

Figure 2: Engine assembly

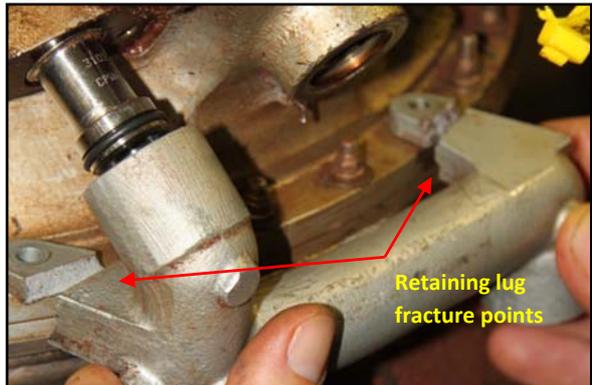
The engine examination revealed accident damage to several components and oil lines. All of the engine's external oil seals were inspected with no pre-accident defects identified. The engine was disassembled at the hot section and accessory gear box, so an internal examination could be conducted. No pre-accident defects were noted during the internal examination. The accessory gear box chip detector, reduction gear box chip detector and the engine's main oil filter were inspected, with no foreign particles or debris noted in the oil system. Approximately 1 quart (0.92 L) of oil was drained from the engine, which had a normal operating capacity of 14 quarts (13.25 L). A sub section of oil pressure tube, that transferred oil from the oil pressure pump to the reduction gear box, was found to have fractured at both attachment lugs (Figure 3).

Figure 3: Oil transfer tube

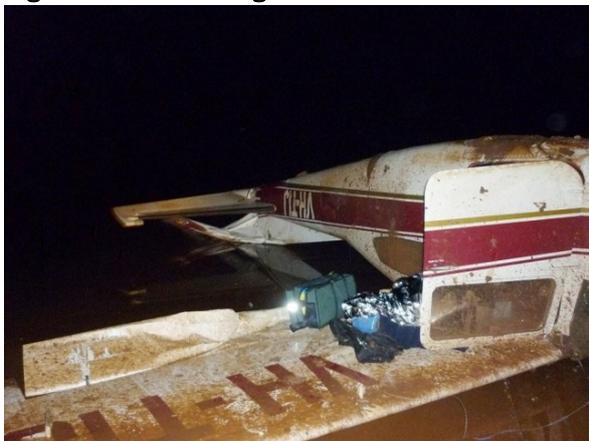
His next recollection was waking up and realising the aircraft had collided with terrain. The aircraft sustained serious damage (Figure 1).

Figure 1: VH-TIJ resting inverted on salt lake

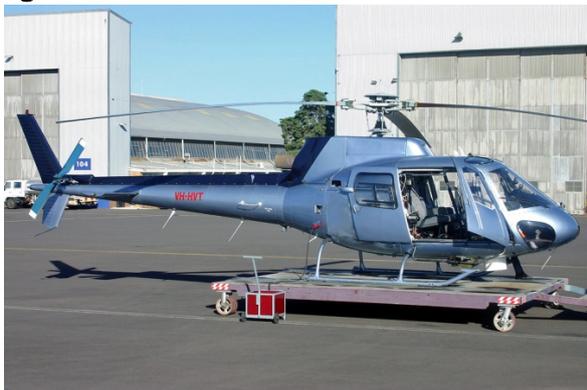
At about 1110 Eastern Standard Time⁸⁴, the pilot stated that he commenced a right turn with the intention of returning via the same route. The pilot reported that during the turn, the helicopter was travelling between 10 and 15 kts and descending slightly to maintain the height above the canopy. About two thirds of the way through the turn, the pilot observed a tree branch protruding about 1 m above the average height of the surrounding canopy and about 2 m away from the front of the helicopter. The pilot recollected trying to climb the helicopter, but the branch impacted the front lower right side about 2 seconds later. The branch contacted and broke the helicopter's chin bubble and slid down the right hand the side of the helicopter (Figure 2).

Figure 2: VH-HVT
