**ON ACCIDENT TO
M/S KINGFISHER AIRLINES ATR-72 AIRCRAFT
VT-KAC AT MUMBAI ON 10.11.2009.**

**AIR SAFETY DIRECTORATE
O/o DIRECTOR GENERAL OF CIVIL AVIATION
OPP. SAFDARJUNG AIRPORT, NEW DELHI**

REPORT ON ACCIDENT
TO M/S KINGFISHER AIRLINES ATR-72 AIRCRAFT
VT-KAC AT MUMBAI ON 10.11.2009.

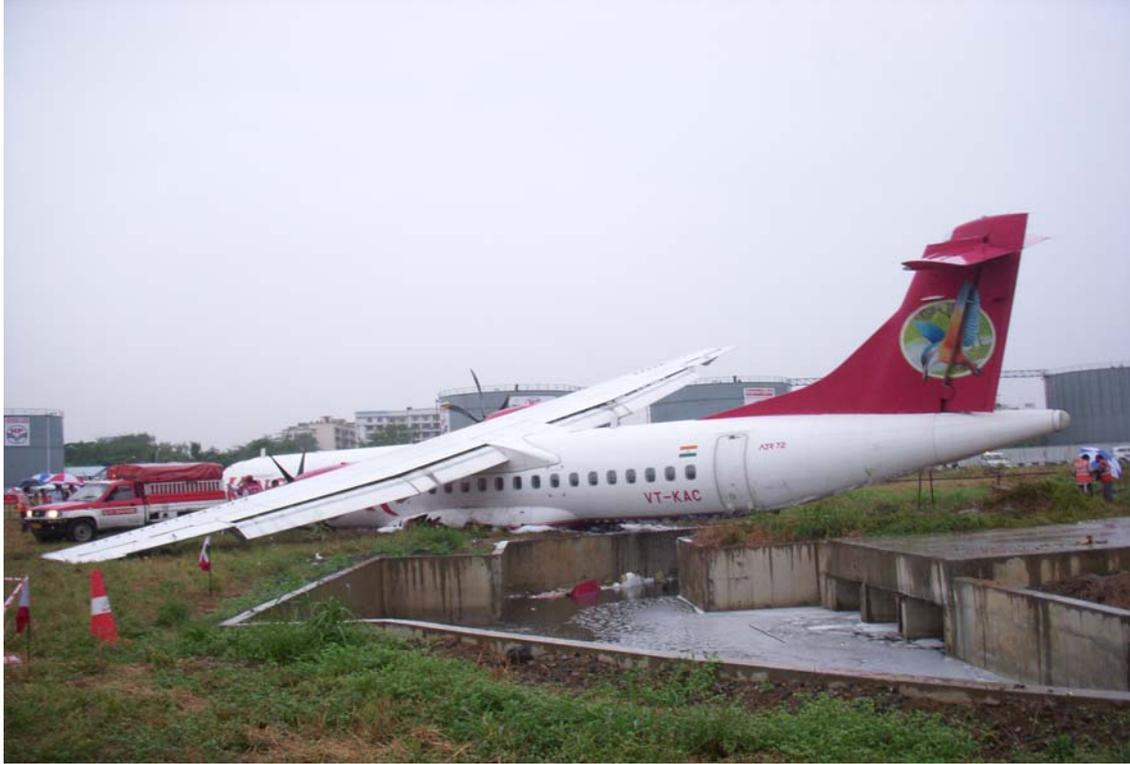
After the accident Right Hand Propeller of aircraft was rotating for some time. Fire fighting personnel reach the spot immediately & helped in evacuation process. Fire Extinguisher (Foam) was sprayed on Both the Engines to flame out #2 engine. The L.H. wing was touching the ground and aileron and wing tip got damaged. L.H. Propeller Blades were broken and damaged. The Nose landing gear was collapsed with Nose section completely damage. The Port Landing gear got detached and fell in the open canal. The right landing gear was damaged but intact with the Aircraft and the tires were burst. Nose section-bottom portion was crushed and Lower fuselage was damaged due rubbing on uneven terrain.

Aircraft in the final resting position

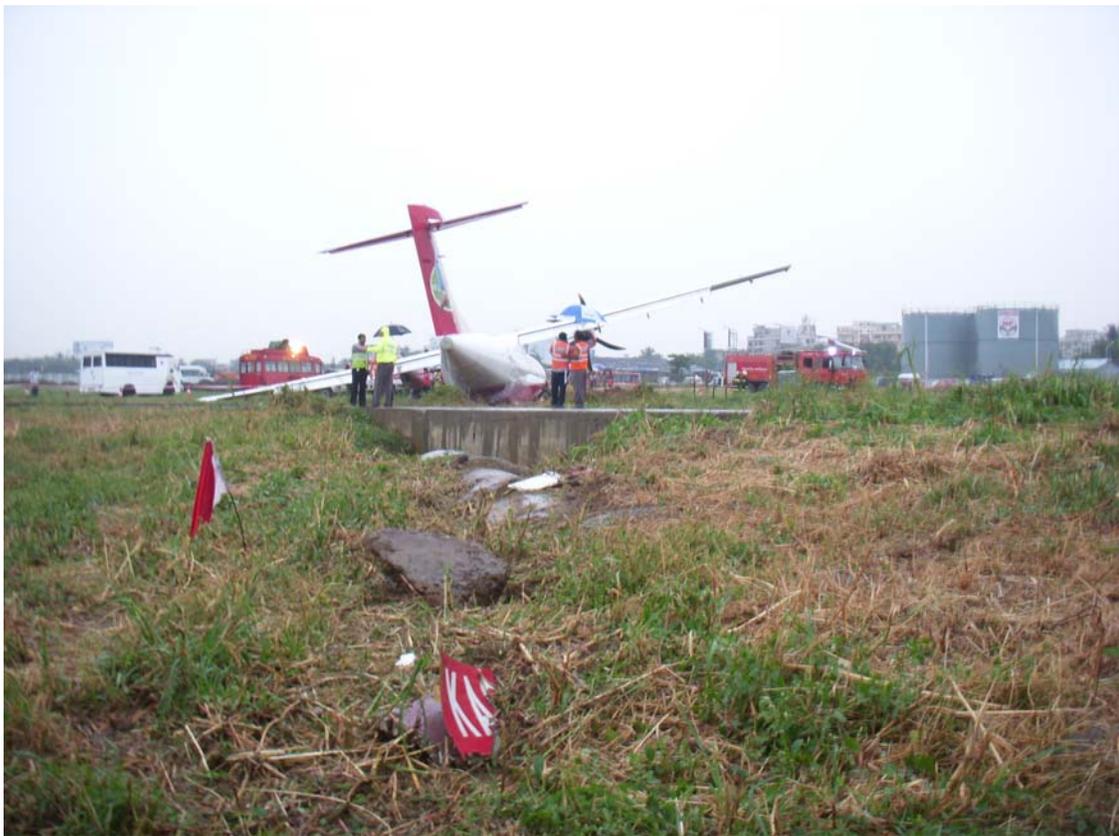
Rear view

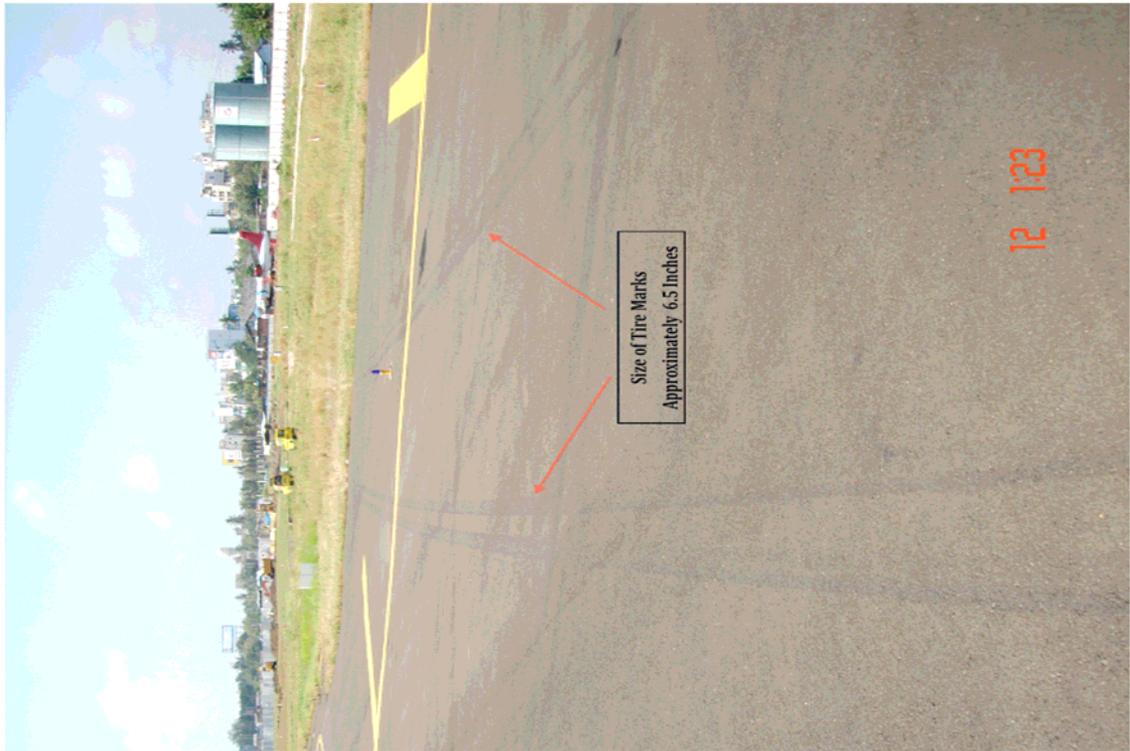
Point from where aircraft turned into unpaved wet area

Seeing the runway end, the pilot initiated 45 ° right turn after crossing N10 and exited the runway. It rolled into unpaved wet area. Just prior to leaving the runway the pilot asked for the Condition Levers to feather/fuel shutoff. After the aircraft stopped the right engine was still running though the Condition Lever was shut off. The crew then pulled the right emergency handle followed by the left emergency handle but the engine failed to shutoff. Crew came out from the emergency hatch and then went to the left side forward cabin emergency exit and assisted the cabin crew with the evacuation of passengers. All the passengers including crew evacuated safely without any major injuries. There was no fire.

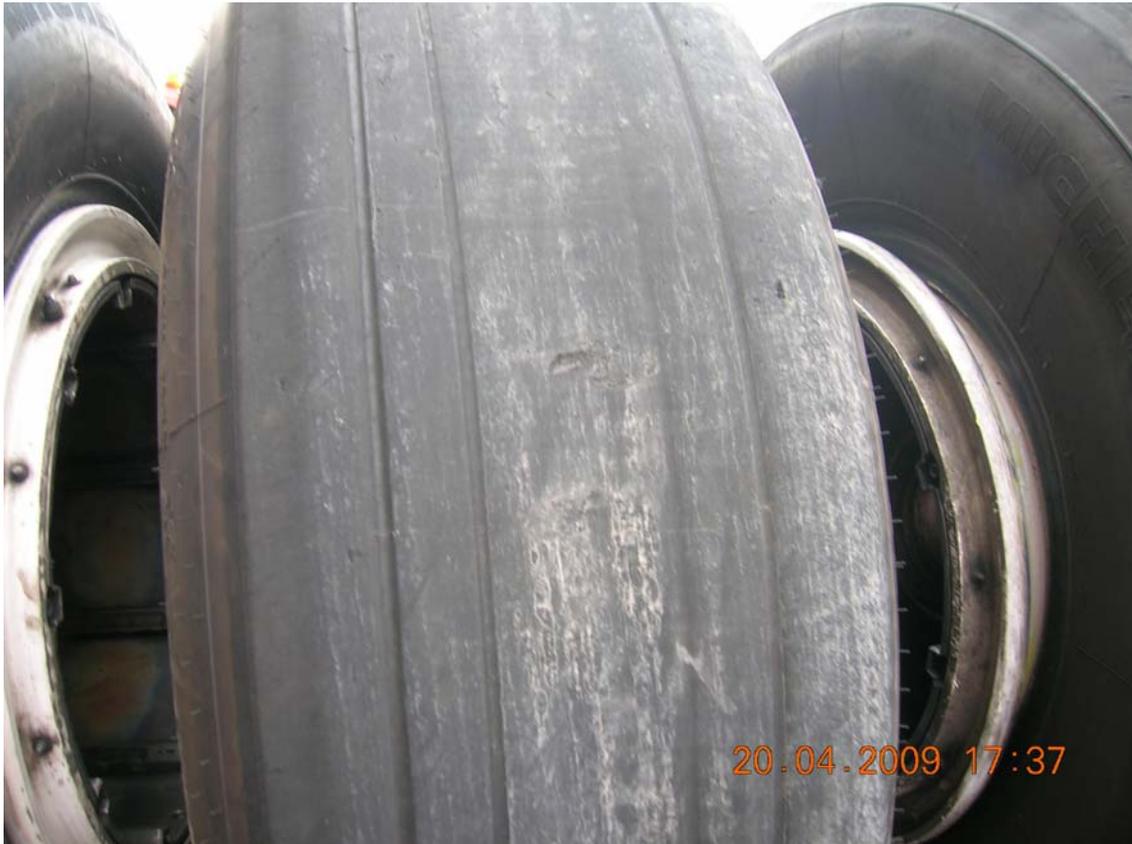
Tire inspection showed signs of partial aquaplaning. All the four brake assembly were inspected at Kingfisher wheel and brakes shop & no discrepancy was observed.

Tyre indicating signs of partial aquaplaning

The increase in landing distance on water-affected runways is primarily due to reduced coefficient of friction between the tyres and the runway. The reduced coefficient of friction can effect deceleration and directional control. The extent of reduction depends on the depth of water, the aircraft ground speed and type of aquaplaning. Reverted-rubber aquaplaning occurs when a wheel 'Locks up' (or stop rotating) is dragged across a wet surface, generating steam. The steam pressure lifts the tyre off the runway surface. Heat from the steam causes the rubber to revert to its unvulcanised state, leaving a black, gummy deposit of reverted rubber on the tyre. Reverted-rubber aquaplaning will also typically leave distinctive marks on the runway, with black marks on the edges of the contact patch and clean section in the middle where the runway surface have been effectively steam cleaned. Inspection of the tyres and the runway indicates that due to full brake application by the crew Reverted-rubber aquaplaning took place.
