AIRCRAFT ACCIDENT REPORT AND EXECUTIVE SUMMARY

Reference:	CA18/2/3/8719								
Aircraft Registration	ZS-SJW	Date of Accident	7 December 2009		Time of Accident	0901Z							
Type of Aircraft	Embraer 135-LR (Aeroplane)			Type of Operation	Domestic Schedule								
Pilot-in-command Licence Type		Airline Transport	Age	39	Licence Valid	Yes							
Pilot-in-command Flying Experience		Total Flying Hours	11 973,5		Hours on Type	2 905,8							
Last point of departure		Cape Town International Airport (FACT), Western Cape province											
Next point of intended landing		George Airport (FAGG), Western Cape province											
Location of the accident site with reference to easily defined geographical points (GPS readings if possible)													
On the R404, a public road adjacent to the aerodrome (geographical co-ordinates: S34°00.306' E022°23.534')													
Meteorological Information	Surface wind: 090°/2-5 kt; Temperature: 20°C; Cloud base: 8 000 ft, with light rain

The crew were unable to decelerate the aircraft to a safe stop due to ineffective braking of the aircraft on a wet runway surface, resulting in an overrun.

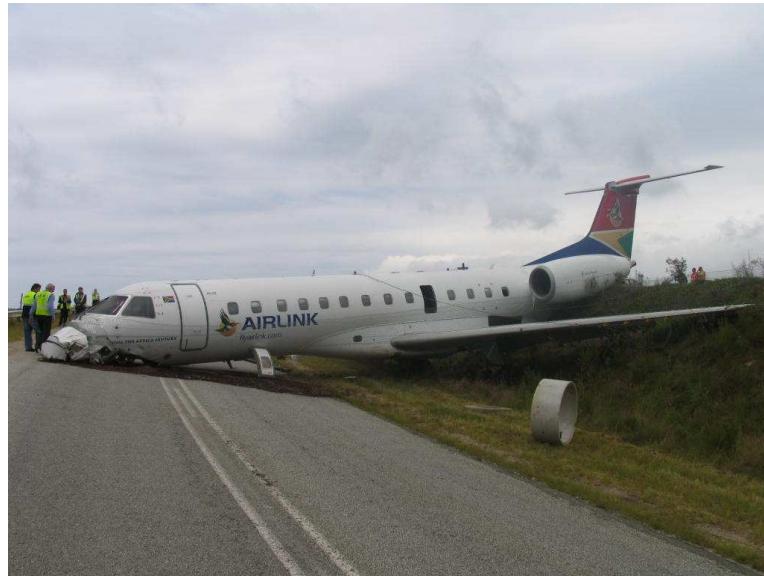
1.3.1 The aircraft rolled off the runway, and came to rest with its nose on the road and its aft fuselage on the embankment. It suffered substantial damage, especially to these two sections.

Figure 1(a): The aircraft after coming to rest on the roadway.

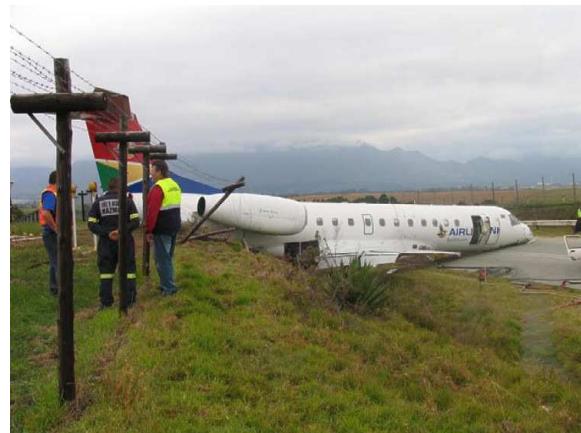
Figure 1(c): The broken perimeter fence.

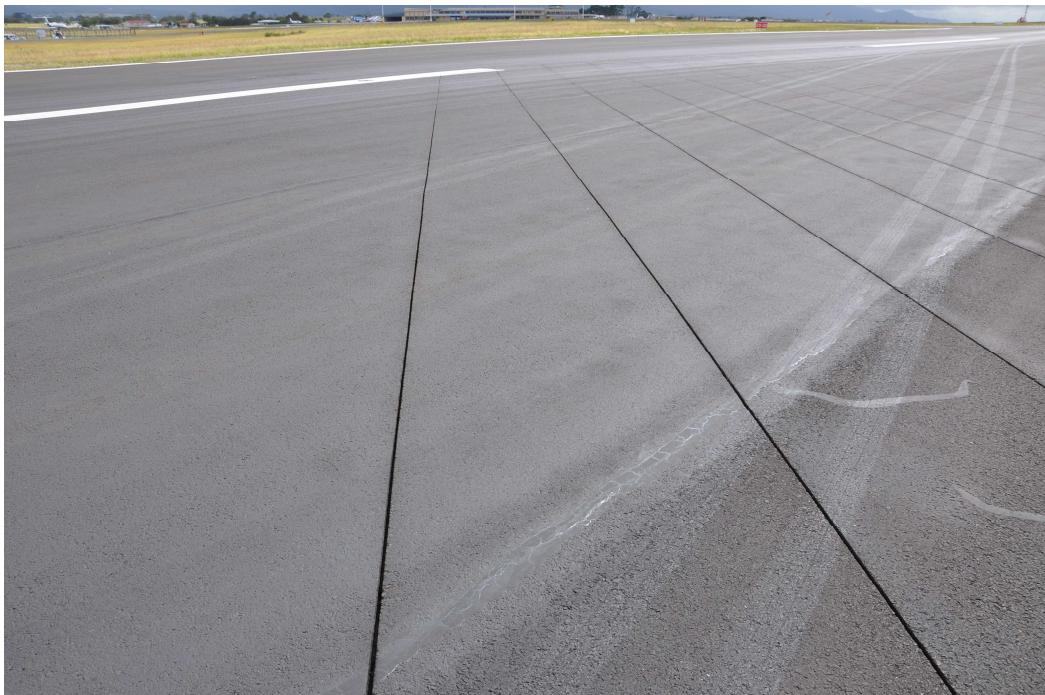
The slots were cut at 45° to the centreline, and ran from the centreline to the runway edge for a distance of 120 m westward from a point 36 m west of the western edge of runway 02/20. They were on average 10 mm wide and 55 mm deep, spaced at 1,4 m intervals (measured perpendicularly), and cut only on the right-hand side of the runway. As a result of the pressure of numerous landings, the asphalt had crept and several slots had partially closed up. Cracks had also formed. According to aerodrome officials, the slotted area had been a cause of concern because of inadequate drainage during rainy conditions.

Figure 12: The slots cut into the runway surface at George aerodrome.

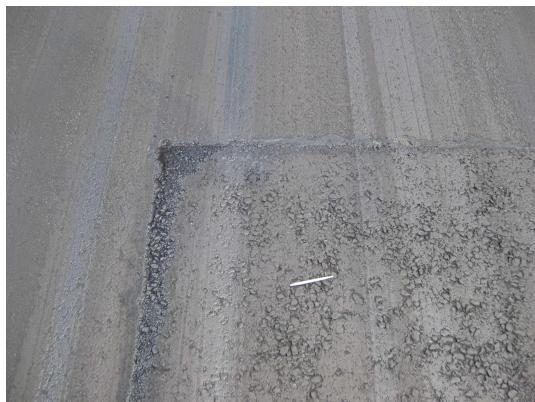
Several areas on the runway had been repaired (the patches were backfilled). These areas were clearly visible as the aggregate used (continuously graded NMAS 19.0) was substantially larger than that of the primary runway surface texture. The predominant aggregate in the repaired sections had a pebbled appearance in contrast to the well-compacted primary runway surface texture.

Figure 23(a): A milled area on the runway.

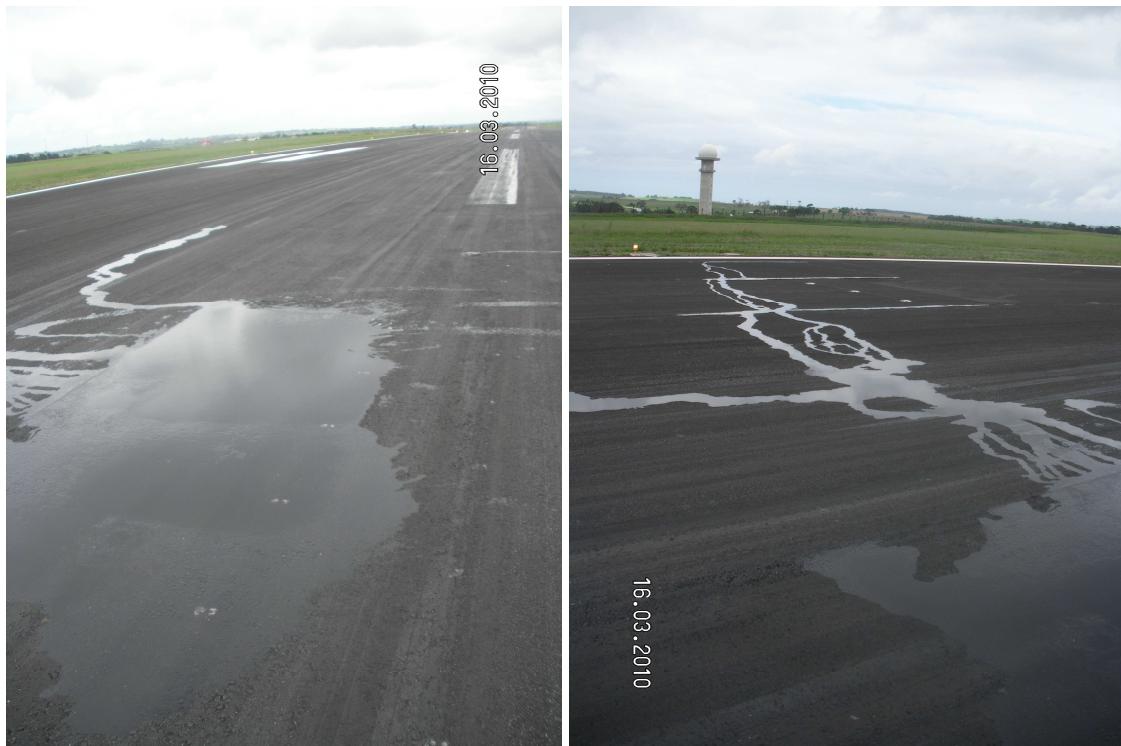
"5.5 Deformation of the runway with time may also increase the possibility of the formation of water pools. Pools as shallow as approximately 3 mm in depth, particularly if they are located where they are likely to be encountered at high speed by landing aeroplanes, can induce aquaplaning, which can then be sustained on a wet runway by a much shallower depth of water. Improved guidance regarding the significant length and depth of pools relative to aquaplaning is the subject of further research. It is, of course, especially necessary to prevent pools from forming whenever there is a possibility that they might become frozen."

Figure 24: The puddle of water on the runway and the subsequent runoff to the left of the runway.

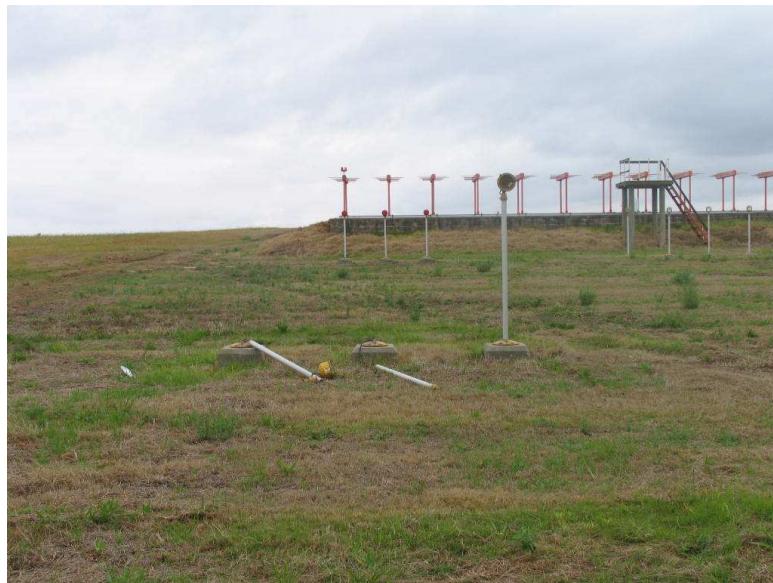
After the aircraft left the runway to the right at the end of runway 11, it crossed the grassy area to the right (as seen from the cockpit) of the approach lights and rolled onto runway 29 and towards the ILS localiser antenna. It then struck and destroyed two approach lights in the second row and damaged a third. This set of lights comprised three frangible light towers, individually mounted on cast concrete pillars and arranged at right angles to the runway centreline.

Figure 35: The ILS localiser antenna and damaged approach lights.

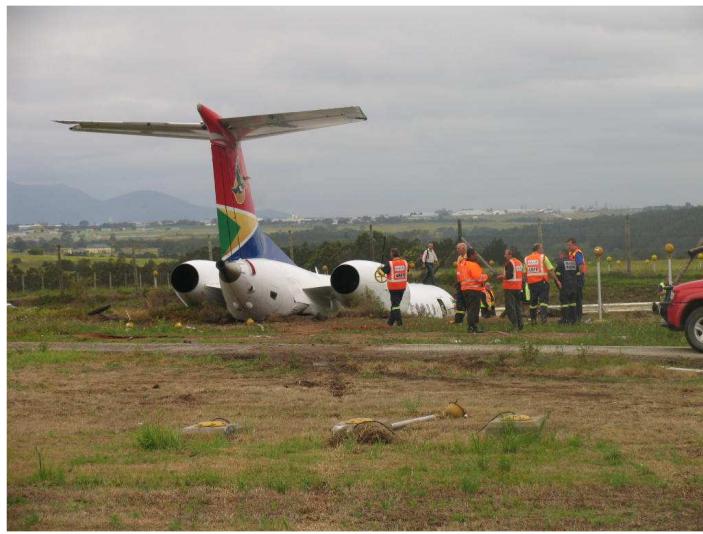
Figure 36: The damaged approach lights are visible in the foreground.

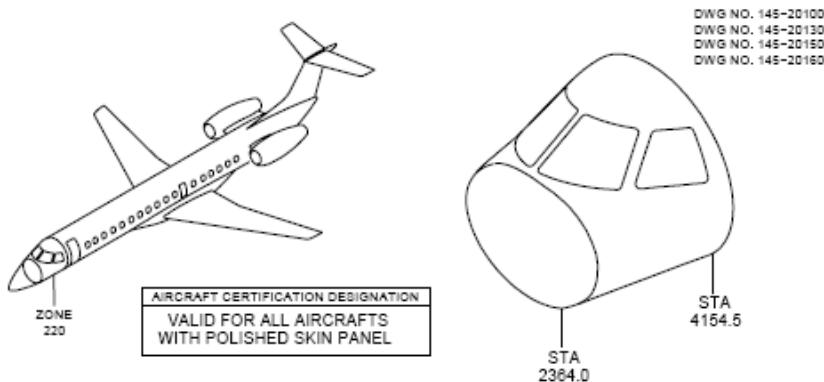
No break-up of the aircraft occurred. However, there was substantial deformation of the lower front fuselage sections I and II, including the nose and cockpit. The nose section was completely destroyed up to station 2364.0. There was also considerable damage to the cockpit section between stations 2364.0 and 4154.5. This was caused when the nose gear collapsed after striking the concrete pillar supporting the approach light and when the aircraft skidded down the embankment onto the roadway.

Figure 38: The damaged sections at the front of the aircraft.

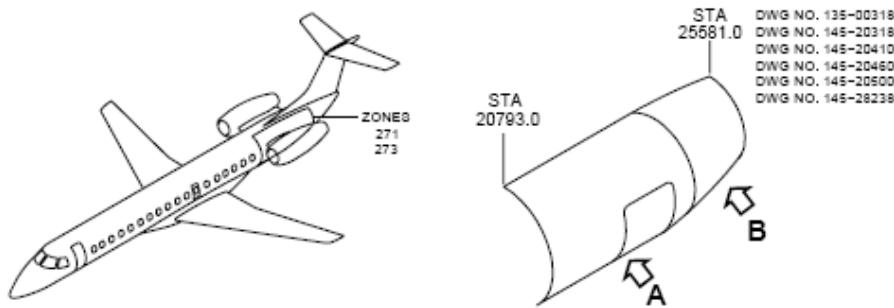
The centre section of the aircraft sustained very little damage. Substantial damage was caused to the rear fuselage lower sections I and II, which excludes the vertical and horizontal stabilisers and the engines. This was located between stations 20793.0 and 25581.0.

Figure 39: The damaged sections at the rear of the aircraft.

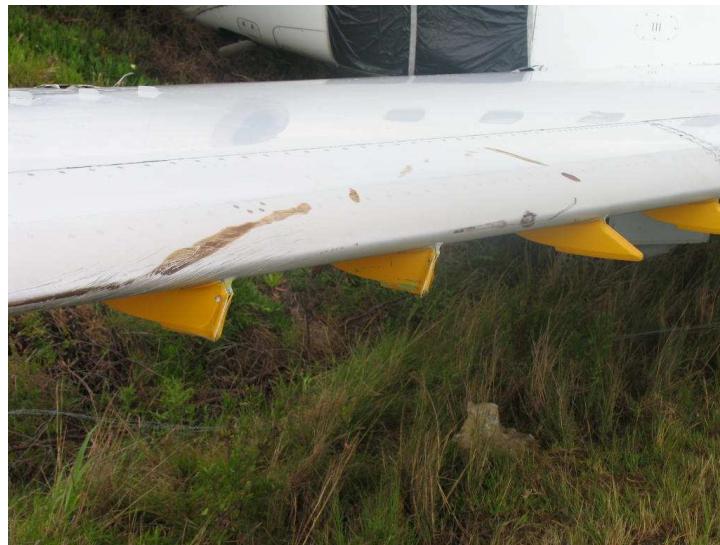
Figure 40(a): Damage to the right wing leading edge.

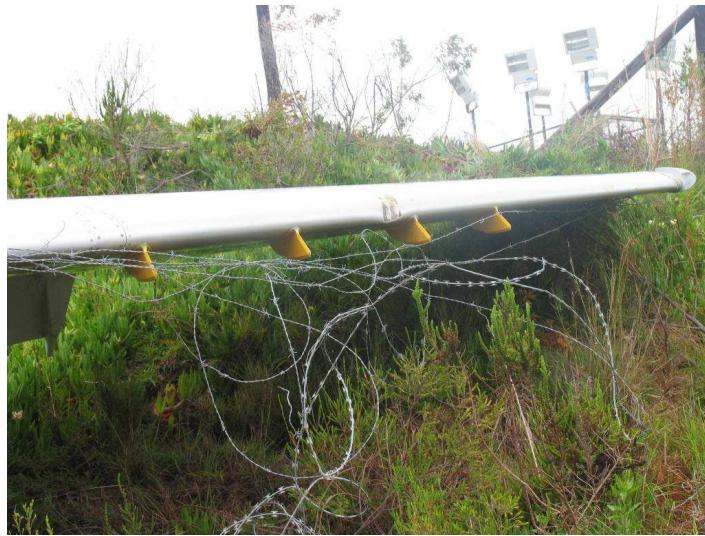
Figure 40(b): Damage to the left wing leading edge.

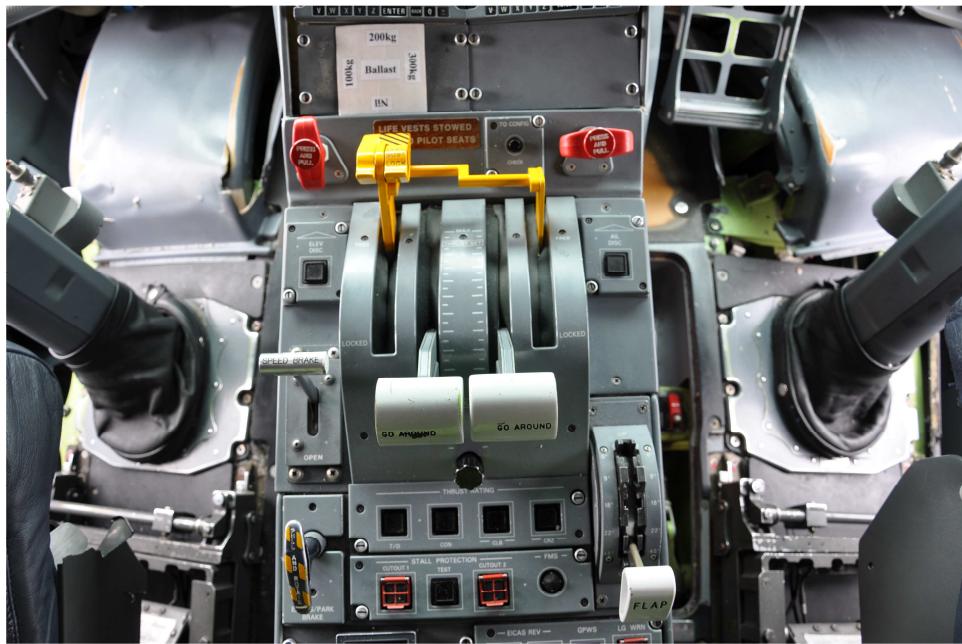
This was photographed to document switch and lever selections and positions. Instrument readings were not available, as the instruments could not be powered up during the on-site investigation. The flap lever was observed in the 45° position and the speed brake lever in the closed position. The landing gear selector lever was found in the down position. Several circuit breakers were in the deactivated (open) position. Both forward cockpit windows were shattered.

Figure 41: The lever selections in the cockpit after the accident.

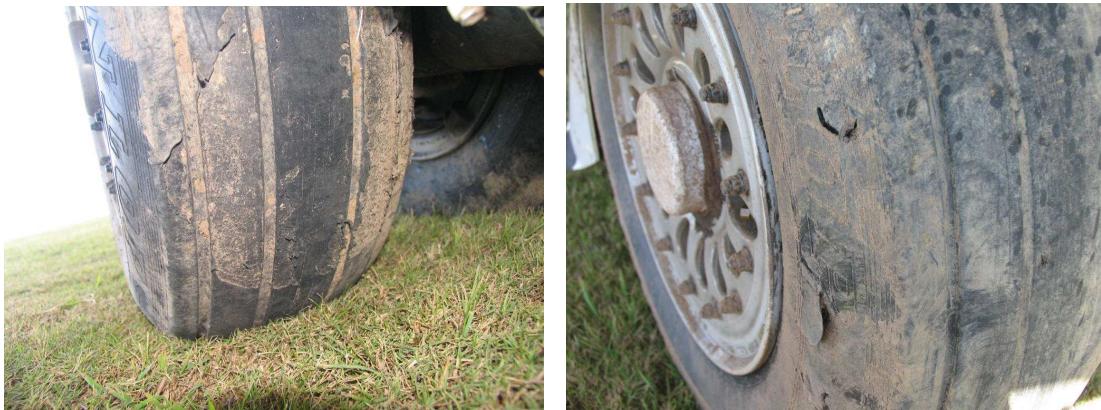
damaged during the accident due to the deformation of the nose structure. Both nose wheel tyres were deflated due to damage caused by the wheel striking the concrete base of the approach light. Several of the main tyres had significant side impact damage, so their pre-accident condition could not be evaluated with precision. There was no anomaly or unserviceability with the braking system.

Figure 43: The two tyres on the left main gear assembly showed evidence of hydroplaning and side impact damage.

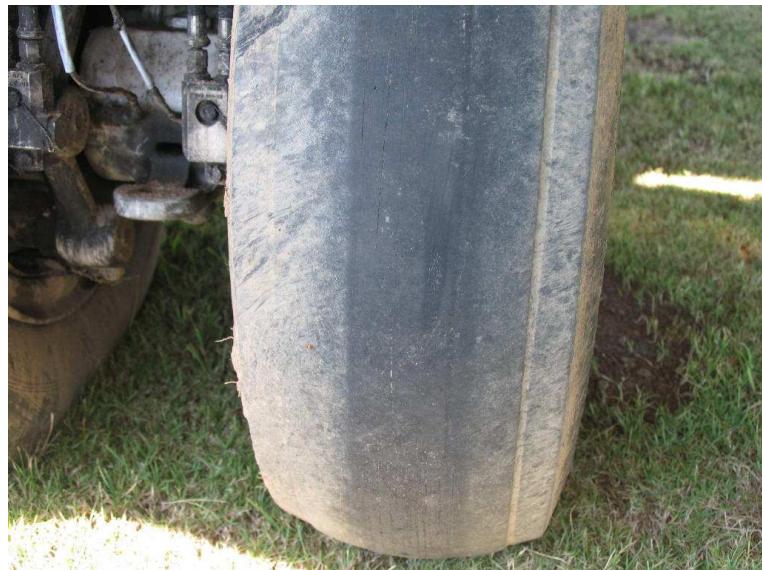
Inspection of the four main landing gear tyres during the onsite investigation displayed evidence of severe peeling associated with hydroplaning. All four remained inflated, however. The left main inner tyre's tread depth was measured as 0,5 mm. Due to a logistical problem, it was impossible to remove all four main tyres from the wreckage, so one tyre from each main gear assembly was removed – tyre No. 2, serial number 08284318, and tyre No. 4, serial number 09014331 – and forwarded to Dunlop Tyres in the UK for examination and evaluation.

Figure 45: The tread of the left main inner tyre showed an advanced state of wear.

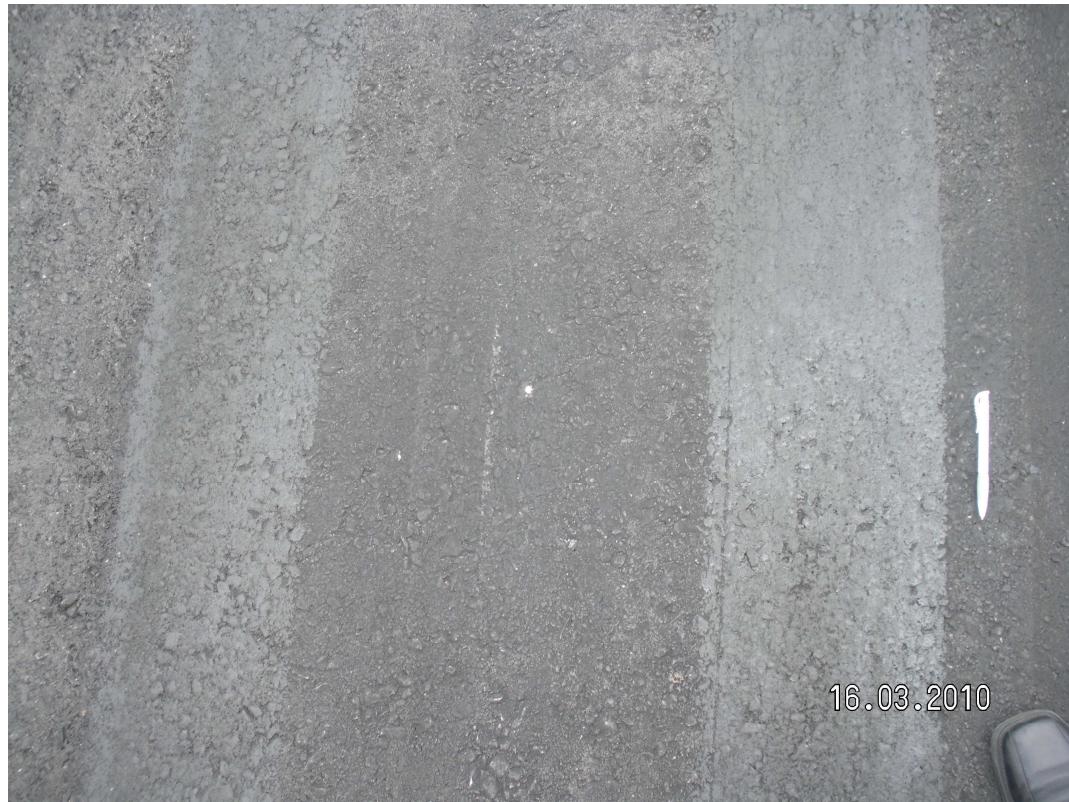
Rubber deposits from spinning tyres were observed in the touchdown zones of both runways 11 and 29. There was little difference in the macro-texture of the rubber-coated surface and the uncoated surface. The similarity in appearance and texture between the rubber-coated and uncoated surfaces did raise a concern about the nature of the runway macro-texture: should the rubber deposits be removed, it might have had very little, if any, effect on the macro-texture of the surface.

Figure 46: The texture of the tyre markings and adjacent runway surface

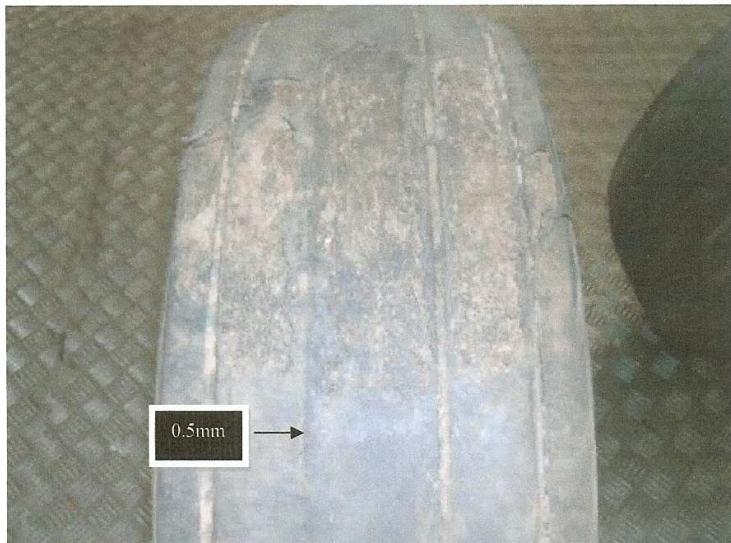
Photo # 1
Tyre serial number 08284318 exhibiting an area of tread with partial melting of tread rubber approximately the area of the tread footprint.

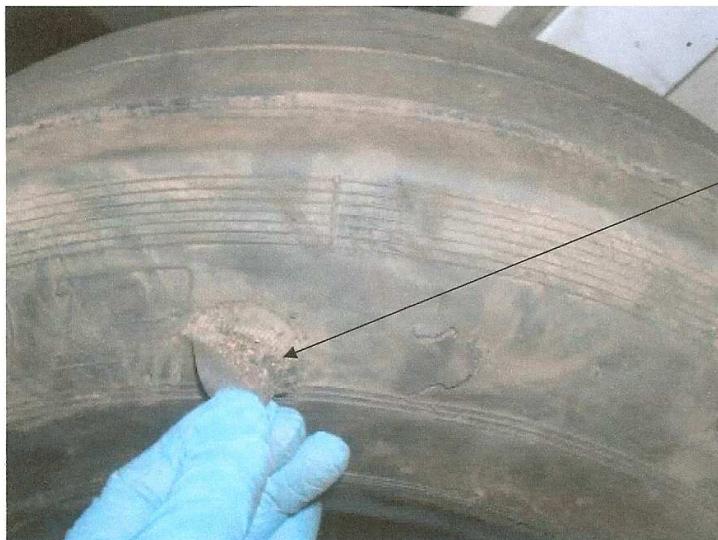
Photo # 2 tyre serial number 08284318 shows gouges and cuts to the tyres sidewall. This damage is considered to have occurred as a result of the tyre aquaplaning

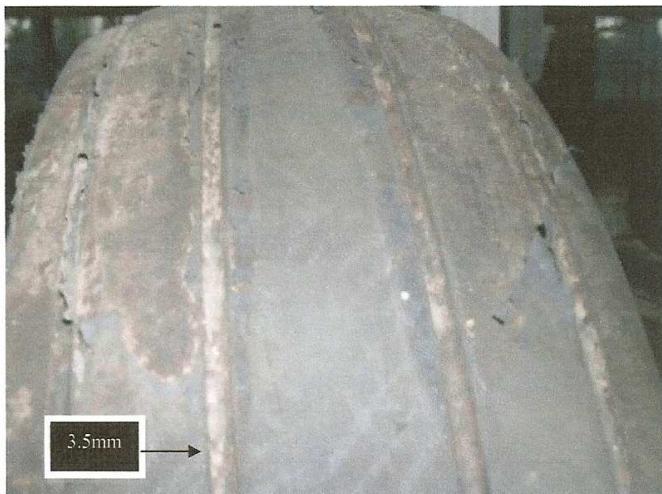
Tyre serial number 09014331 with a similar appearance of partly melted tread rubber as exhibited by tyre serial number 08284318.
