**AVIATION INVESTIGATION REPORT
A11C0100**

**COLLISION WITH TERRAIN
LAWRENCE BAY AIRWAYS LTD.
DE HAVILLAND DHC-2, C-GUJX
BUSS LAKES, SASKATCHEWAN, 2 NM SE
30 JUNE 2011**

Report Number A11C0100

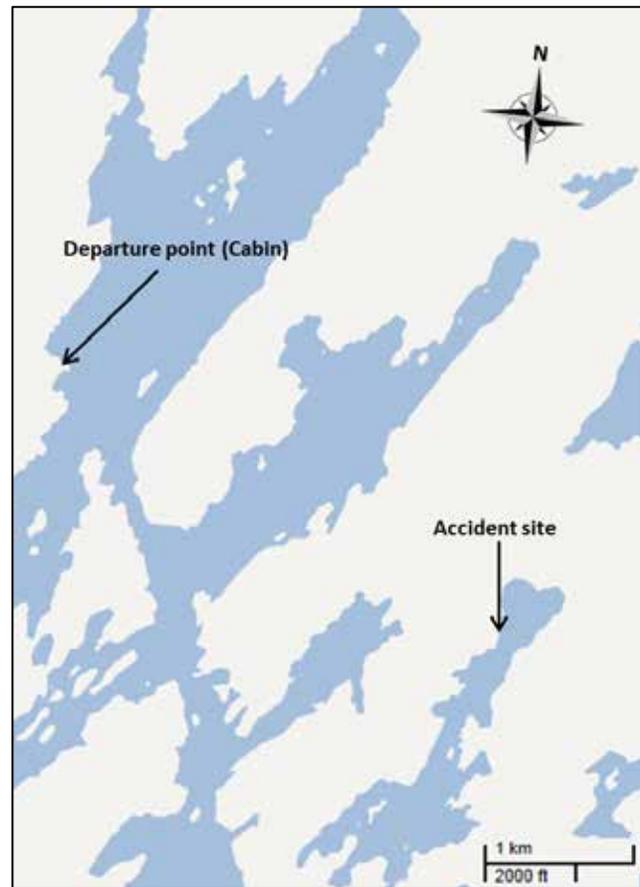
Figure 1. Buss Lakes

The wreckage was located partially submerged in the water on the north shoreline of one of the Buss Lakes approximately 2 nm southeast from the departure lake where the fishing cabin was situated. A portage was required to reach the accident lake by boat from the departure lake (Figure 1).
