**AVIATION INVESTIGATION REPORT
A11P0149**

LOSS OF CONTROL AND COLLISION WITH GROUND

**NORTHERN THUNDERBIRD AIR INC.
BEEHCRAFT KING AIR 100, C-GXXR
VANCOUVER INTERNATIONAL AIRPORT
RICHMOND, BRITISH COLUMBIA
27 OCTOBER 2011**

Report Number A11P0149

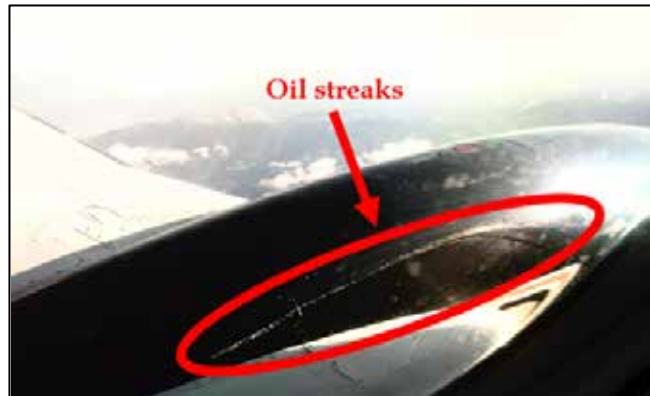
Photo 1. Left-engine oil leak

Before the flight, an oil puddle was discovered under the left engine after the aircraft was taxied to pick up the passengers at a different fixed-base operator (FBO). The crew was aware of this oil, but no further action was taken to determine the source. Overfilling the oil reservoir will cause oil to vent, but it could not be determined whether the captain thought that this was the cause.

The investigation determined that, while a significant amount of oil had leaked from the left engine through the unsecured oil filler cap, enough remained to allow the engine and propeller to operate normally.

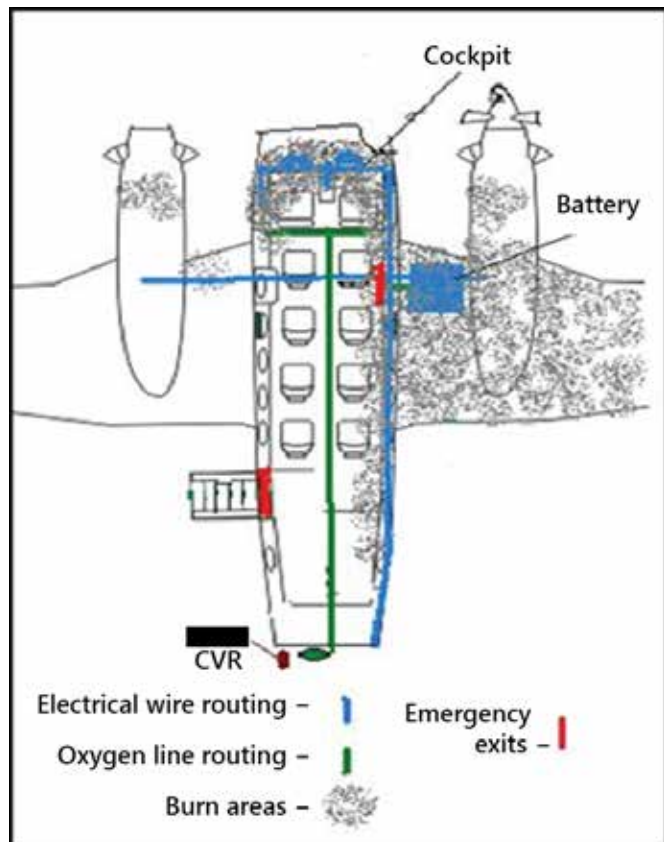
Figure 4. Battery-powered circuits and fire damage

The wreckage left a trail of fire that was consistent with spilled fuel ignited by the landing gear rubbing on asphalt. The right side of the aircraft burned more than the left side (Figure 4).

After the aircraft and engines stopped, the fire was concentrated on the right wing and in areas where the aircraft's electrical-system wiring was routed. The wiring converges to the cockpit area and would have been energized by the battery located in the right wing, until it was disconnected by the investigators hours later. The areas of thermal heat and fire damage mostly matched the areas of the aircraft's main electrical wiring (Figure 4).

Impact damage broke fuel lines and spilled fuel that ignited, causing significant fire and smoke. Some of the fire-damaged areas match the main electrical-wiring areas of the aircraft, possibly

because damaged wiring powered by the battery supported fire in those areas. This hypothesis is supported by evidence that electrical arcing occurred until the battery was disconnected by investigators.

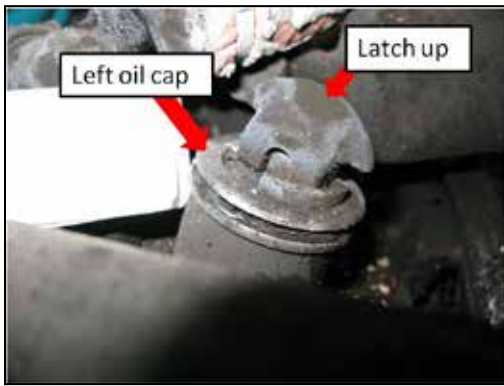
Photo 3. Oil reservoir cap, left engine

⁹ The cap is closed securely by a latching mechanism that requires one to twist a tab 90° and fold it down.

Except for the unlocked left-engine oil filler cap, examination of the wreckage revealed no pre-existing mechanical conditions that would have contributed to the accident. The following analysis focuses on human factors, the operation of the aircraft, aerodynamic characteristics of the aircraft, and crash survivability.

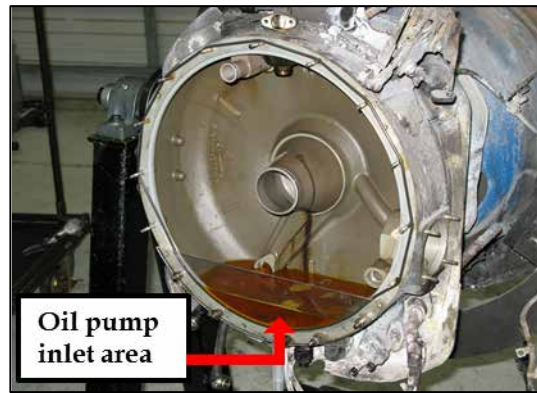
Photo 4. Oil remaining, left engine

Teardown examination of the left engine showed similar damage, consistent with operation at low power (near idle). Similar discolouration marks indicated that there was about 0.8 of a litre of oil remaining in the reservoir after impact. This amount, however, was sufficient to cover the oil pump inlet (Photo 4), meaning that oil was still being supplied to the engine.

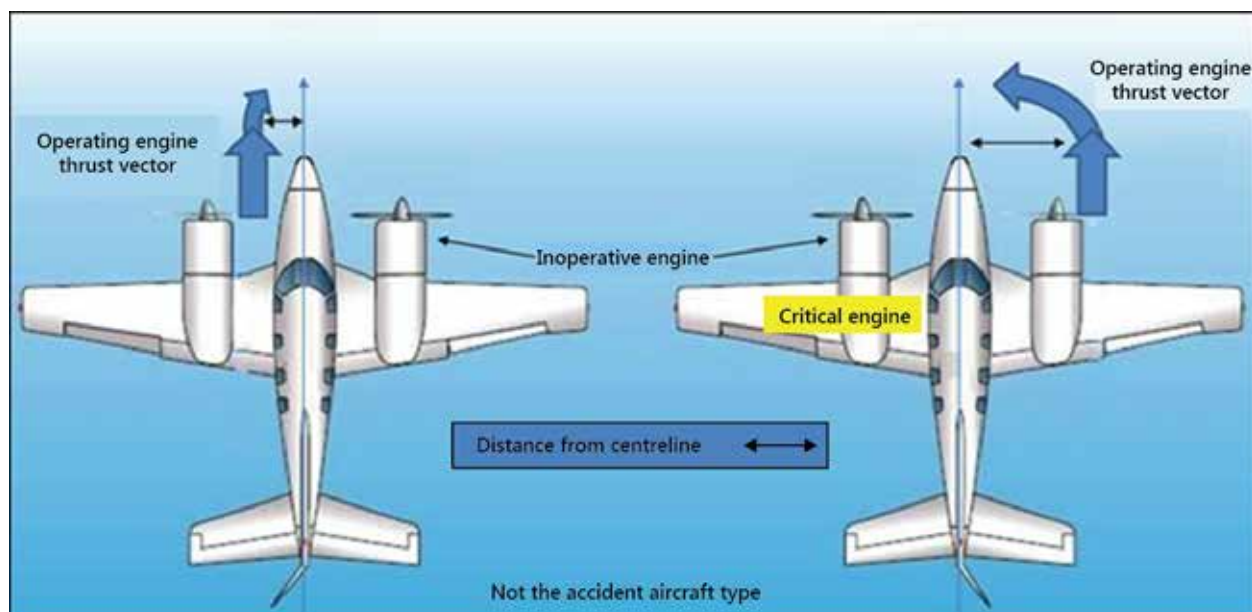
Figure 6. Asymmetrical thrust (Adapted from Figure 12-19, *Airplane Flying Handbook*, FAA-H-8083-3A [US Government Printing Office, Washington DC: 2004], page 12-28. Modifications by TSB.)

On twin-engine aircraft where both engines turn clockwise, such as the Beechcraft King Air 100, the left engine is considered critical (Footnote 5). When an engine becomes inoperative, a yaw effect will develop. The yaw effect varies with the lateral distance from the aircraft's centreline to the thrust vector of the operating engine. This effect is amplified by the thrust produced by the operating engine. Due to the P-factor,¹¹ the right engine develops its thrust vector further away from the aircraft's centreline than does the left engine. The failure of the left engine will result in a larger yaw effect from the operating right engine (Figure 6).

The aircraft had slowed below the V_{REF} speed and below the minimum speed to maintain directional control for its configuration during the final stages of the approach to land. The captain took action to regain V_{REF} speed by adding power; when power was added, it was likely added only to the right engine. Having the left engine at idle and the propeller not feathered caused the aircraft to yaw left due to asymmetrical thrust/drag. The asymmetrical thrust was compounded by the P-factor, as the angle of attack increased when the aircraft slowed. Because the airspeed was low, the rudder was not effective enough to arrest the yaw.

These combined effects caused the aircraft to yaw left and roll, and to pitch down.

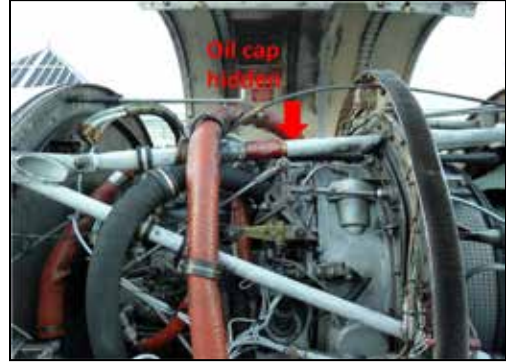
Photo 5. Oil cap hidden from normal view

The overnight maintenance-inspection checklists include “check engine oil level” as one of their tasks. This task implies removing the oil reservoir cap and replacing it; however, there is no check for verifying the security of the cap. The cap is difficult to see when closing the engine cowling (Photo 5).
