Final Report No. 2140 by the Swiss Accident Investigation Board SAIB

concerning the accident involving the
Raytheon 390 aircraft, registration D-IAYL

on 19 December 2010

Bever/GR

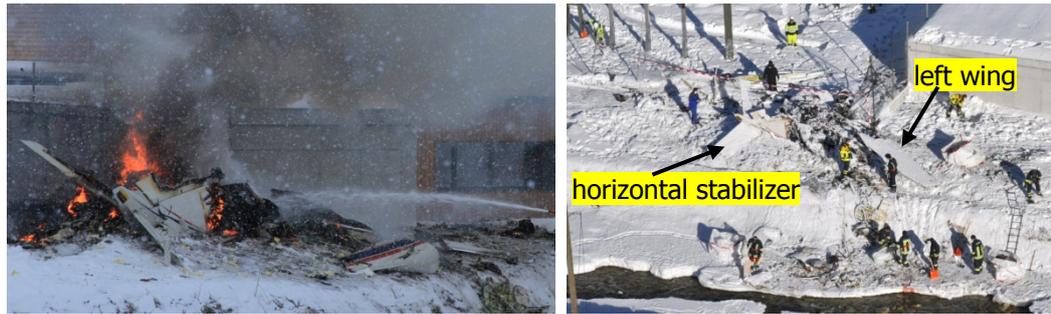
The debris field extended over a very small area, as a result of the virtually vertical dive before impact. The explosion-like fire which broke out therefore affected almost all the parts of the wreckage.

Figures 2 und 3: Horizontal stabilizer and tailcone (left); Debris after extinguishing the fire (right)

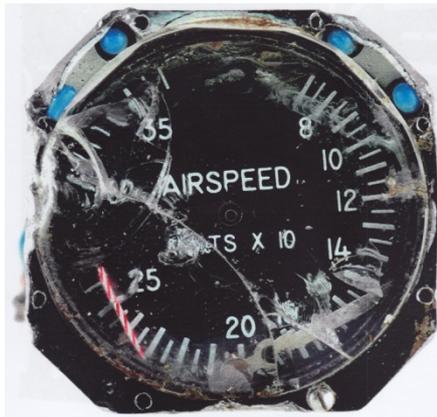
Figure 4: *standby airspeed indicator*

The traces on the detached white pointer of the airspeed indicator indicate that the pointer touched the dial when it became detached. It was found that traces of abrasion are present which could have been produced by contact with a pointer on the one hand between the indicated values of 120 kt and 125 kt and on the other hand between the indicated values of 180 kt and 185 kt. The last airspeed recorded in the EGPWS before impact indicates a calibrated airspeed (CAS) of 122.2 kt, which approximately corresponded to the indicated airspeed (IAS) indi-

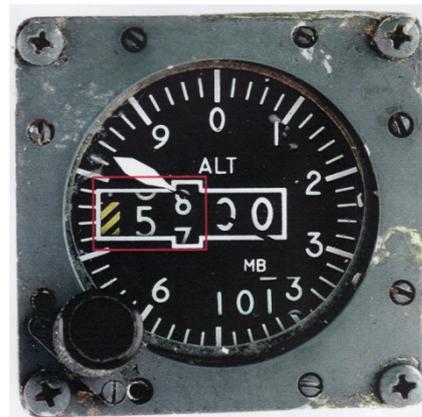
Figure 5: *standby altimeter*

There are no pointer marks on the dial; this can be explained by the fact that the pointer moved approximately 2 mm above the dial. The traces noted in connection with the indication show that the number drums concerned were indicating a value between 5700 ft and 5800 ft on impact. This does not correspond exactly with the tip of the pointer, which indicates a reading of 5830 ft. The point of impact is at an elevation of 5610 ft AMSL. In this context it must be borne in mind that the number drum for pressure indication must have read 1012 hPa on impact. It must be assumed the value was set at the standard pressure of 1013 hPa. This setting corresponds to a difference of 11 millibars from the local pressure at the time of the accident, which led to an altitude indication in the aircraft, which was 352 ft above the actual value. Since no pointer traces were found on the dial, however, no precise statements can be made concerning the actual pointer indication at the time of impact.

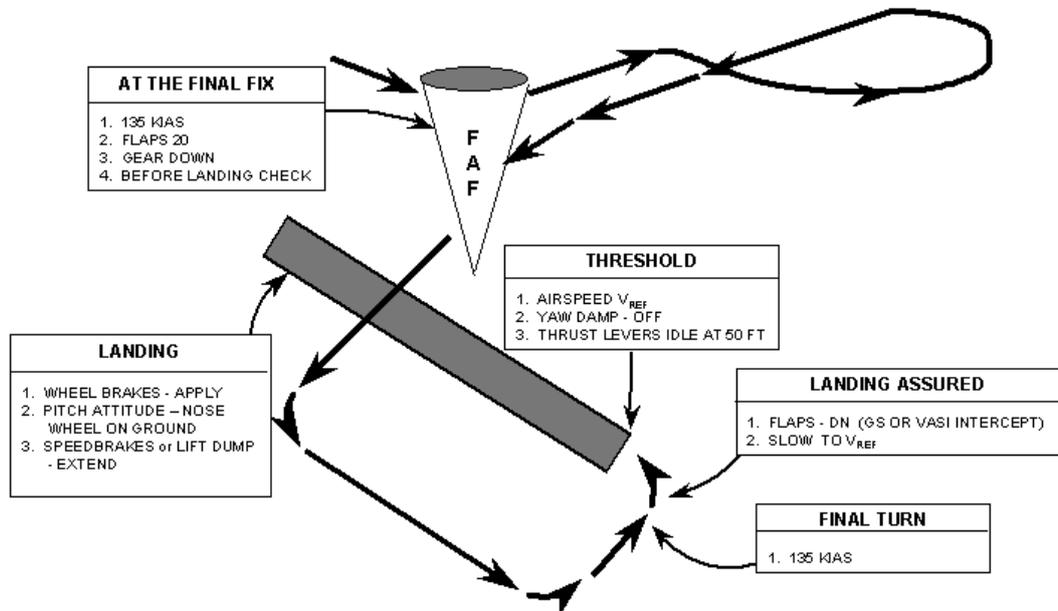
Figure 6: schematic presentation of the circling approach

As the figure shows, on transition to level flight and before the final turn (or base turn) is initiated, the airspeed must be 135 KIAS. It is expected that the flaps are set at the 20° position and the landing gear should be extended.

In this context it should be noted that at a speed of 135 knots and a bank angle of 30 degrees, a radius of 850 metres is needed to execute a 90 degree turn. This means that for a 180° turn from the downwind leg onto the runway centre line a minimum distance of 1700 metres is required between the downwind and the runway.

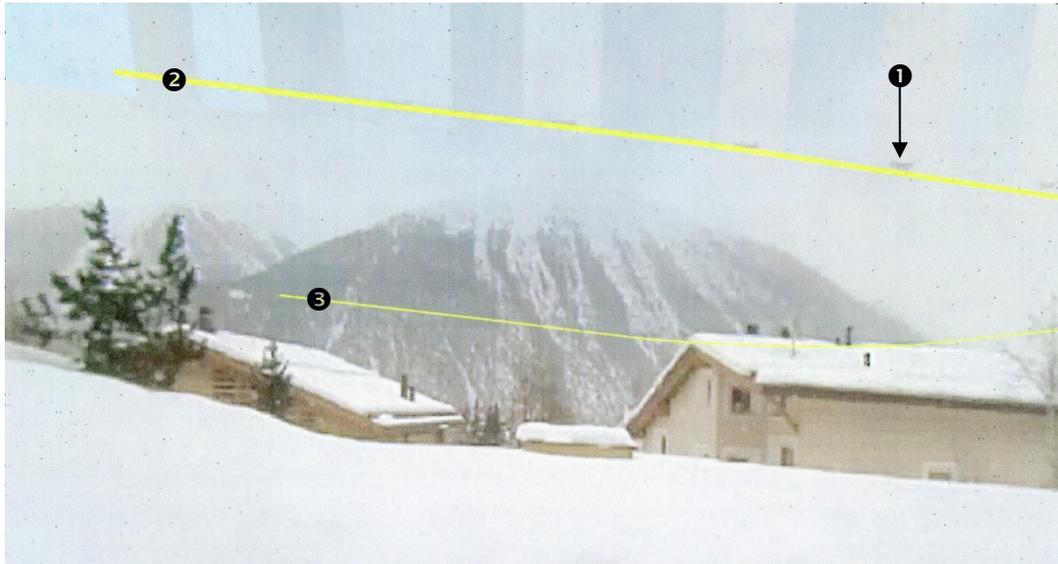
Figure 7: Snapshot from the video recordings

- ❶ Aircraft D-IAYL
- ❷ D-IAYL flight path on downwind
- ❸ D-IAYL flight path after overflying the runway threshold according to EGPWS recordings (not recognisable on the video)

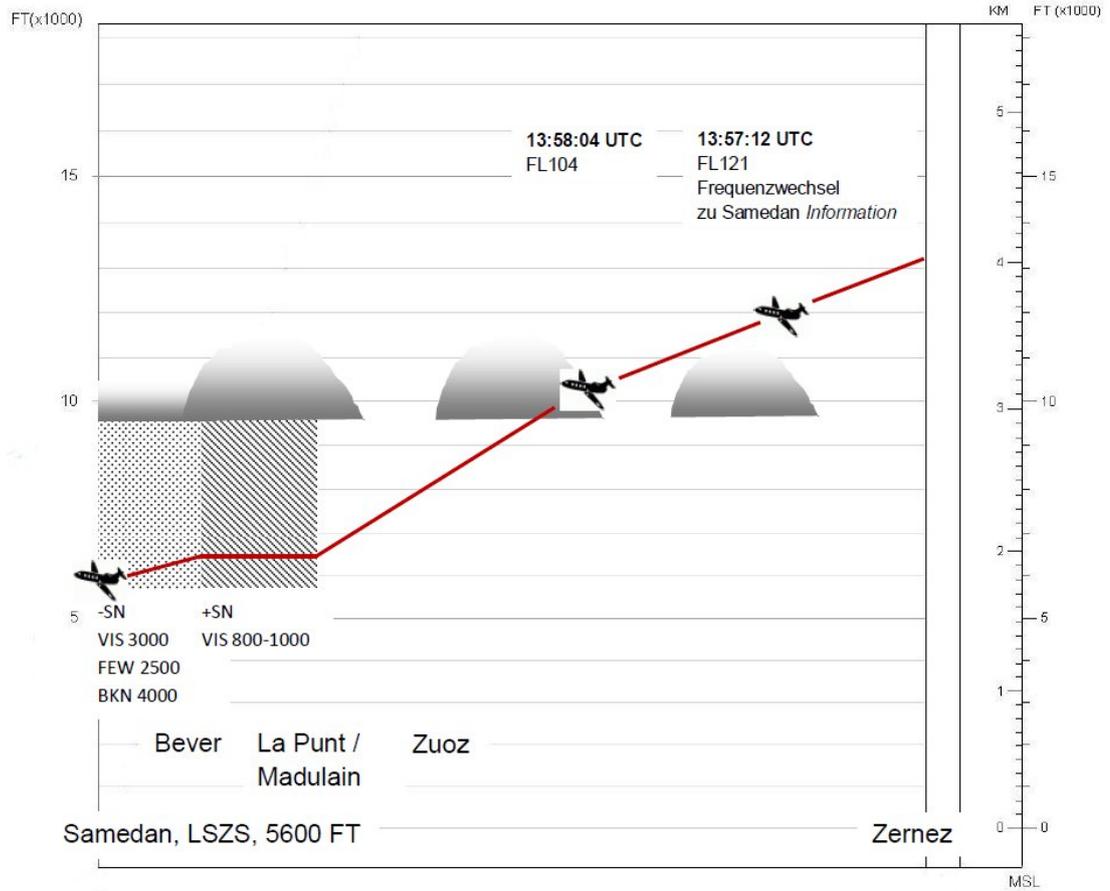
Figure 9: — Flightprofile of the D-IAYL during approach to runway 21

Because of the stable thermal stratification, there was no convection. The intense snowfall was triggered in particular by vertical movement on the upwind side of the wave and by the topography. The wind from Val Bever mentioned by one witness corresponded to the flow of cool air below the driving snow, guided by the topography.

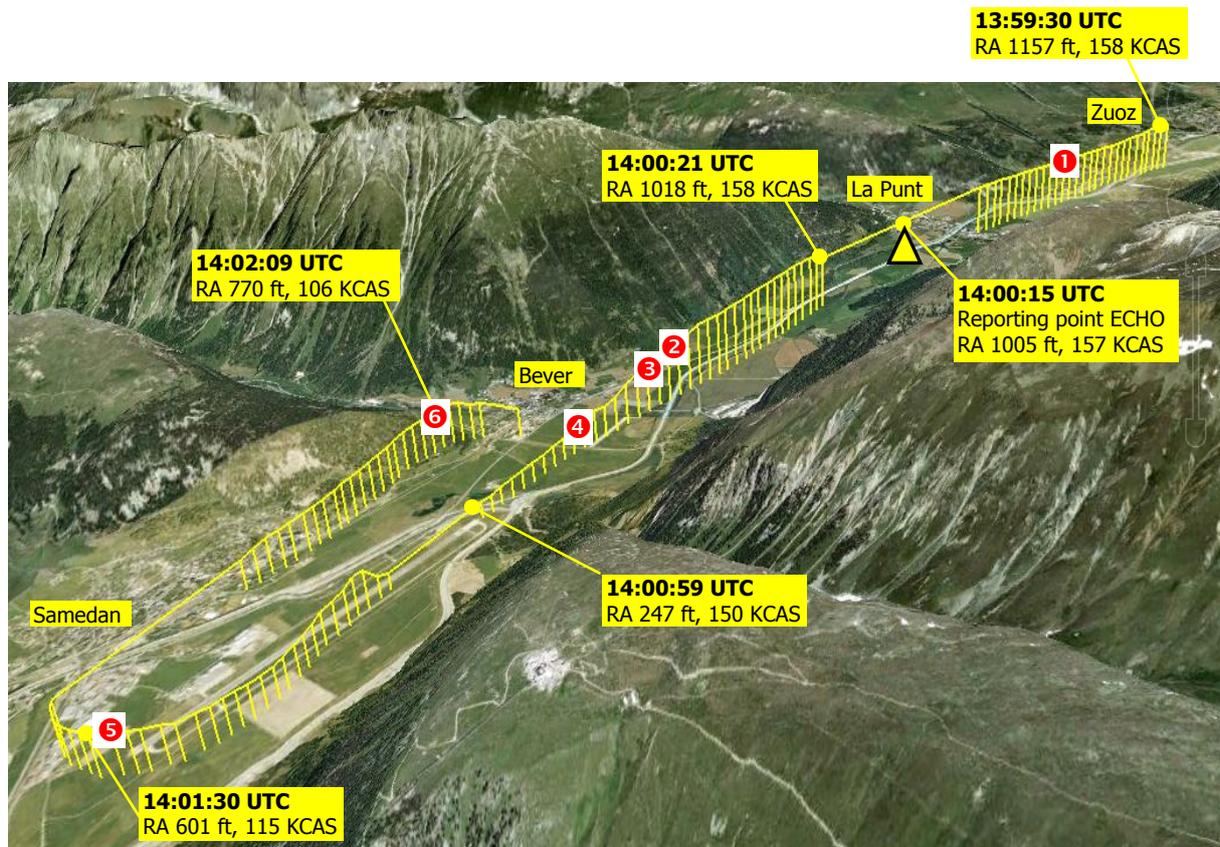
Annex 2: Flight path according EGPWS recordings

- ① EPWGS alert "*caution terrain!*" sounds (only if TERR INHIB is not deactivated)
- ② EPWGS alert "*sink rate!*" sounds
- ③ EPWGS alert "*pull up!*" sounds
- ④ EPWGS alert "*sink rate!*" sounds
- ⑤ EPWGS alert "*bank angle!*" sounds
- ⑥ EPWGS alert "*bank angle!*" sounds

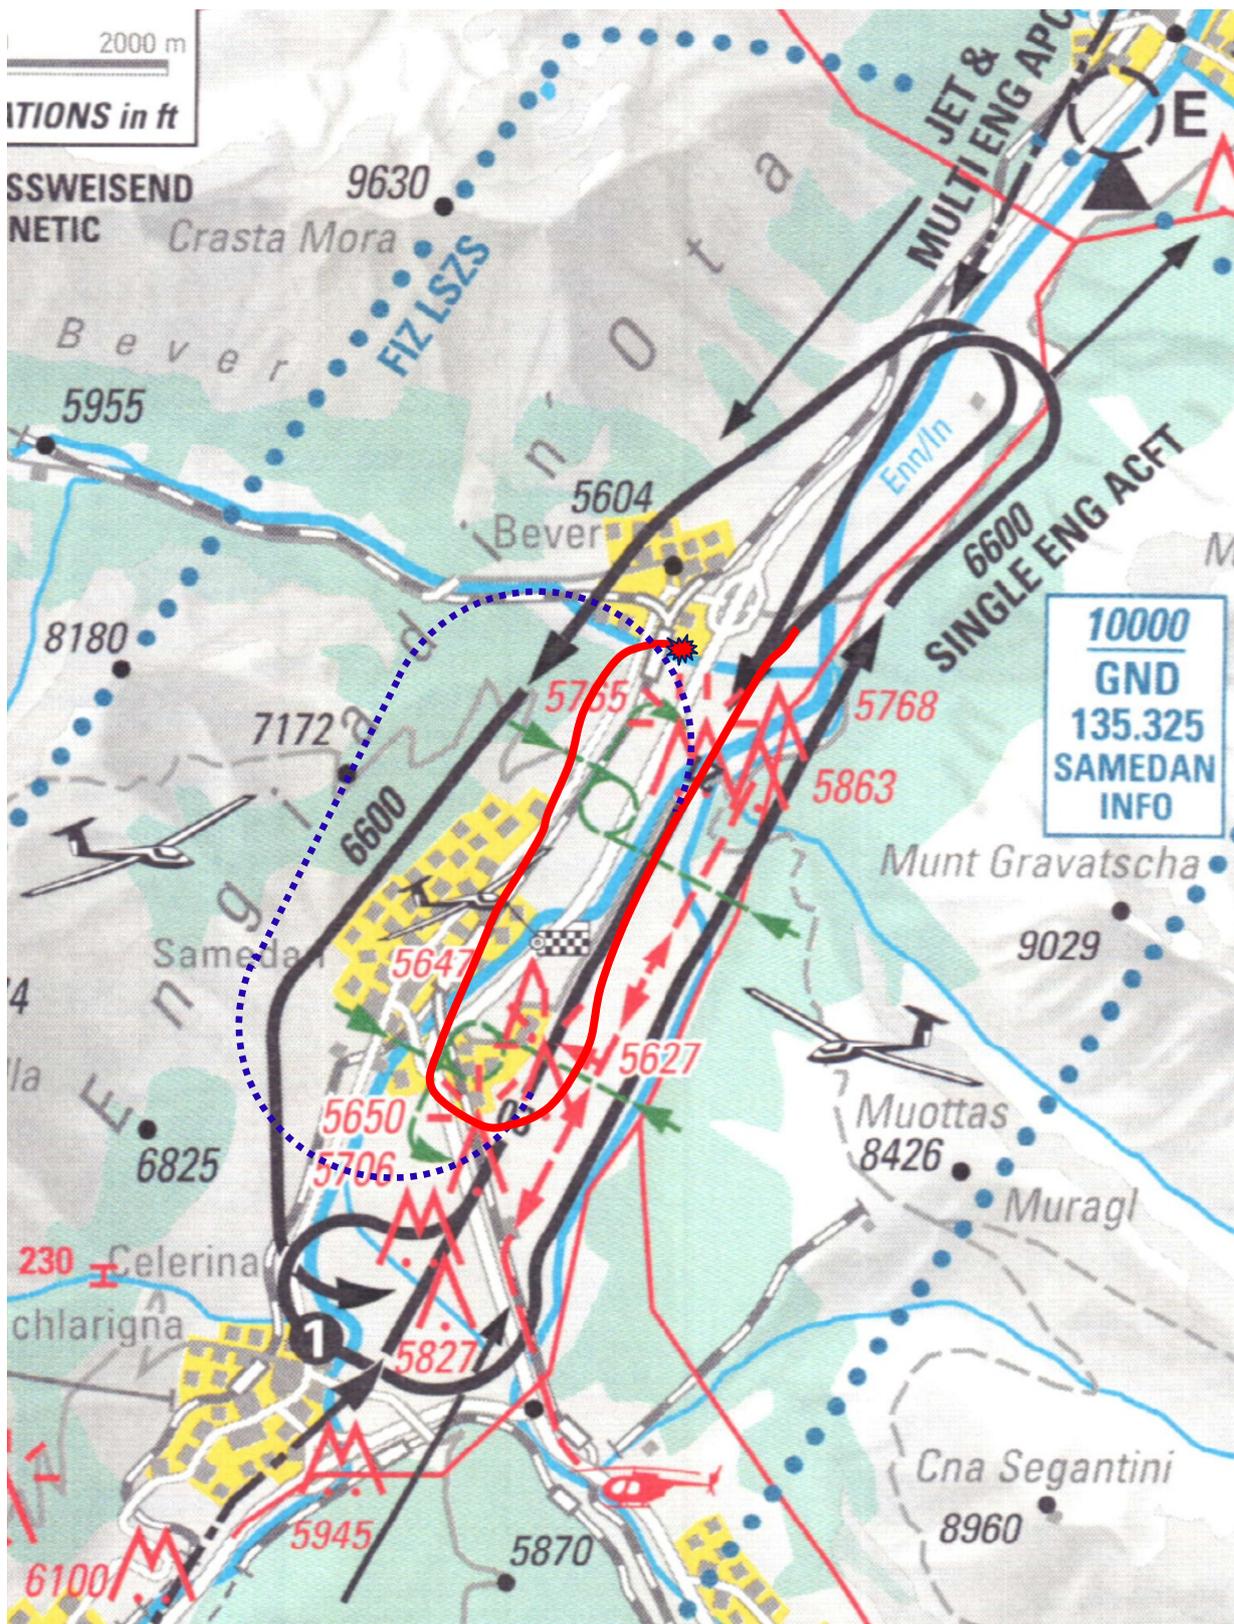
Annex 7: Extract from visual approach chart Samedan with flight path D-IAYL

- flight path D-IAYL according EGPWS recordings with crash site
- ⋯ for comparison a fictitious circling approach is drawn. The turn radiuses are based on a bank angle of 30 degrees and a airspeed of 135 knots.

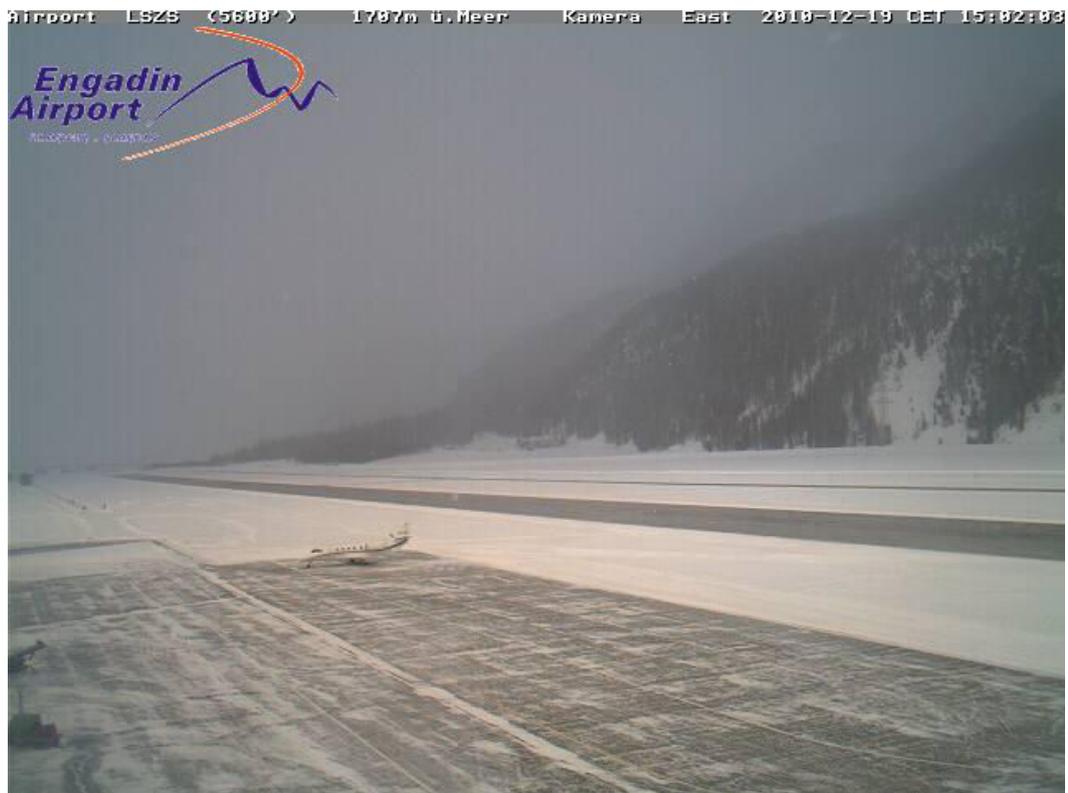
Annex 9: Images of the Samedan airport webcam

Image from 19 Dezember 2010 at 14:02:03 UTC, view direction runway threshold 21. On top left the grey wall with blowing snow extending to the ground is visible. At the same time west of the airport, at the rear of the observer, gaps in cloud are standing out, brightening the tarmac. Those gaps belong to the wave trough in the cloud between Samedan and Celerina.

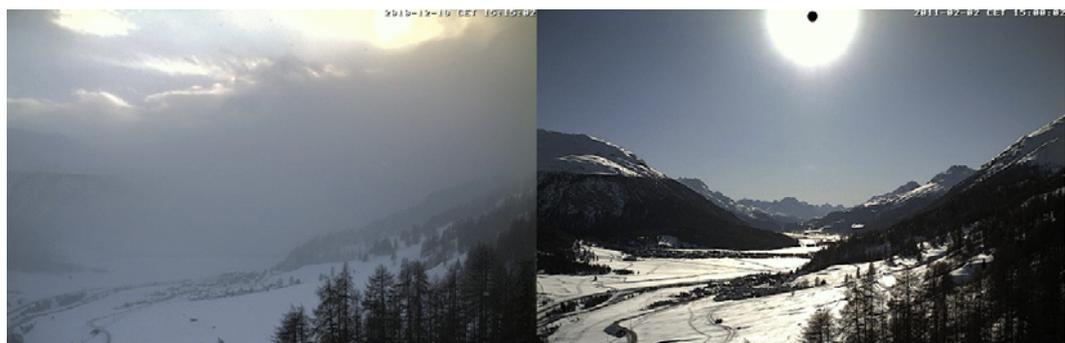
Annex 10: Images of a webcam in Zuoz

Both images come from the webcam on the Hotel Castell in Zuoz. On the left image the north edge of the cloud band with +SN on 19 December 2010 at 14:15 UTC is visible. The image to the right shows the same detail in a cloudless situation. The village in the foreground is Madulain.

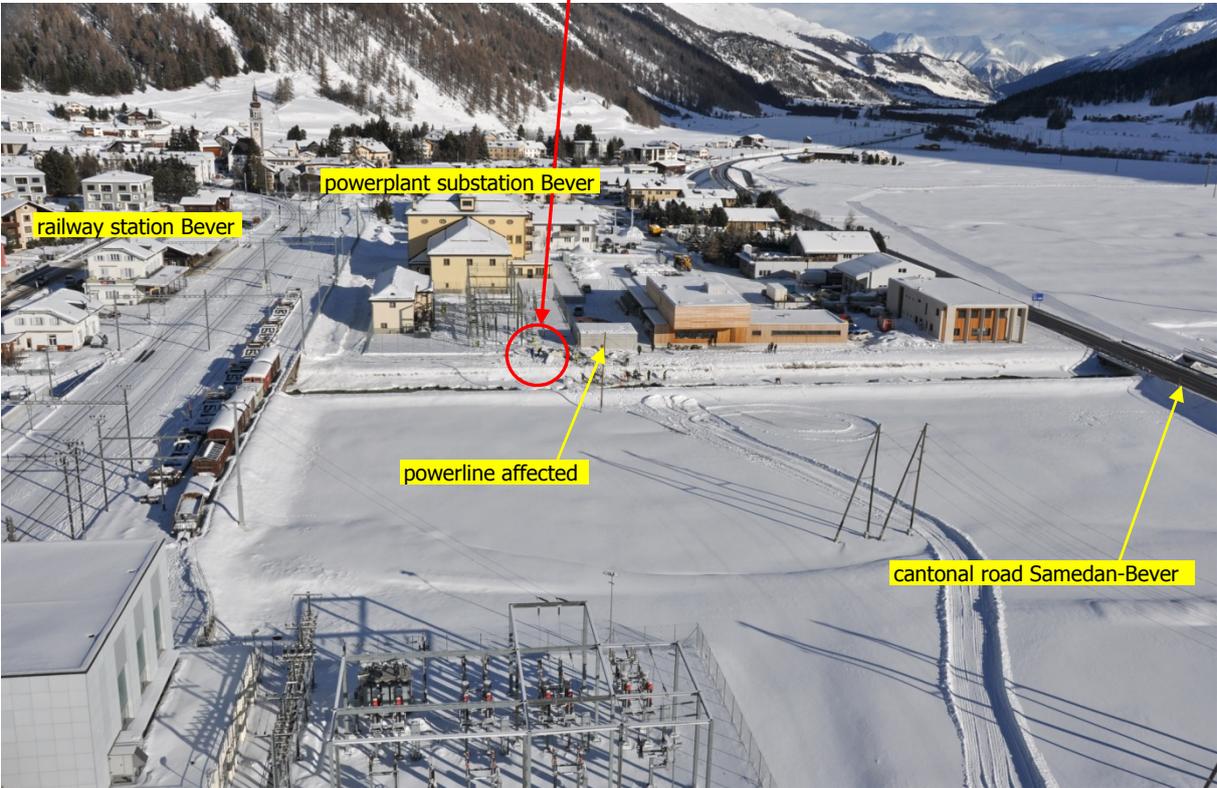
Figure 2: accident site ○ at the powerplant substation Bever (Repower)
