FINAL
KNKT.11.05.10.04

Aircraft Accident Investigation Report

**PT. Merpati Nusantara Airlines
Xi 'An Aircraft Industry MA60; PK-MZK
Utarom Airport, Kaimana - Papua Barat
Republic of Indonesia**

07 May 2011

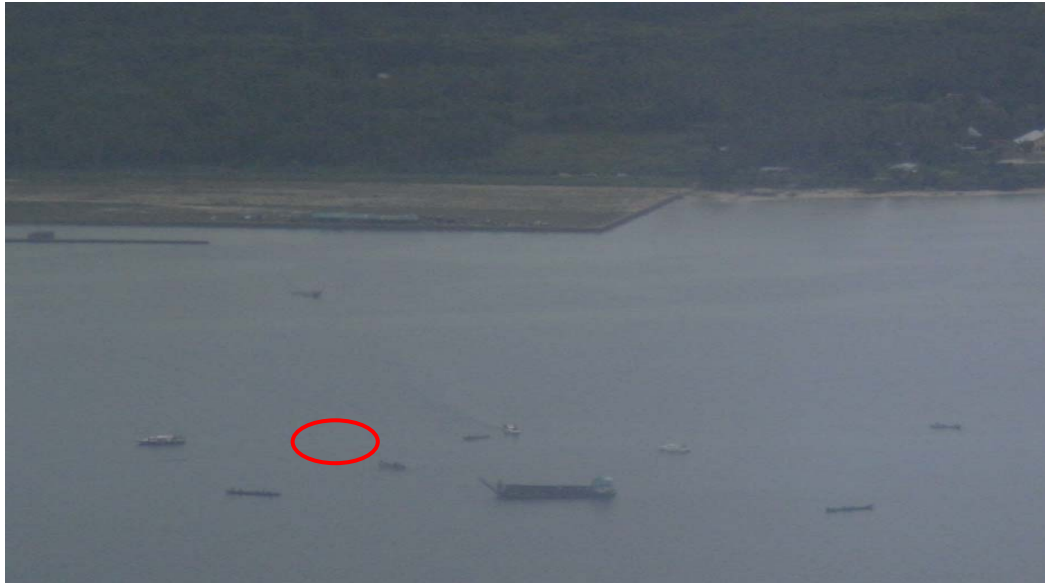
Figure 2: Accident Site (red circle is the impact point)

The accident site was about 800 meters south-west of the beginning of runway 01 or 550 meters from the coastline. The position of the main wreckage was 03° 39' 8" S; 133° 41' 15" E. Most of the wreckage was submerged in shallow sea between 7 to 15 meters deep (Figure 2).

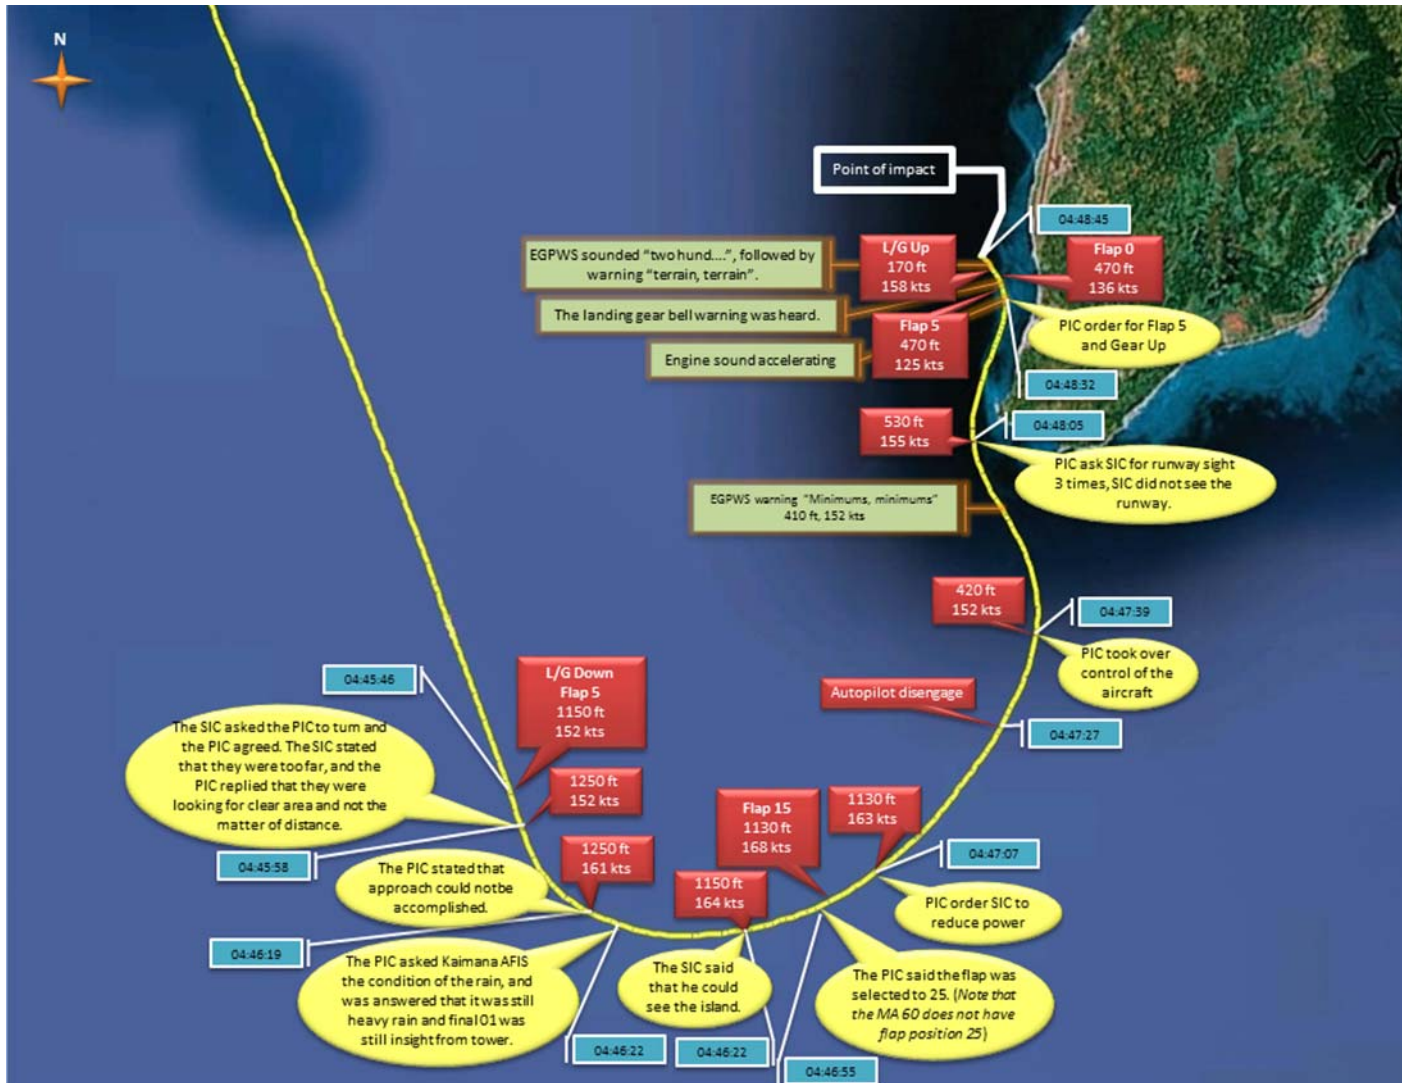
Figure 3: Events in the final segment of flight

The aircraft roll to the left with bank angle of 11 and continuously increased up to 38 degree. The rate of descend increased significantly up to about 3000 feet per minute and finally impacted into the shallow sea.

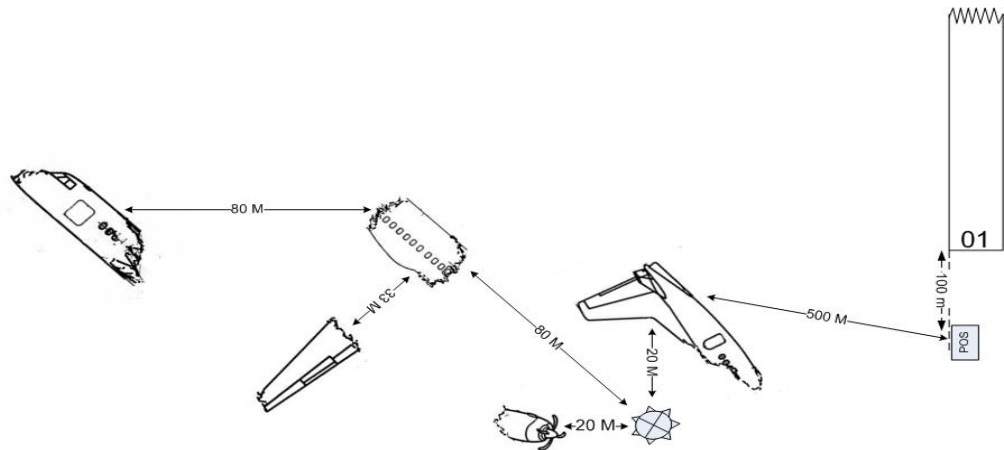
Figure 6: Wreckage distribution (not to scale)

The wreckage was spread over an area around 100 m x 200 m on the sea floor.

Light parts of the aircraft such as seat cushions and pieces of propeller blades were immediately recovered, while large parts such as two broken fuselage pieces, the left wing, center section, the left engine gearbox, landing gears, and the empennage were later salvaged from the sea.

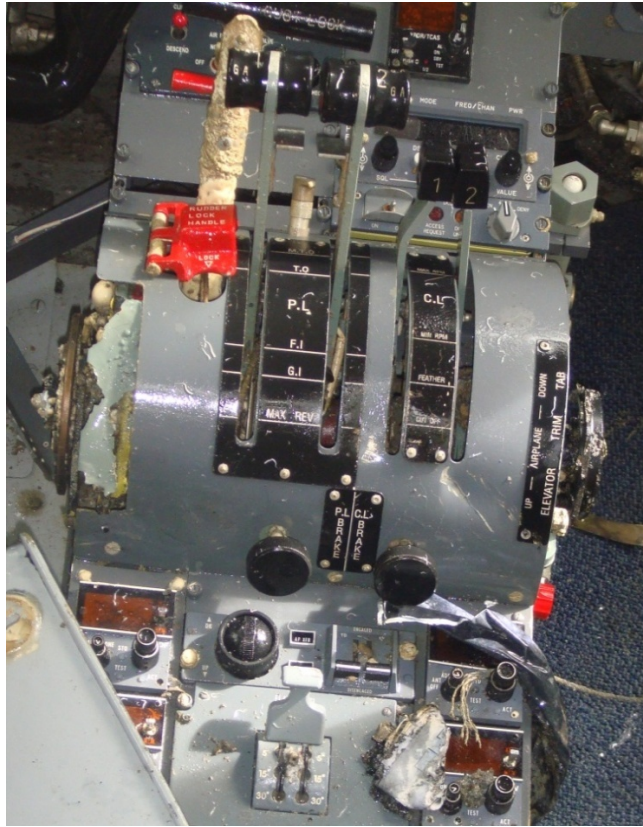
Figure 7: Recovered Pedestal

The landing gear handle was found in the up position. The condition levers (propeller control levers) were in the maximum forward position. The engine power levers were in the forward position. The flap selector was in the 0 position (Figure 7).

The aircraft had three flap screw jacks on each wing. Four of the six flaps screw jacks were recovered and found in the fully retracted position.

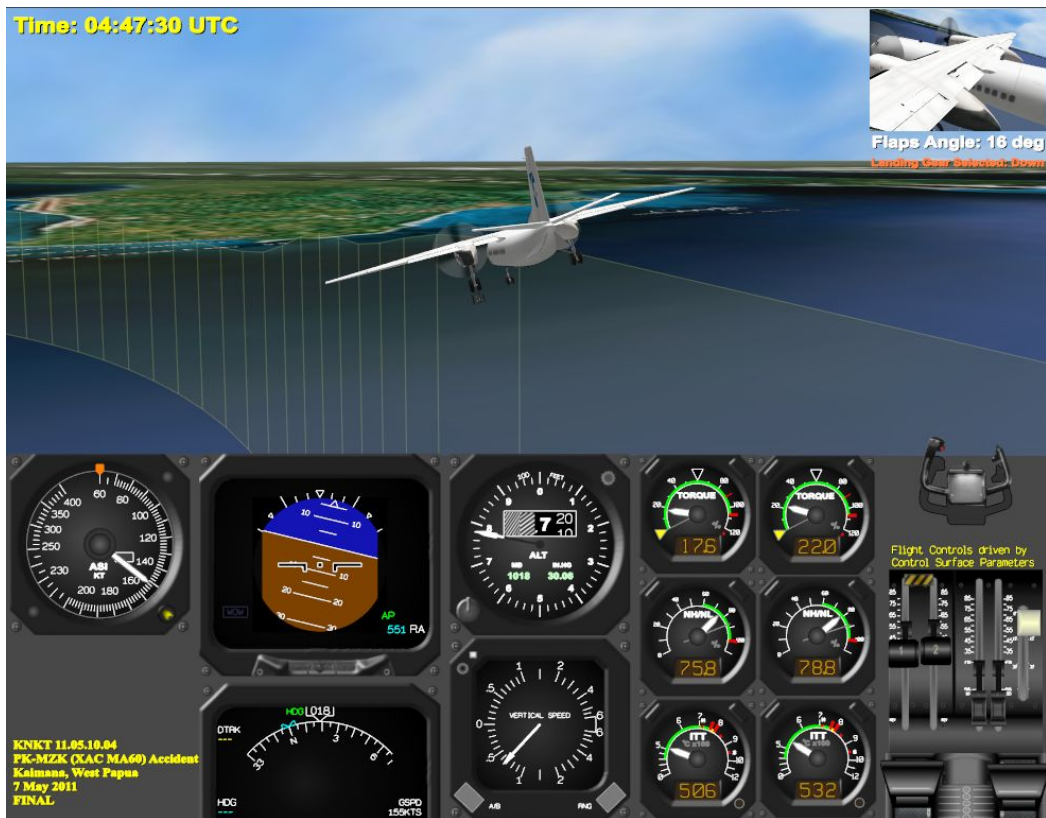
Figure 8: Screenshot of flight animation

Kaimana did not have an instrument approach procedure and an approach should be conducted in visual approach under Visual Meteorological Condition (VMC). At the time of the accident, the weather at Kaimana was raining with the visibility of two kilometers and did not meet the DGCA and operator requirements for a visual approach having visibility of more than five kilometers.

The crew did not conduct an approach briefing. During the final segment of the flight the crew became preoccupied by looking outside the aircraft to find the runway.
