PRELIMINARY
KNKT.11.12.26.04

Aircraft Accident Investigation Report

PT. Merpati Nusantara Airlines

CASA 212-200; PK-NCZ

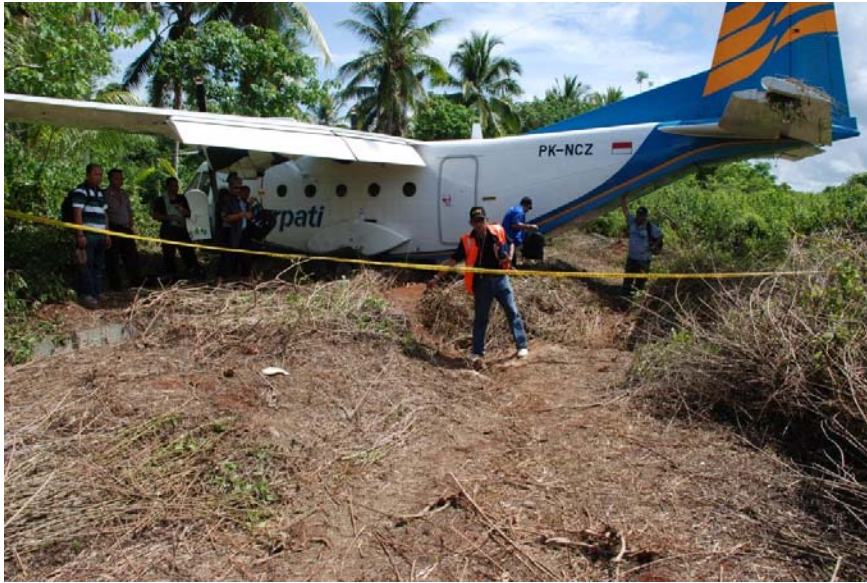
On 3 December 2011 at 04:07 UTC a Casa 212-200 aircraft registered PK-NCZ operated by PT. Merpati Nusantara Airlines on a scheduled flight from Langur to Larat, touched down at 224 meters from runway 09, was bouncing twice to the left of runway centre line, out of the runway and stopped at 607 meters from runway 09 touch down area as final position, and 15 meters to the left of runway edge.

Figure 1: Final position of the aircraft 15 meters to the left of runway edge, 607 meters from touch down area runway 09.

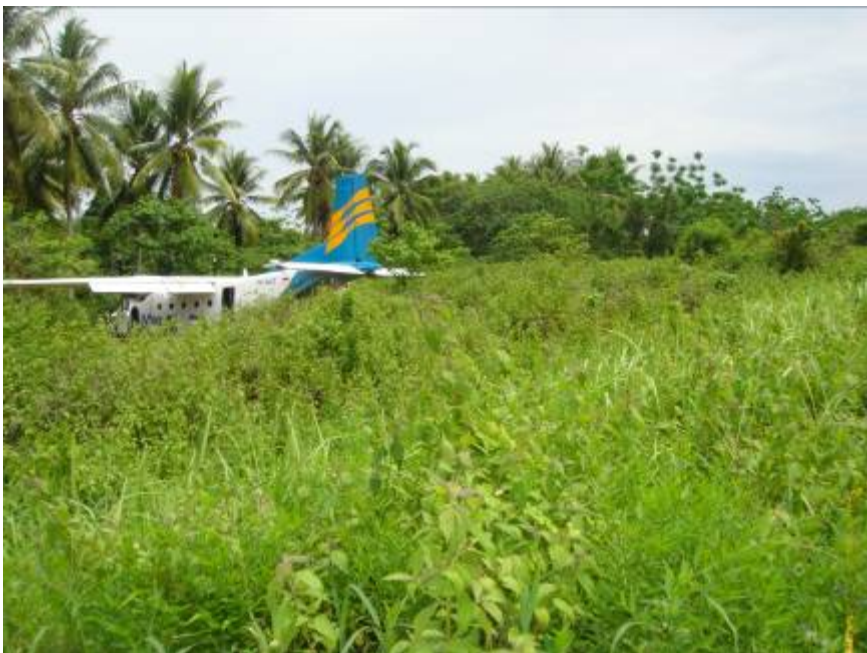
Figure 2: No sign of landing gears marking on the grass

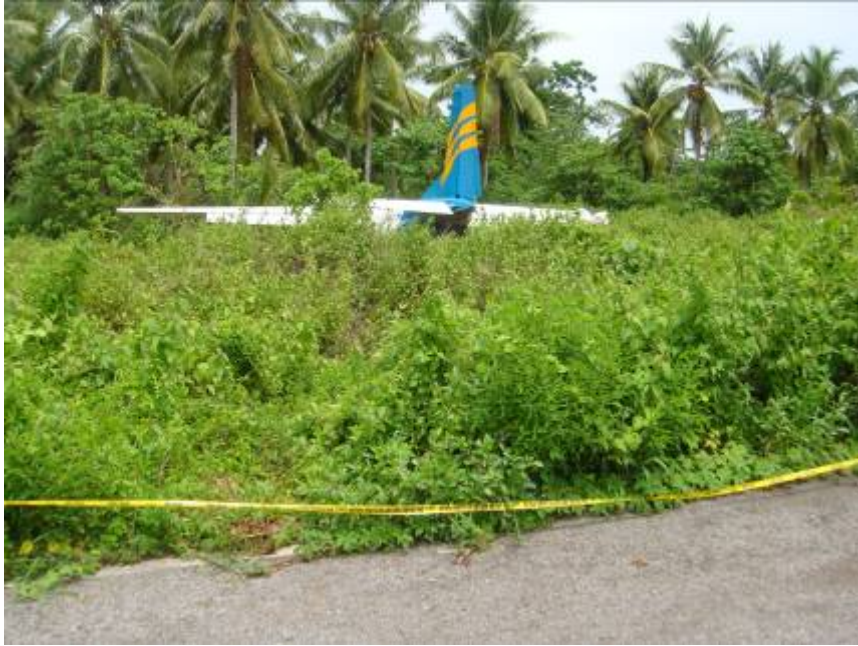
Figure 3. Only one landing gear mark on the grass.

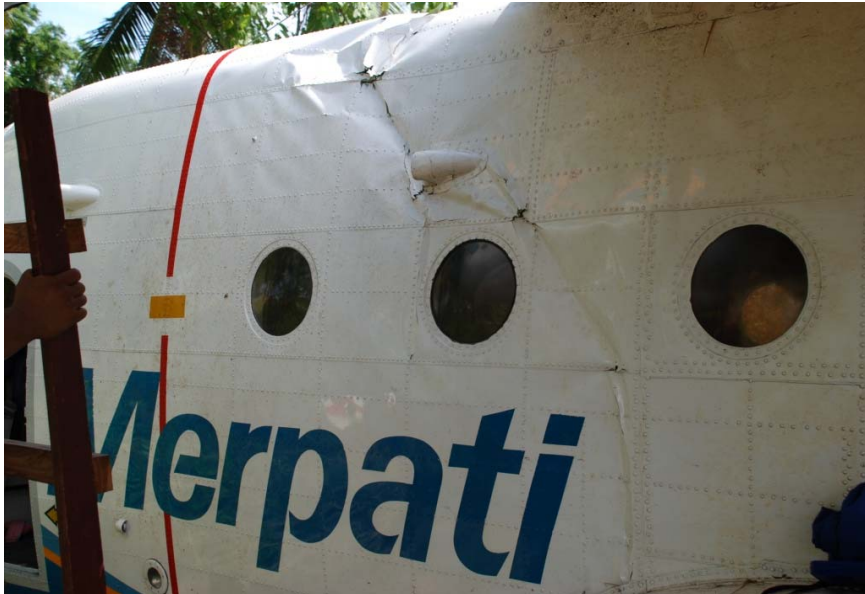
The fuselage left side were heavy wrinkles.

Figure 6: Left side of fuselage wrinkled

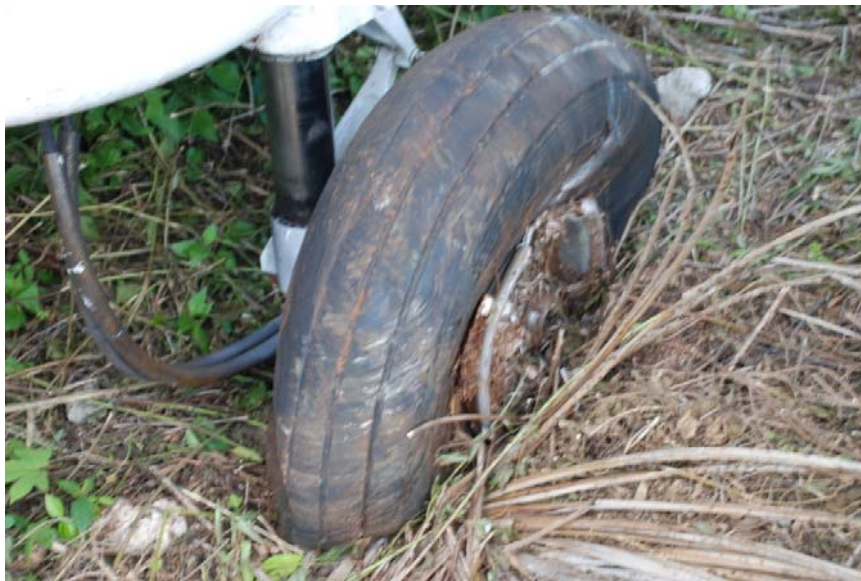
Figure 7: Right Wheel tire and skid mark on it
