FINAL
KNKT.11.11.25.04

Aircraft Accident Investigation Report

**PT. ASI Pudjiastuti Aviation
C208B Cessna Grand Caravan ; PK-VVG
Bilogai Airstrip, Sugapa
Papua
Republic of Indonesia**

26 November 2011

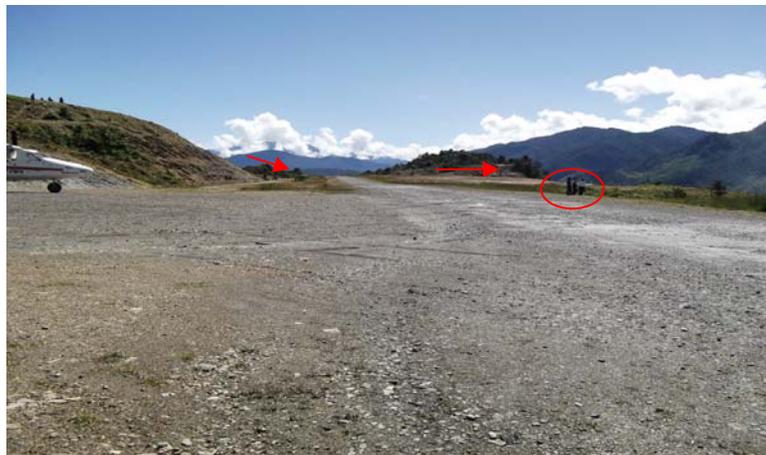
Figure 2: The walking direction of local people

There were no fences and no warning sound signal/sirens to alert the local people which on the runway area during aircraft takeoff and landing.

Nearby the runway, there is a local farm field owned by local people that they crossed the runway to go through the area.

There was no warning signal to alert if unauthorized persons entering the runway, especially during any aircraft take off and landing.

NTSC recommends that Directorate General of Civil Aviation should assure that unauthorised person entering onto active runway in Bilogai/Sogapa Airport was protected or prohibited by any mean or at least a warning signal should be available to alert any people not to enter the runway when the aircraft on approach or prior take off.

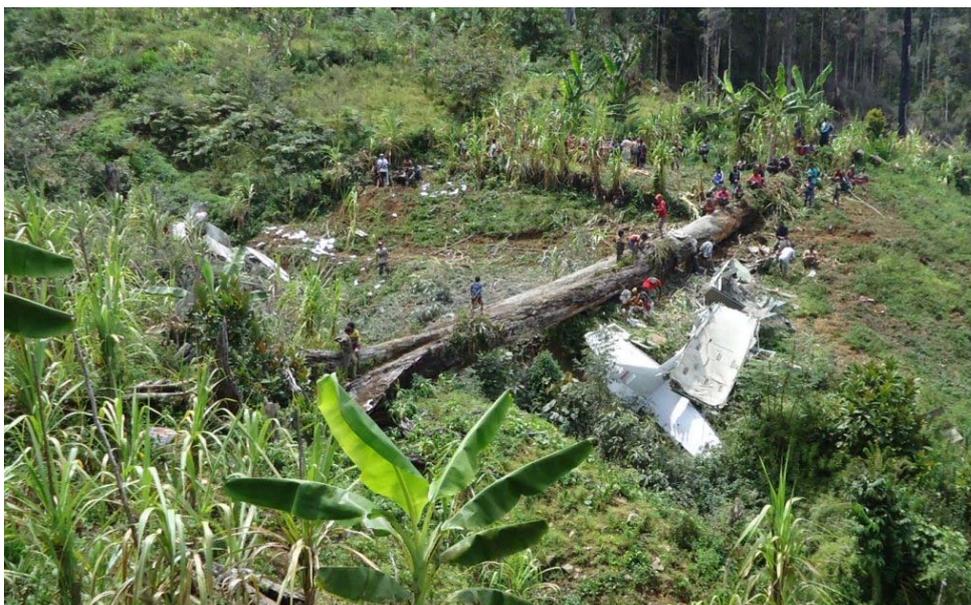
Figure 4: The accident site

The wreckage was in two areas separated by a large tree trunk with the diameter about 1 meter. The fuselage, tail plane, roof and main landing gear were located at northern side of the tree while the wings, nose landing gear, cockpit completed with engine and propeller were situated at southern side of the tree.

The aft fuselage and tail plane were aligned almost parallel with the trunk and the tail plane pointing to 120°.

The fuselage had broken up, but the roof was still intact, showing clean separation and no evidence of twisting.

The wings were lying in V pattern with the left hand wing inverted and outer end facing 120°. Most of the outboard section of the wing up to flaps was damage.

The cockpit was facing 340° and complete with engine and propeller, although partly buried in the mud, exhibited distortion consistent with being under power at the time of impact.

The lock-wire of the emergency power lever was broken. The flap selector was found set at 20°. The legs of the captain seat had collapsed. The floor below second in command seat had been pushed upward by impact.

The second in command control column had dislodged from the instrument panel in a full back position. The control for the inertial separator was unlocked.

The propeller was partly buried in the mud and bent, and it indicated that the engine was still in power at the time of impact.
