AIRCRAFT INCIDENT REPORT AND EXECUTIVE SUMMARY

Reference:	CA18/3/2/0825	
Aircraft Registration	ZS-SGX	Date of Incident	10 January 2011		Time of Incident	1850Z
Type of Aircraft	Boeing 737 -200		Type of Operation		Commercial	
Pilot-in-command Licence Type		Airline pilot	Age	66	Licence Valid	Yes
Pilot-in-command Flying Experience		Total Flying Hours	26 512		Hours on Type	Unknown
Last point of departure		Hoedspruit military aerodrome, Limpopo province (FAHS)				
Next point of intended landing		O. R. Tambo International Airport, Gauteng province (FAJS)				
Location of the incident site with reference to easily defined geographical points (GPS readings if possible)						
Hoedspruit military aerodrome taxiway						
Meteorological Information		Intermittent rain				
Number of people on board	2 + 1	No. of people injured	0	No. of people killed	0	
Synopsis						
<p>The aircraft was flown on a non-scheduled charter flight from O. R. Tambo International Airport to Hoedspruit military aerodrome, where it landed safely and all 97 passengers disembarked. The crew then prepared to return to O. R. Tambo International Airport with no passengers on board. Whilst taxiing to the cleared holding point fo

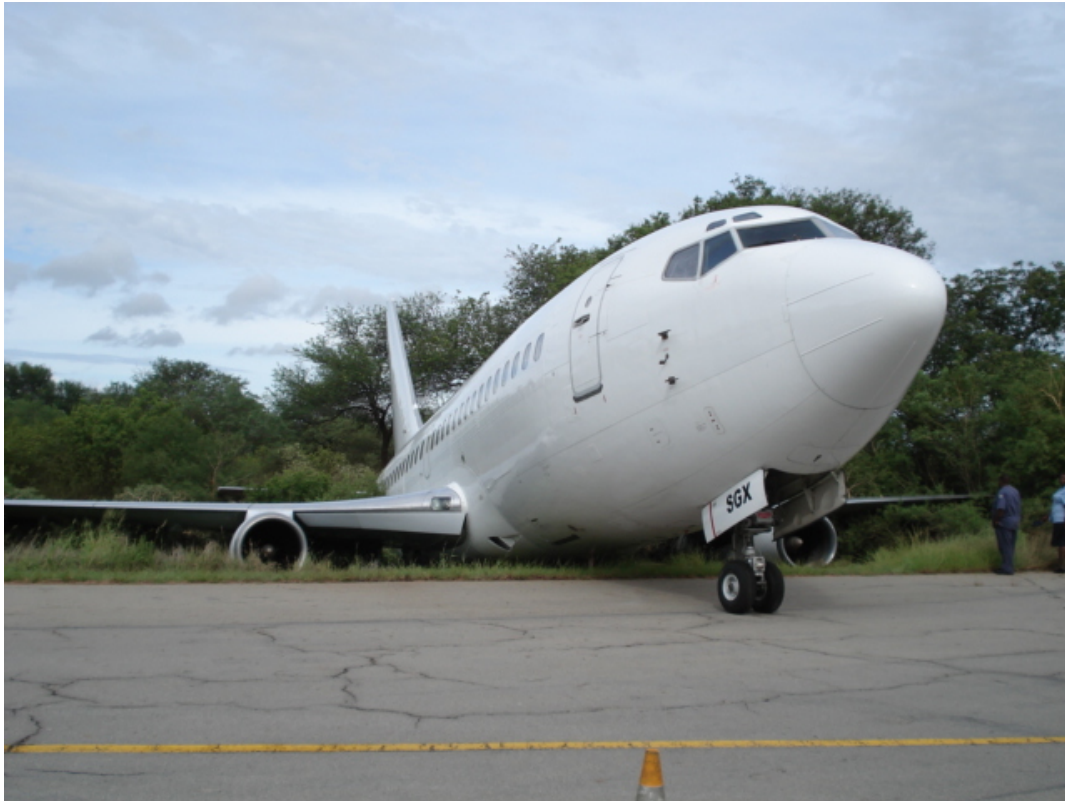
1.1.4 The aircraft was accordingly reversed, but the pilot failed to stop in time. The main wheels rolled off the edge of the taxiway and the aircraft slipped backwards down a four-metre embankment, coming to rest with the nose-wheel still on the taxiway. The captain attempted to power the aircraft out, but was unsuccessful as the angle of the embankment was too steep (see Figure 1 below). Nobody was injured and the following day the aircraft was towed to the VIP parking area.

Figure 1. The final position of the aircraft.

1.12.1 The aircraft slipped backward down a steep four-metre embankment, coming to rest with the nose-wheel still on the taxiway and the tail section in thorn trees. The aeroplane suffered substantial damage to both engines, the tail section, the undercarriage and the wings.

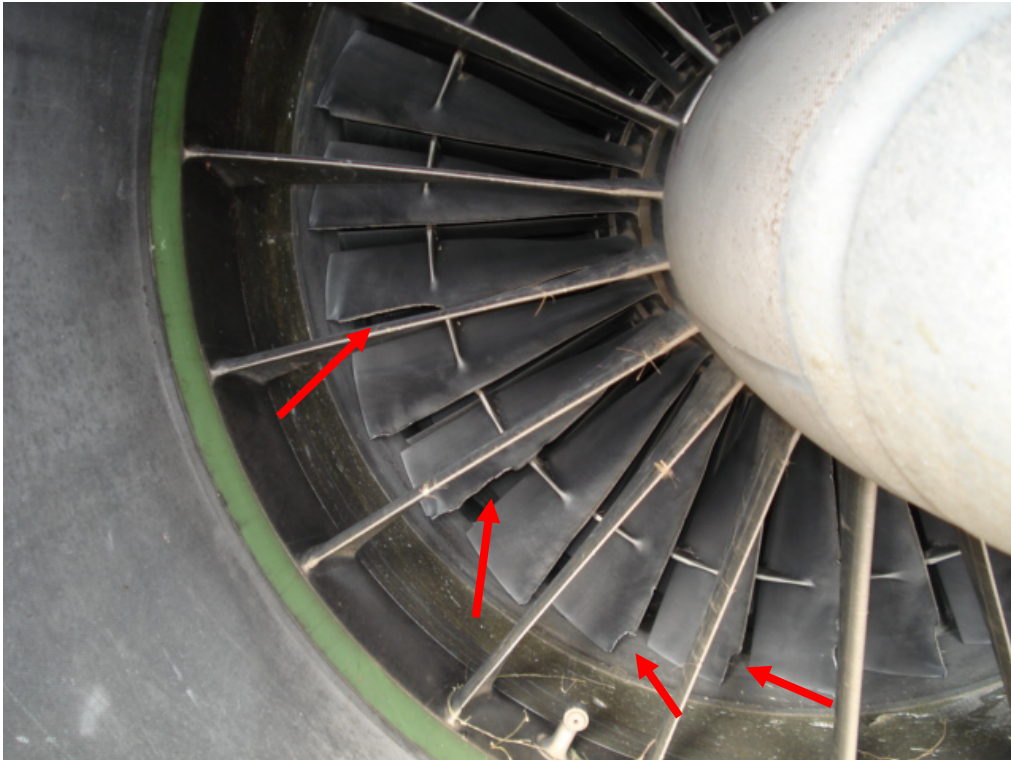
- Left engine sustained severe foreign object damage
- Main gear subjected to unknown stresses

Figure 2. Damaged fan-blades on No. 1 engine.

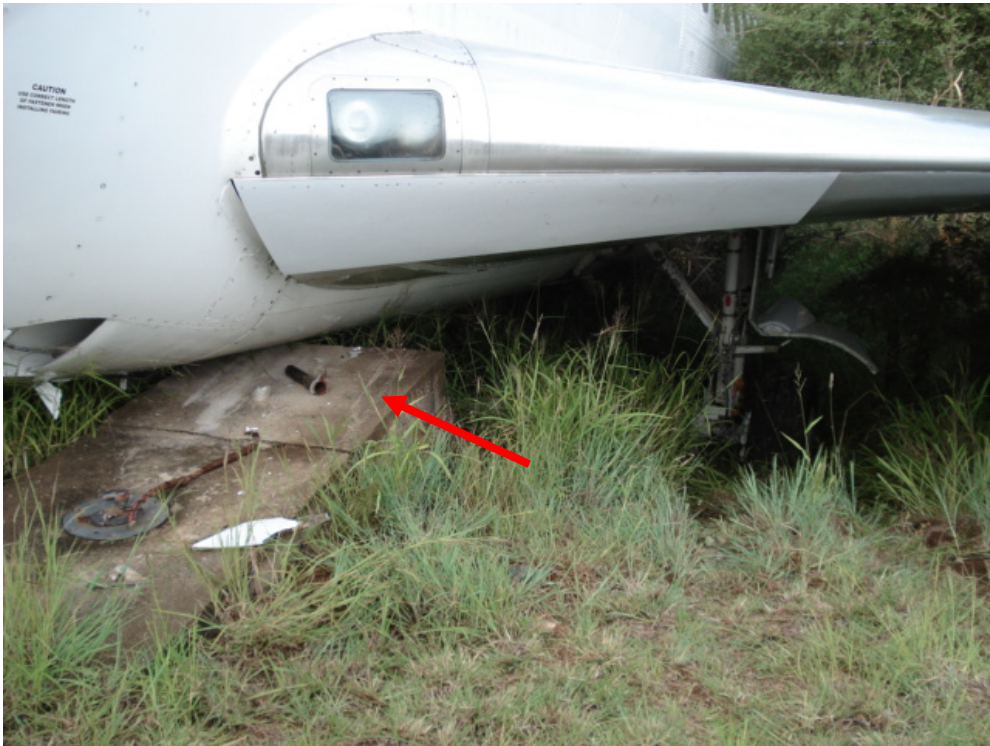
Figure 3. Concrete structure on ground caused damage to aircraft belly.

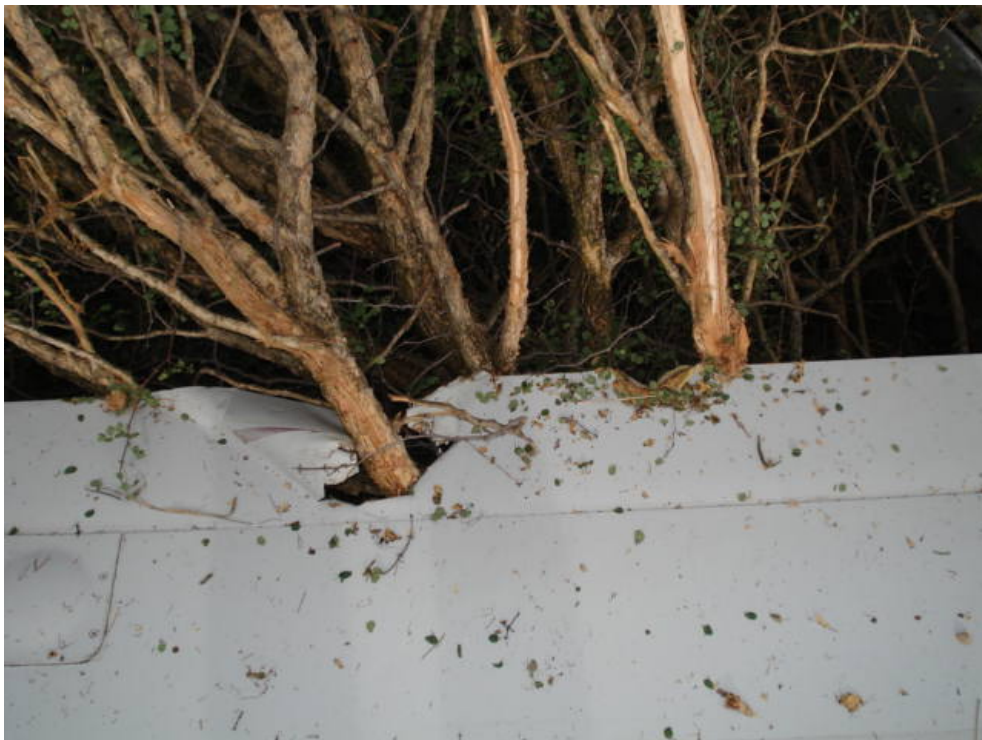
- Right wing outboard leading edge slat damaged
- Right wing aileron and flap trailing edge damaged
- Left wing inboard flap trailing edge damaged
- Left horizontal stabiliser leading edge dented
- Forward environmental equipment bay damaged
- Aft lower fuselage skins dented due to ground contact

Figure 4. Damaged right wing aileron.
